# Mould & Moisture Assessment St. Peters Consolidated School

**Project No. 12620**

**March 9, 2011**

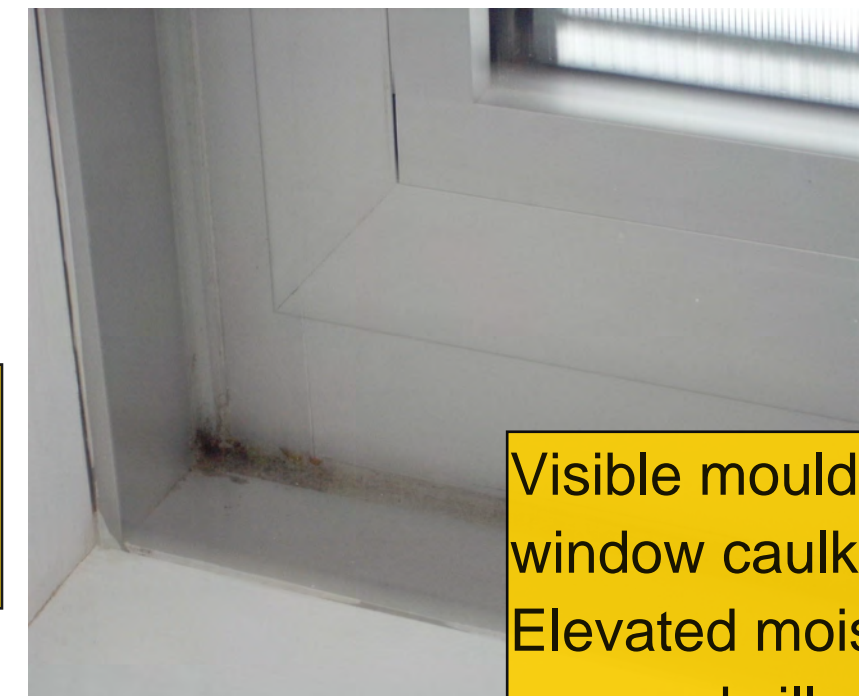
Visible mould on mechanical pipe insulation

Visible mould on window caulking. Elevated moisture on wood sill

Visible mould on shelving units and wall
