# Mould & Moisture Assessment Three Oaks Senior High School

**Project No. 12620**

**March 22, 2011**

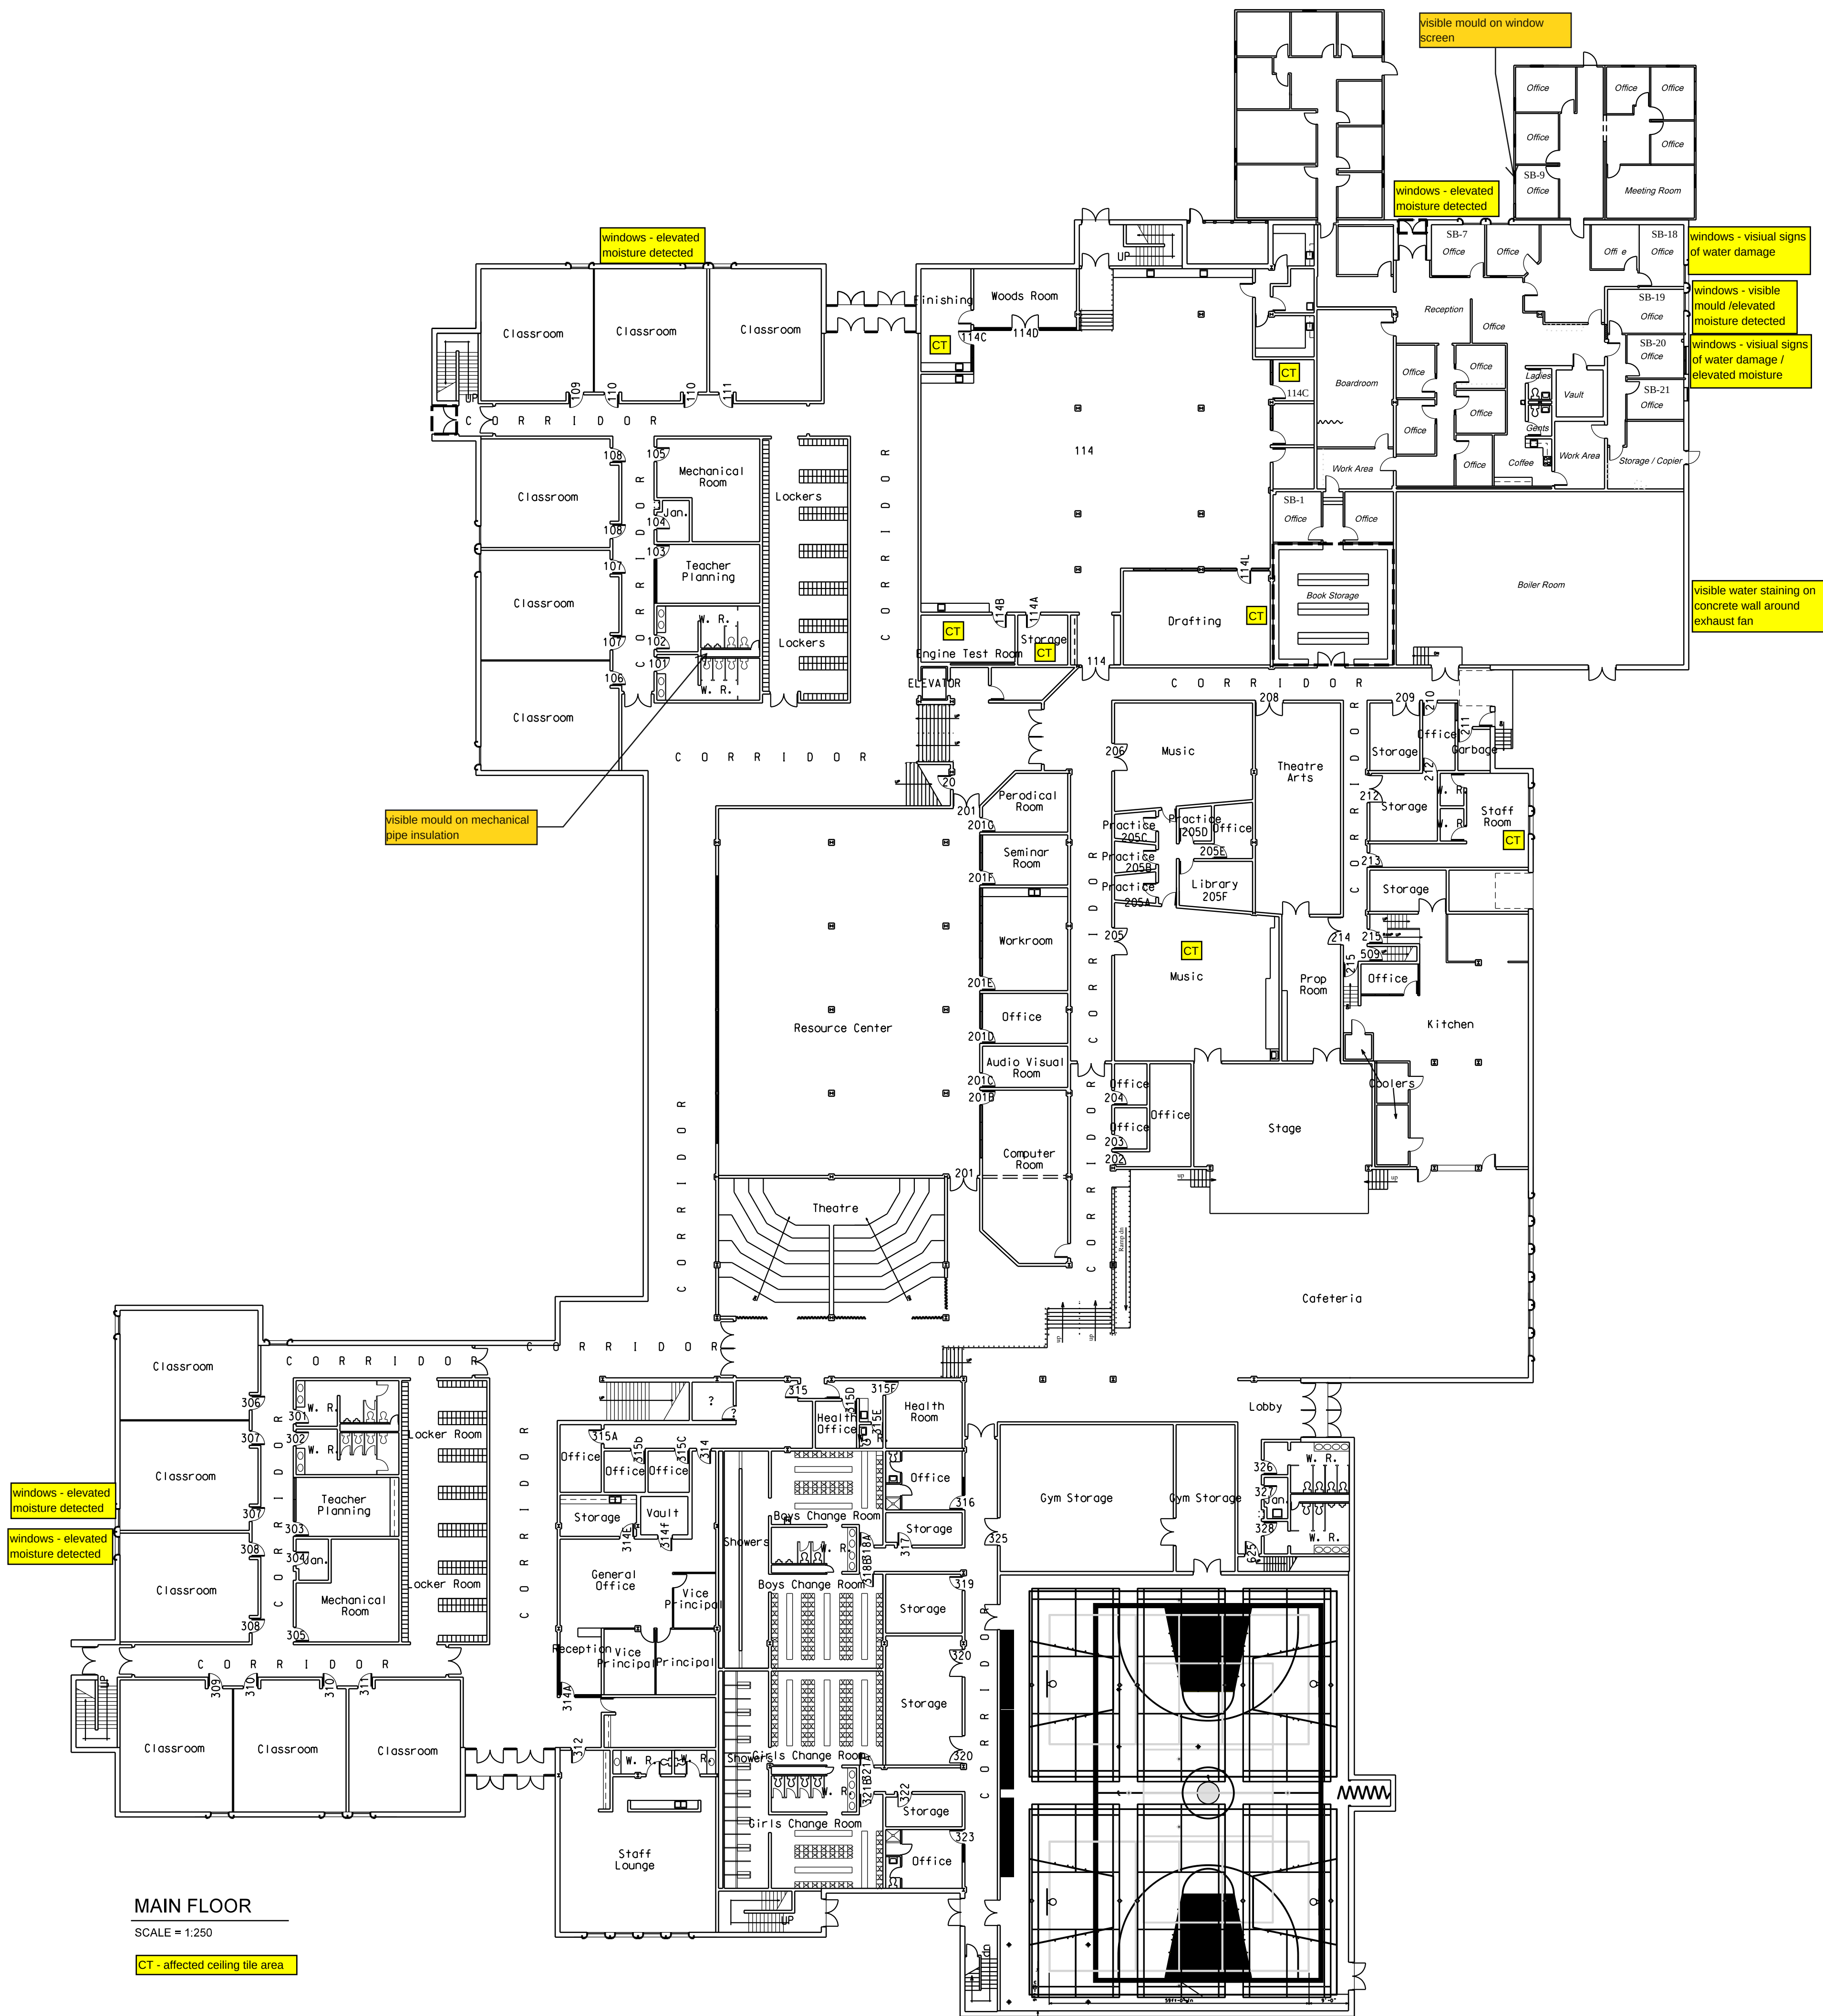
Main Floor Plan

| <b>Table III</b><br><b>Summary of Moisture affected areas</b> | | |
|---|---|---|
| Rms 110, 307, 308, 406, 408, 409, 412, 420, 422, 606, 607, 612, Corridor 200A; SB-7; SB-18; SB-19; SB-20 | Minor water damage and / or elevated moisture detected around window sills. | Further investigation required into addressing water infiltration and potential hidden mould |

| Rms 114A; 114B;<br>114C; 114I; 114L; 205;<br>213; 613; 614; 616;<br>616A; 618; 619; 620;<br>SB-1 | Stained ceiling tiles observed<br>and reported throughout the<br>building on both levels (see<br>site floor plan - Appendix I for<br>location markings). | Replace ceiling tiles as<br>precautionary measure and to<br>assist in detecting further water<br>leaks. Some leaks were reported<br>at the time of assessment. |

CT - affected ceiling tile area

Several windows throughout the school were found to have elevated moisture and/or visible water damage in or around windows sills. These locations are noted in Table III and are identified on the site floor plan (Appendix I). Further investigation should be carried out in these areas to address water infiltration issues and potential hidden mould

All ceiling tiles exhibiting evidence of water damage are recommended to be removed and replaced as a precautionary measure while those ceiling tiles identified and/or exhibiting evidence of suspect mould contamination are recommended to be removed following Level 1 mould remediation protocols.

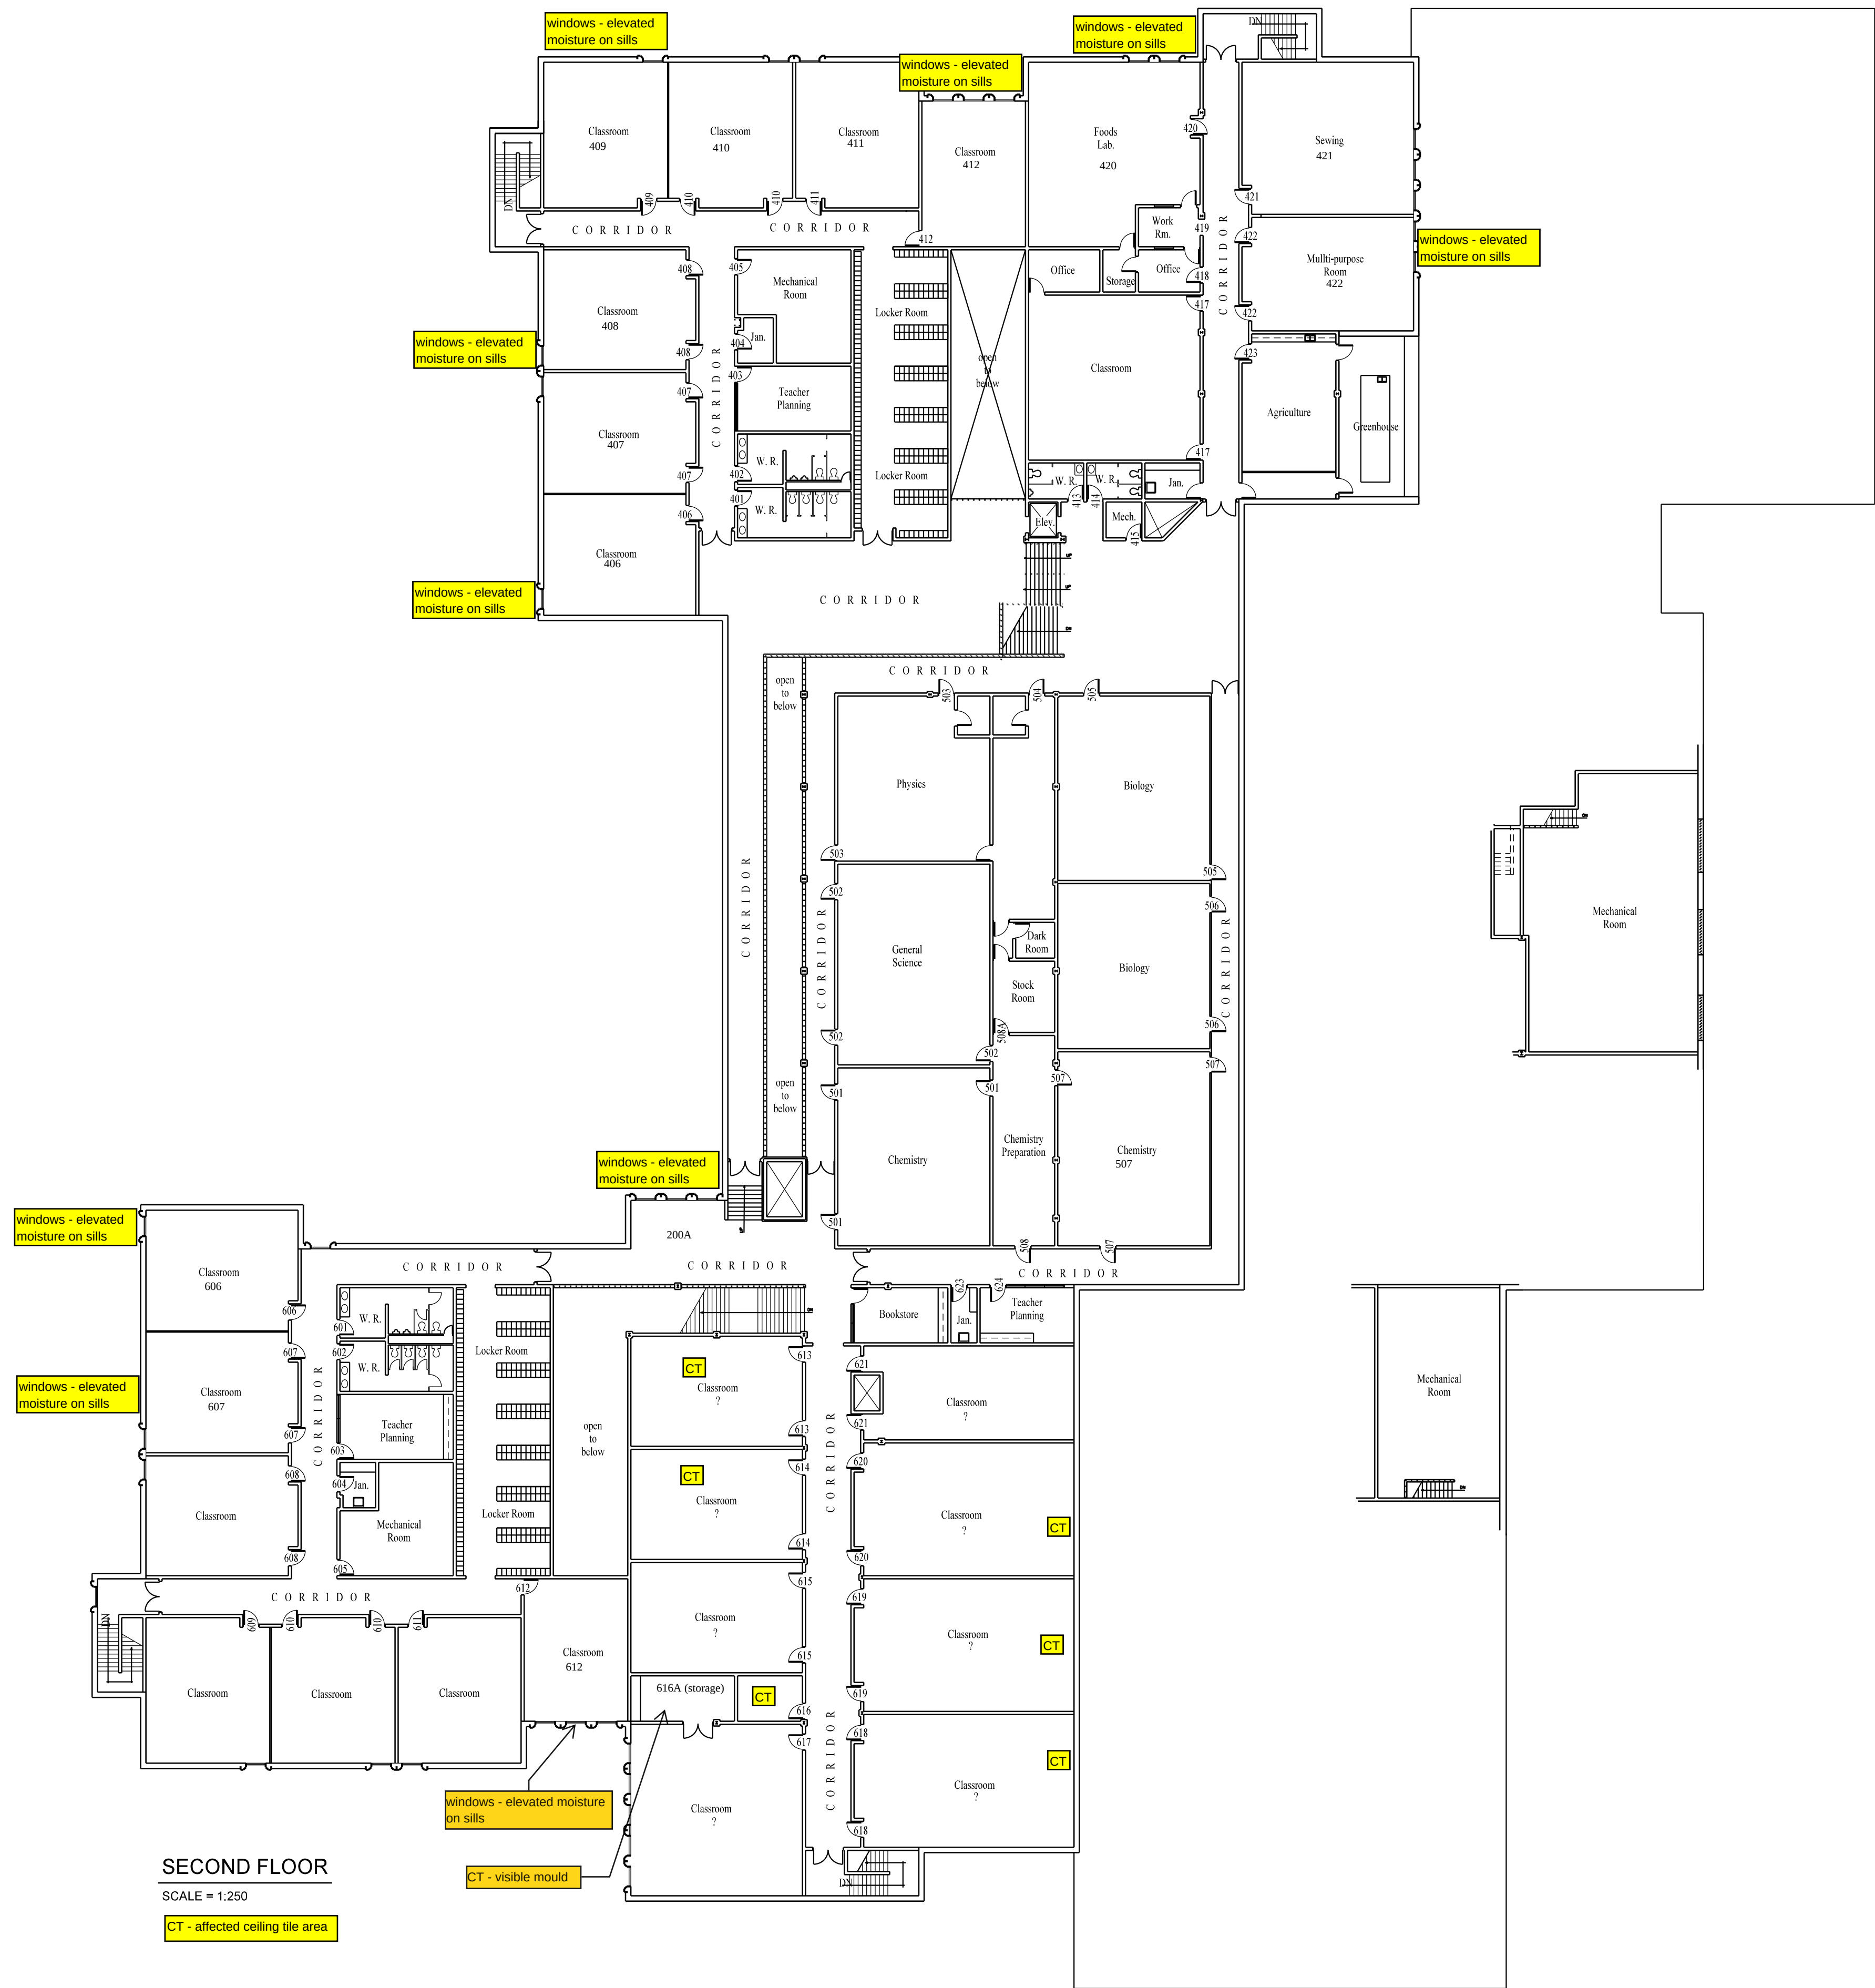
| Rms 618; 619; 620 | Visible water damage around<br>skylight enclosure<br>Delaminated wall finish.<br>(Elevated moisture detected<br>on drywall wall surface). | Further investigation required into<br>addressing water infiltration and<br>potential hidden mould |

The skylight on the second level has extensive water infiltration around the base of the skylight and elevated moisture detected. It is recommended that further investigation be conducted in these areas to address water infiltration and potential hidden mould.
