**TIGNISH CONSOLIDATED
ELEMENTARY SCHOOL**

Mould & Moisture Assessment Tignish Consolidated Elementary School

Project No. 12620

May 4, 2011

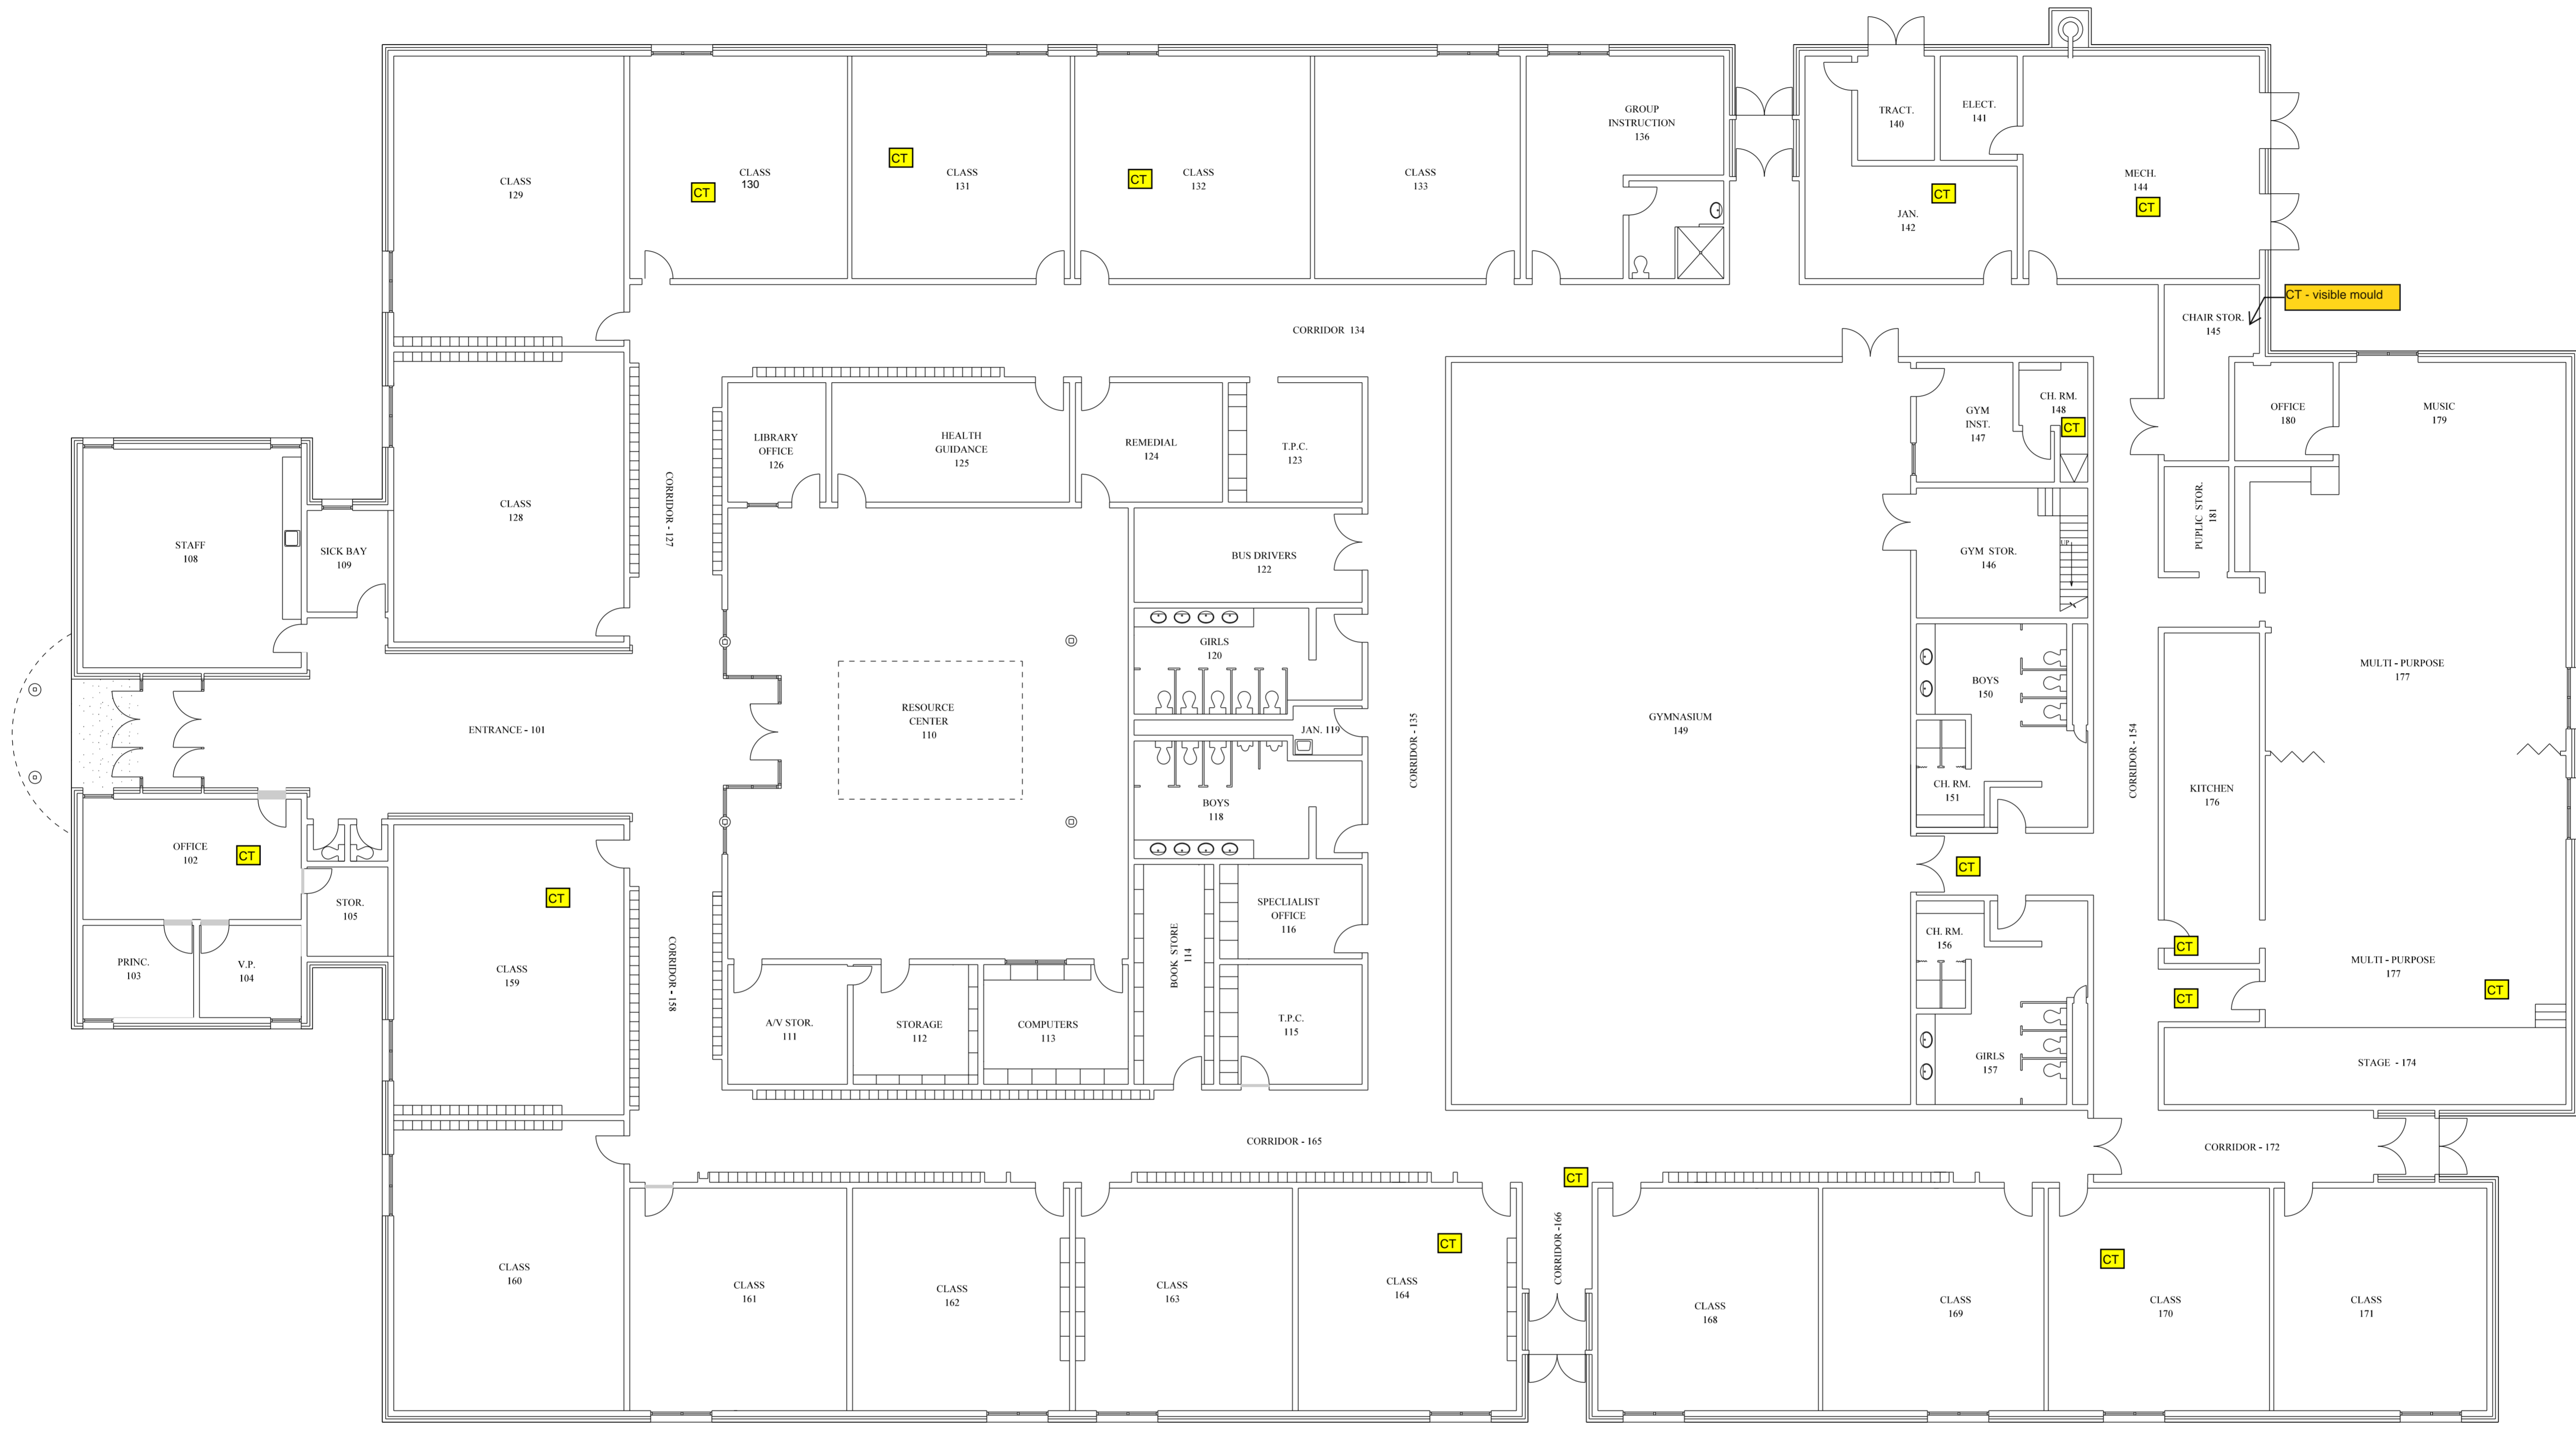
Drawing Title :
Main Floor Plan

| Table III Summary of Moisture affected areas | | |
|---|--|--|
| Rm-102, 130, 131, 132, 142, 144, 145, 148, Corridor 154, 159, 164, 166, 170, 176, 177 | Stained ceiling tiles observed and reported throughout the building (see site floor plan - Appendix I for location markings) | Replace ceiling tiles as precautionary measure and to assist in detecting further water leaks. Some leaks were reported at the time of assessment. |

CT - affected ceiling tile area
