# Mould & Moisture Assessment West Royalty Elementary School

**Project No. 12620**

**May 17, 2011**

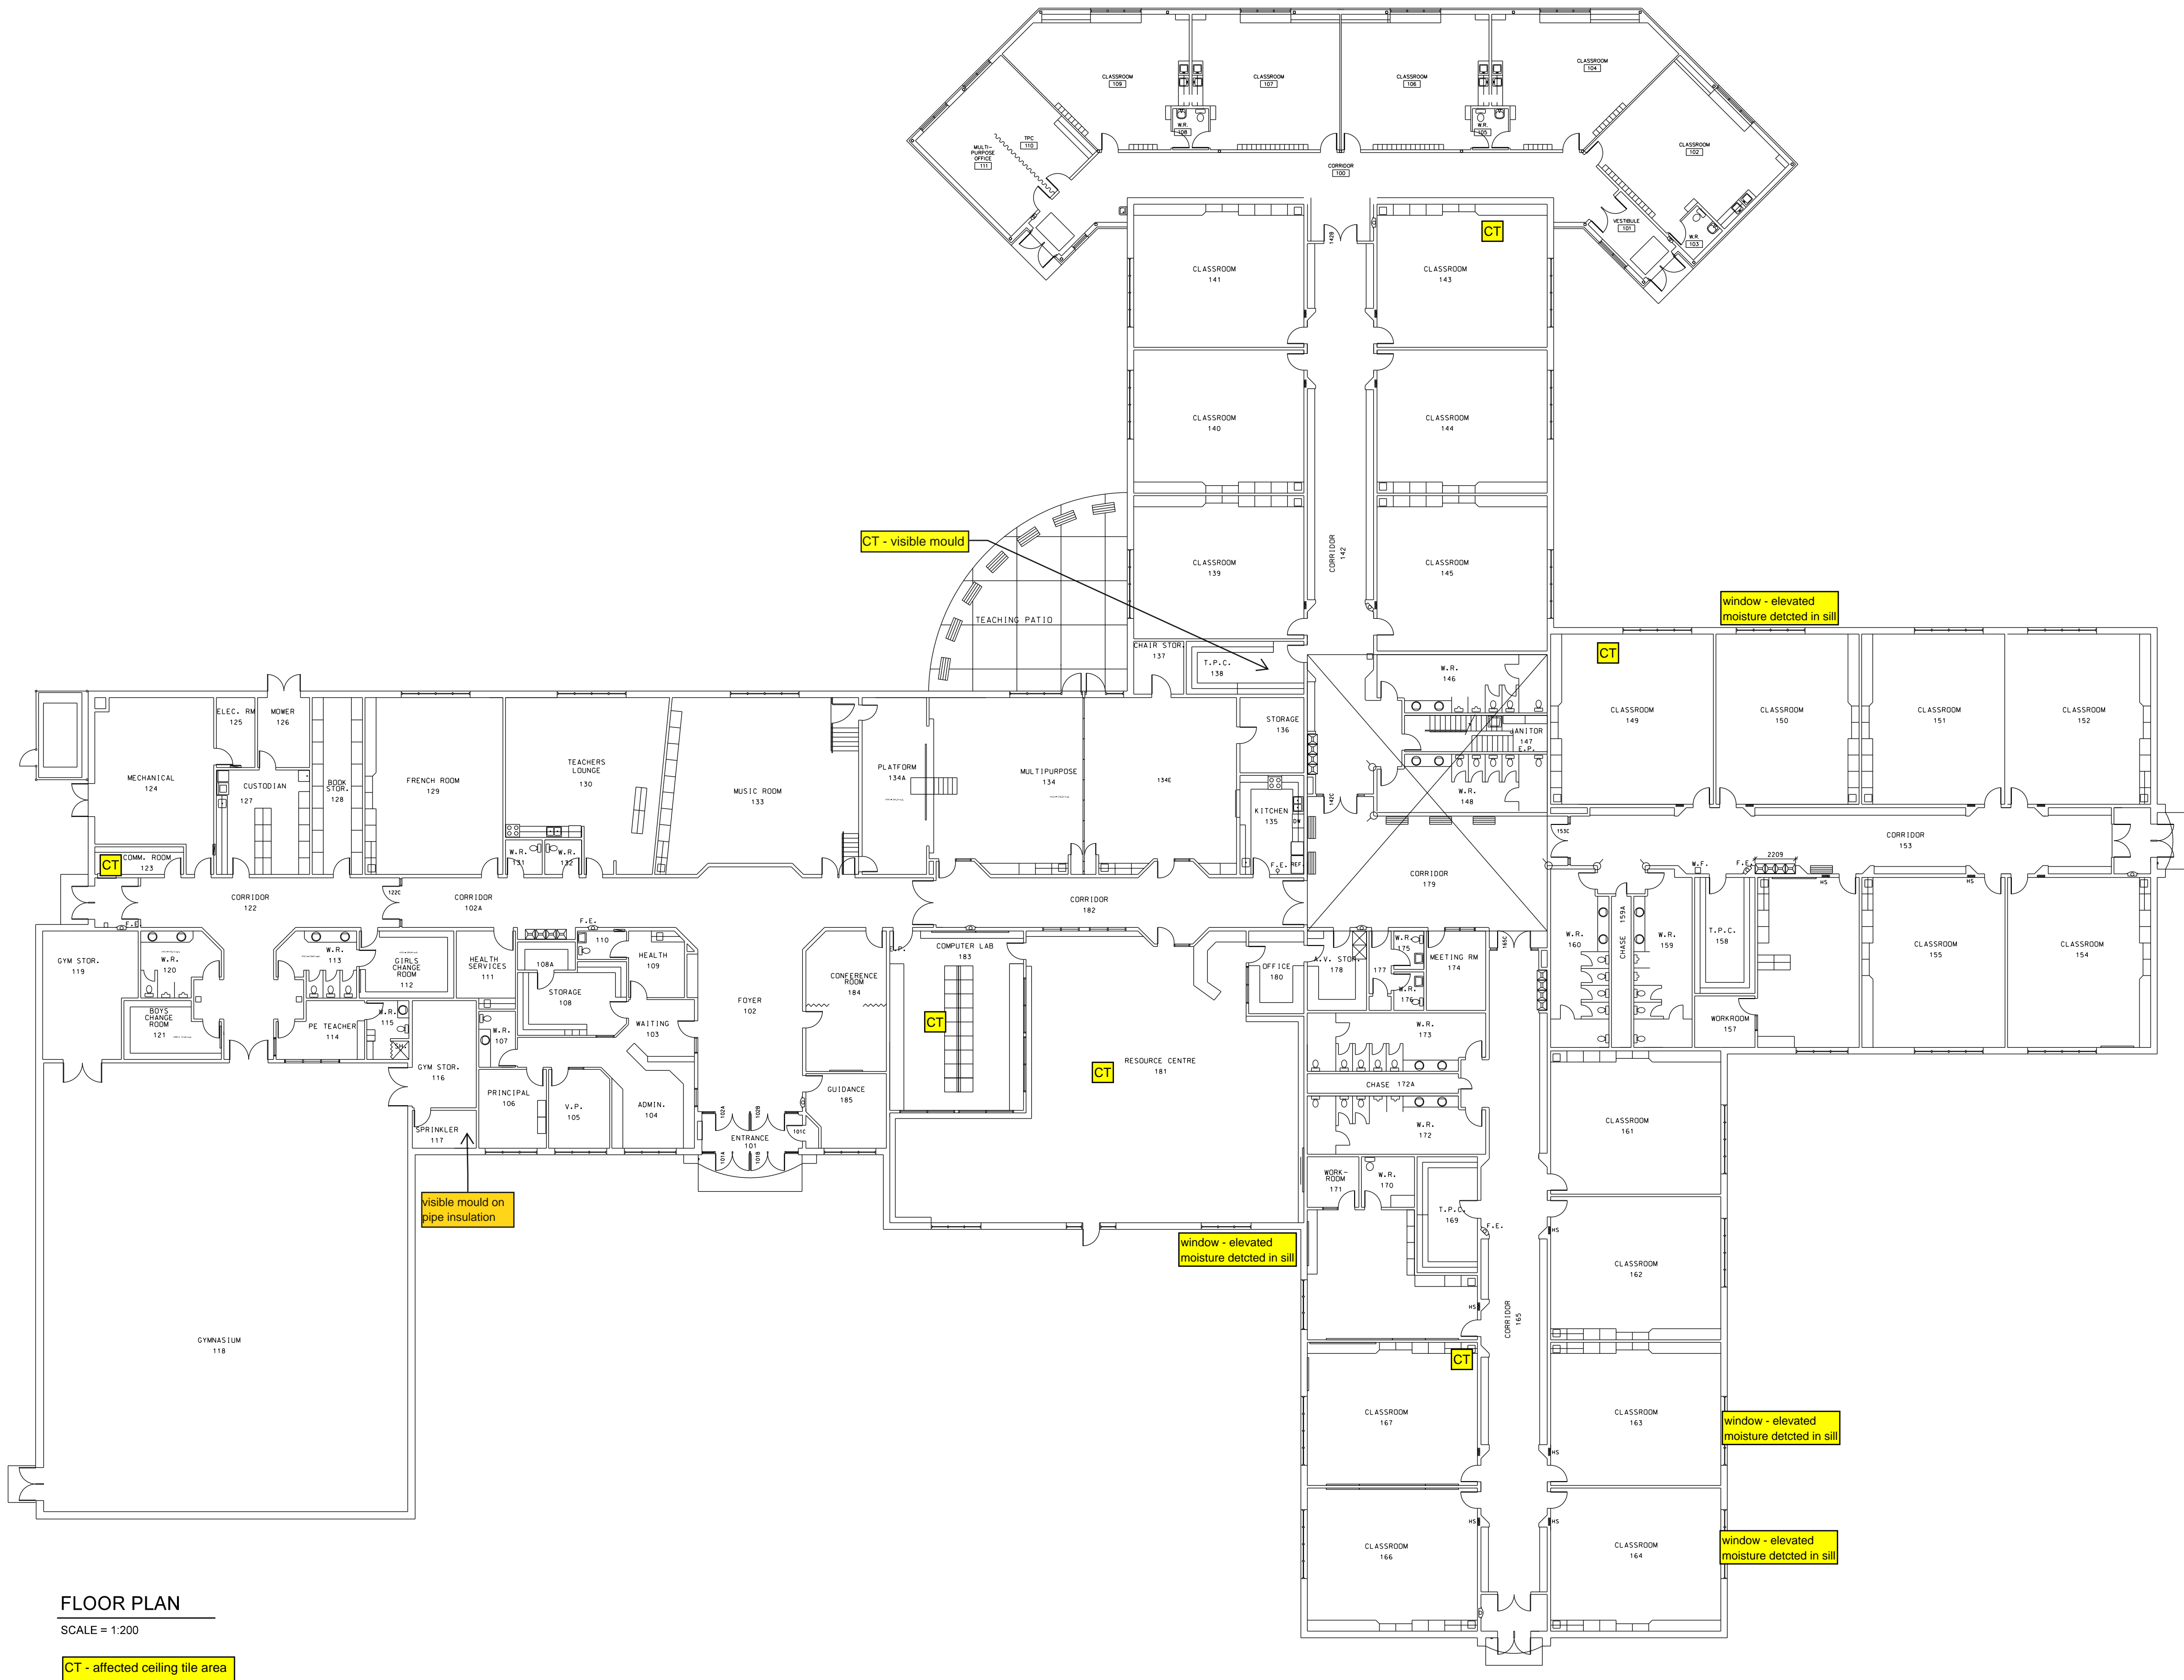
Drawing Title :  
**Floor Plan**

<b>Table III</b> <b>Summary of Moisture affected areas</b>		
<b>Room No. / Description</b>	<b>Comments / Observations</b>	<b>Action required</b>
Rms 123; 143; 149; 167; 181; 183	Stained ceiling tiles observed and reported in the noted locations (see site floor plan - Appendix I for location markings).	Replace ceiling tiles as precautionary measure and to assist in detecting further water leaks.
Rms 150; 163; 164; 181	Elevated moisture detected in window sills at the time of the assessment.	Further investigation required into addressing water infiltration and potential hidden mould.
