**Connaught Point**  
**ENVELOPE MAINTENANCE REVIEW #3**

**Produced by PBEM Ltd.**

**Feb 1, 2007**

Strata Plan LMS 265  
2288 West 12ave,  
Vancouver, B.C

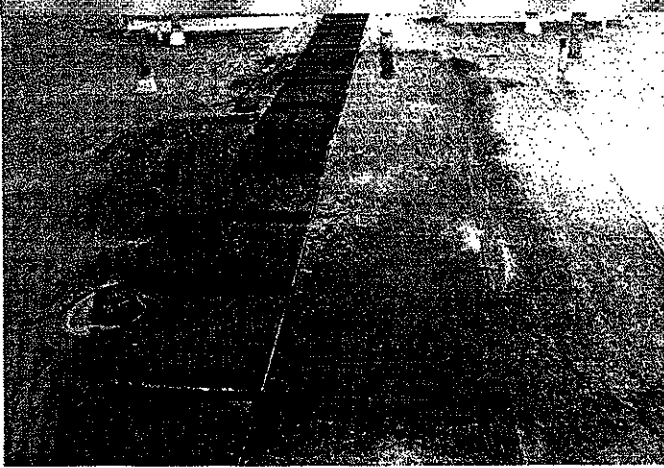
Photo R1: Main Roof

Shows area of ponding

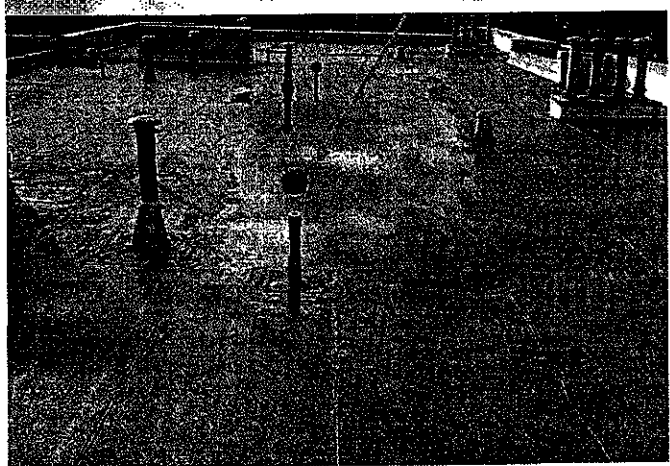
Photo R2 : Main Roof

Shows area of ponding

Reference R3

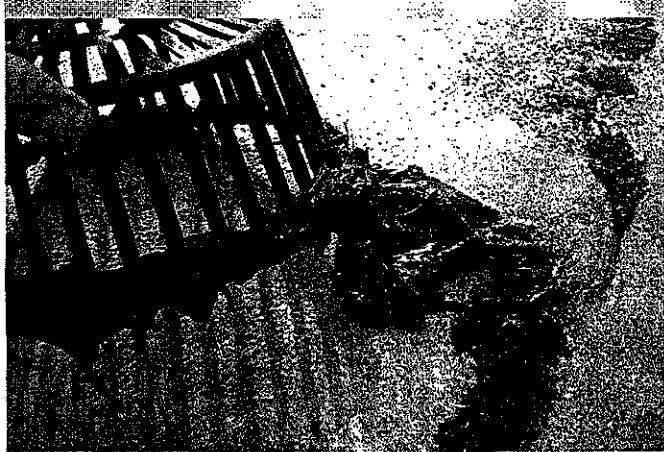
Photo R3: Main roof strainer

Minor debris on strainer

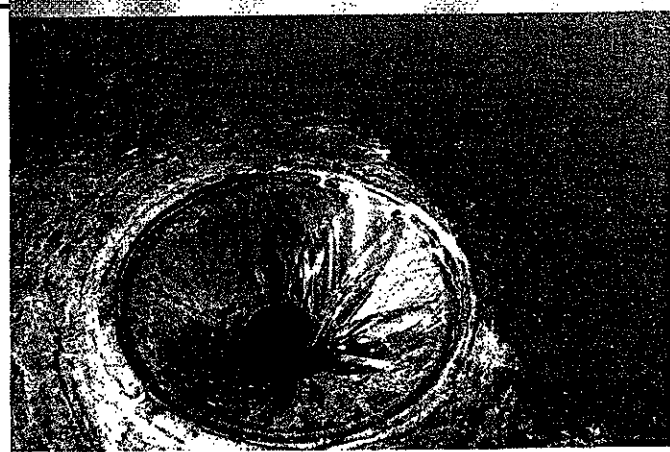
Photo R4: Roof drain

Clearing R3 debris resulted in approx 70 gal less water on roof

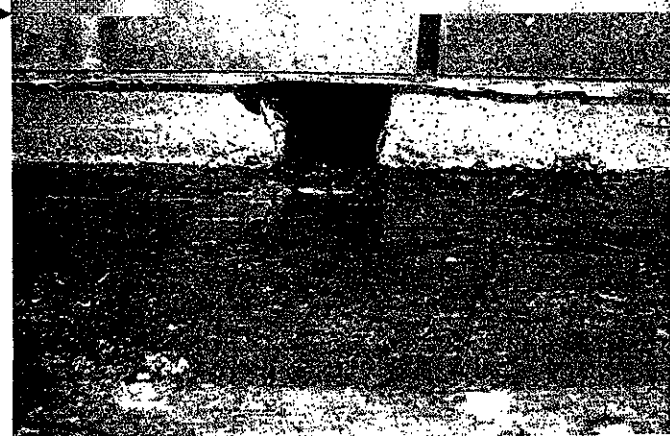
Photo R6:

Larger, lower hole on same detail provides better drainage

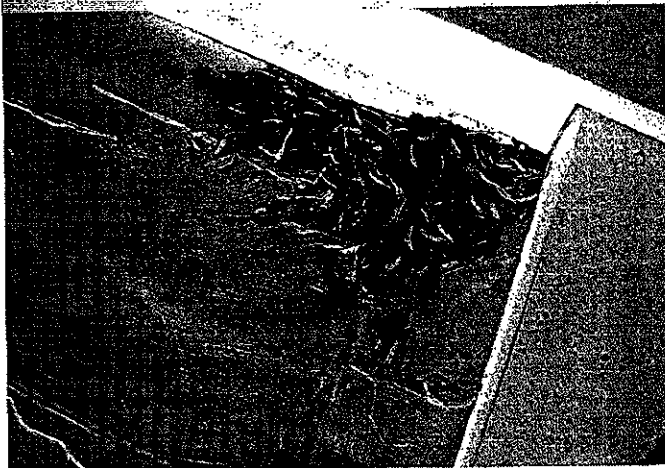
Photo R7: Typical of membrane corner details

Minor debris collecting in corners of main roof

General house keeping is recommended to remove debris from all roof areas (R7) as these materials can shorten the membrane life span, or even puncture it. The cap flashing should also be cleaned periodically to extend the service life of the paint and therefore preserve the service life of the flashing. Minor debris had accumulated around a drain strainer (R3, R4). This minor build up impedes drainage and as the photos demonstrate, allow more ponding on the roof than is necessary. Ponding on the main roof areas (R1, R2, and R5) was observed in several locations. Standing moisture can deposit debris that in turn retains more moisture leading to advanced thermal cycling and/or membrane wear. Housekeeping efforts should include removing debris at these locations several times a year. When the existing membrane reaches its useful life and renewal takes place, the membrane substrate should be modified to eliminate this condition.

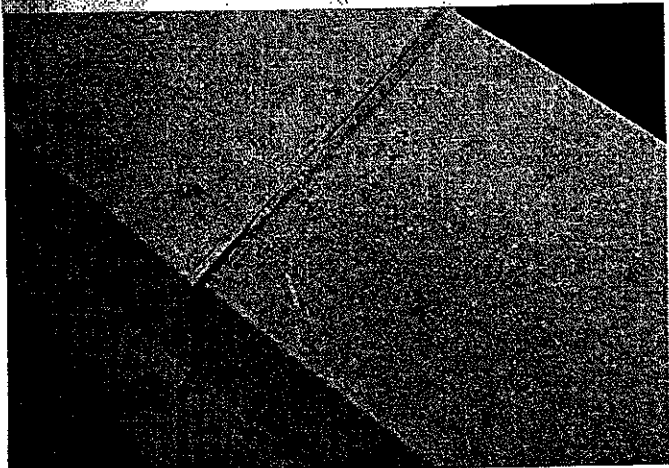
Photo R8: Main roof flashing

| OBSERVATIONS DURING REVIEW | Picture | Level |
|---|---|---|
| Cap flashing and roof detail sealant failures | R8, R9,<br>R10 | 1 |

Failed sealant

Roof perimeter cap flashing, roof penetration cap flashing, and firewall flashing have all been installed with the use of sealant at joints and exposed fasteners. A number of locations displayed failed sealant; PBEM recommends the replacement of all failed sealant in these areas at main roof.

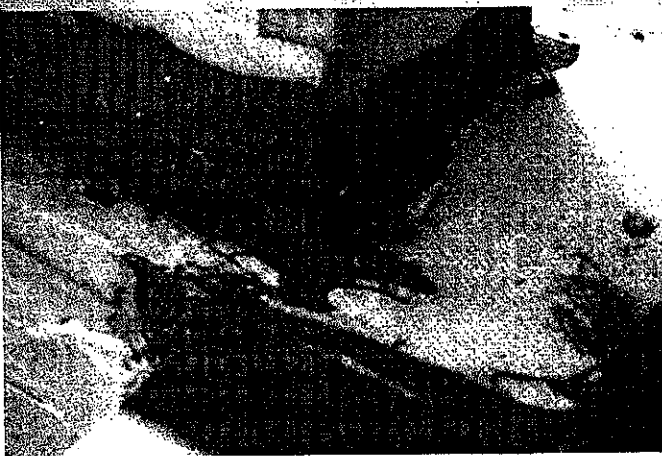
Photo R9: Central main roof

Failed sealant at vent penetration

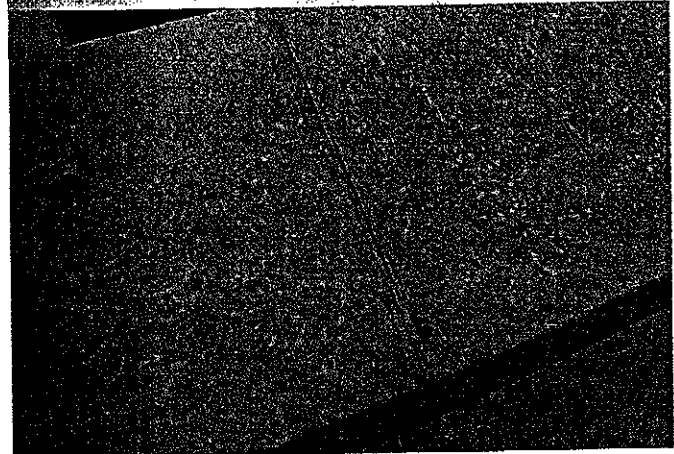
Photo R10: Main roof flashing

Failed sealant

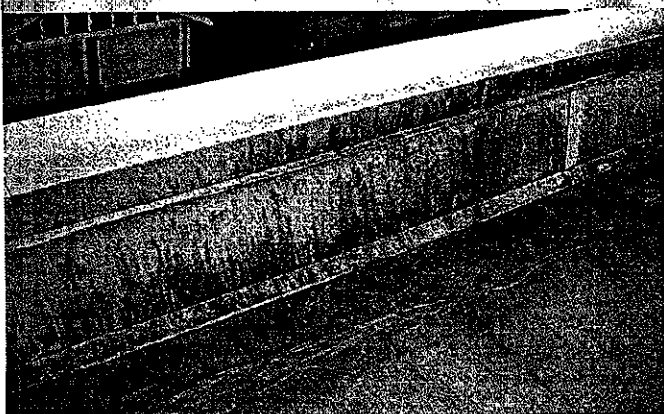
Photo R11: Main roof

Algae accumulating on flashings Typical

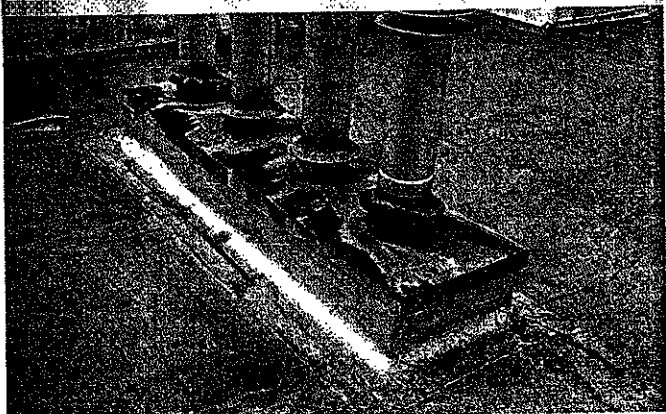
Photo R12: Main roof

| OBSERVATIONS DURING REVIEW | Picture | Level |
|---|---|---|
| Corroding galvanized flashings and ducts | R12 | 3 |

Corrosion of galvanized duct flashing Typical

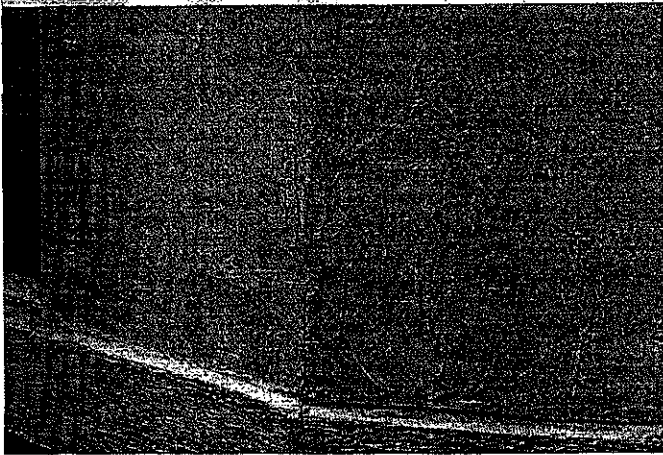
Photo V1 Unit 306 South

Paint deterioration on wood trim

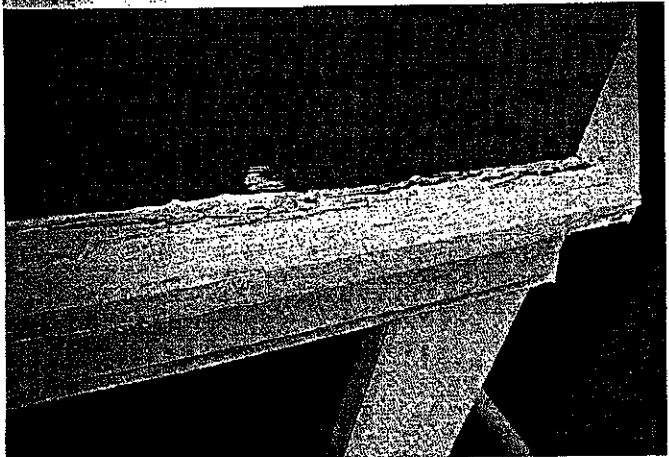
Photo V2 Unit 204 South

Paint deterioration on wood trim

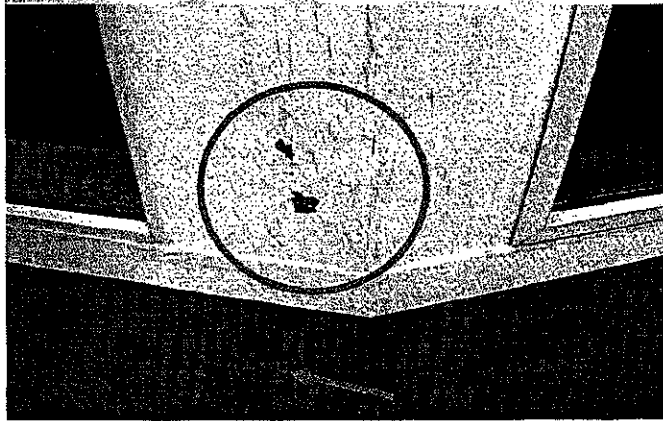
Photo V3 Unit 204 South

Paint deterioration on wood trim & evidence of moisture ingress

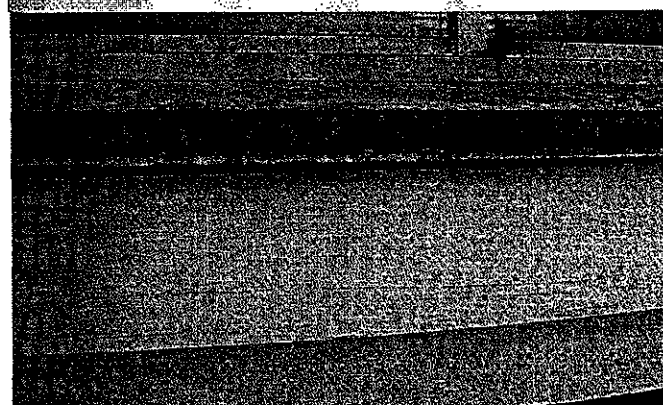
Photo V5

Accumulation of algae and debris Typical

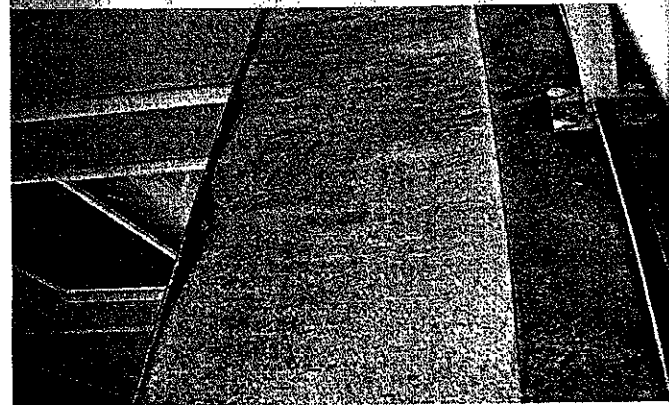
Photo V6

Accumulation of algae and debris Typical

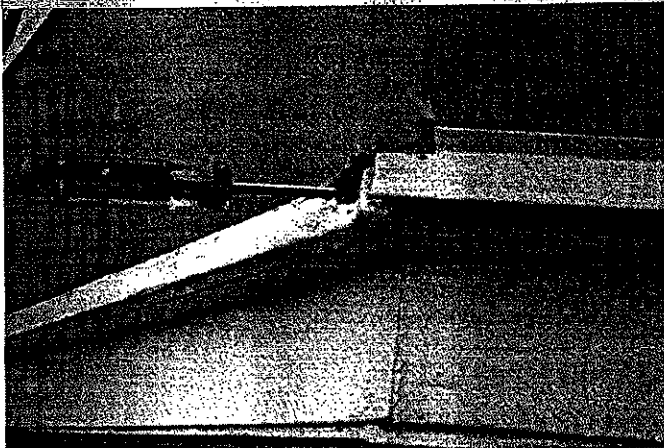
Photo V7: Unit 104 North

No sealant at gum lip or termination

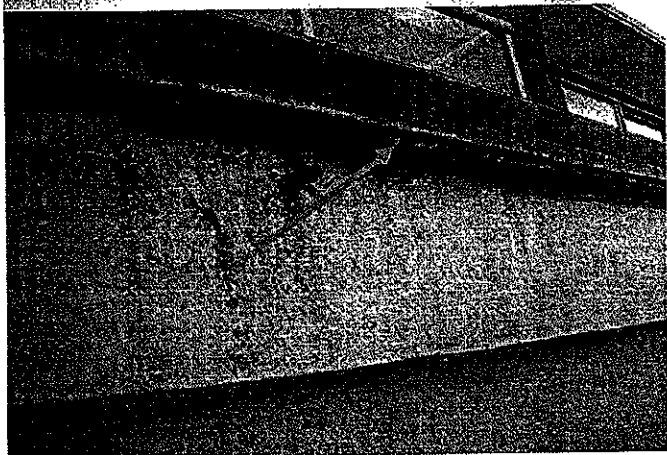
Photo V8: Unit 407 North

Wood under flashing exposed and deteriorated

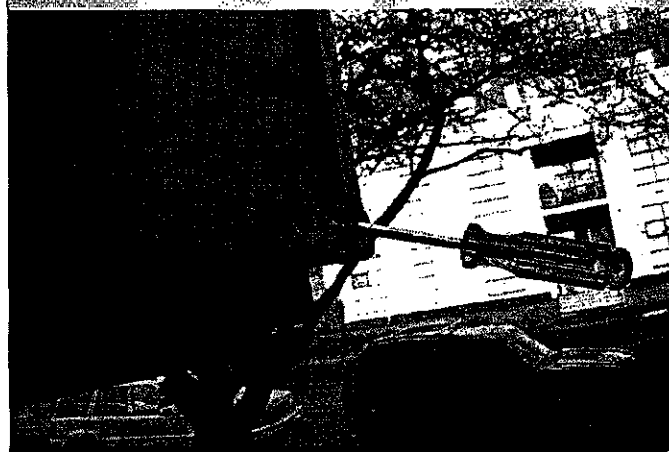
Photo V9: Entry sub roof East

Deteriorated trim

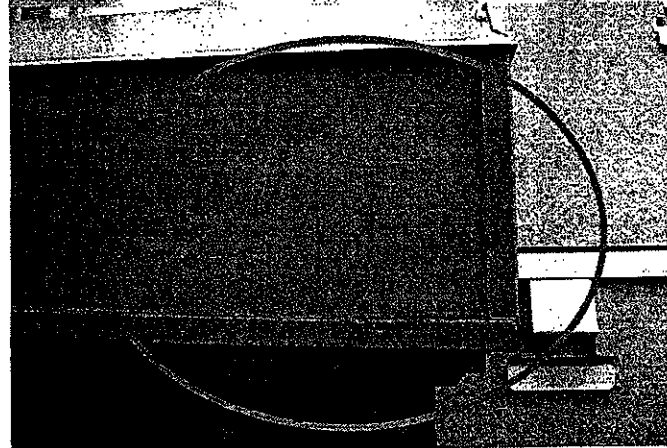
Photo V10: Entry sub roof West

Deteriorated trim and panel

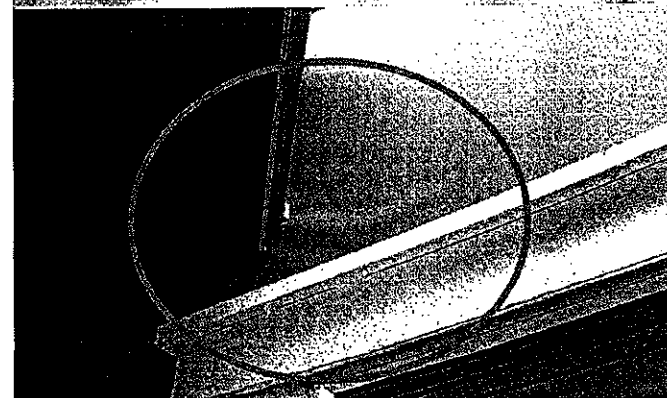
Photo V12: Unit 309 North

Deteriorated panel

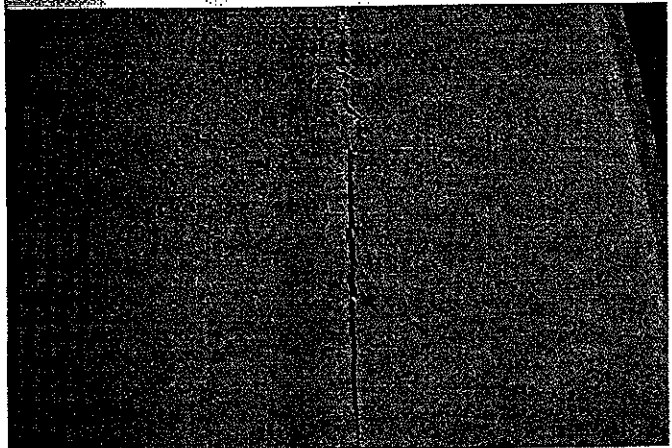
Photo V14: Unit 105

Separated exposes wood trim

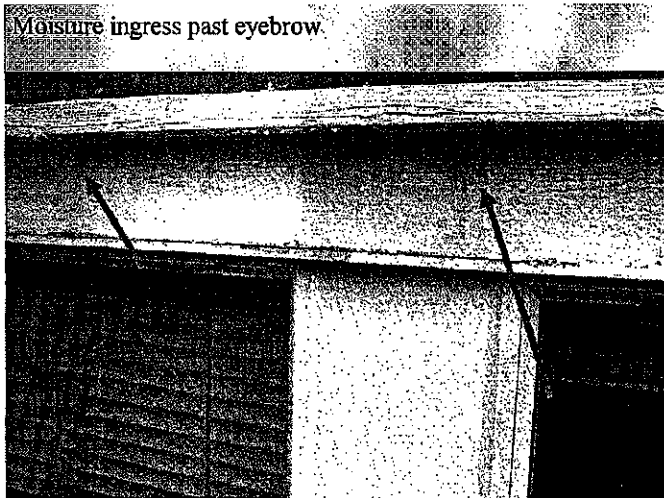
Photo V15: Unit 204 South

| OBSERVATIONS DURING REVIEW | | | Picture | Level |
|---|---|---|---|---|
| Corroding lintels | (South Elevation) | Monitor annually | V15 | 3 |

Moisture ingress past eyebrow

Lintels above balcony areas are showing signs of corrosion. As this is a supporting structure for the brick above, it is imperative to monitor this area for continued or excessive corrosion. At present this detail has not deteriorated noticeably since the last review. PBEM will continue to monitor this detail for change in upcoming maintenance reviews.

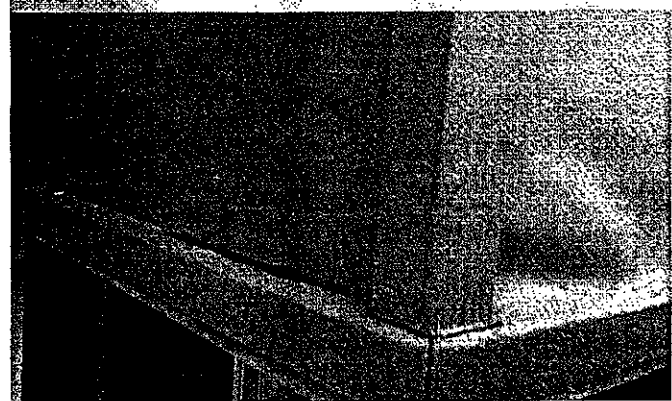
Photo V18 Unit 306 South

Warped balcony panel

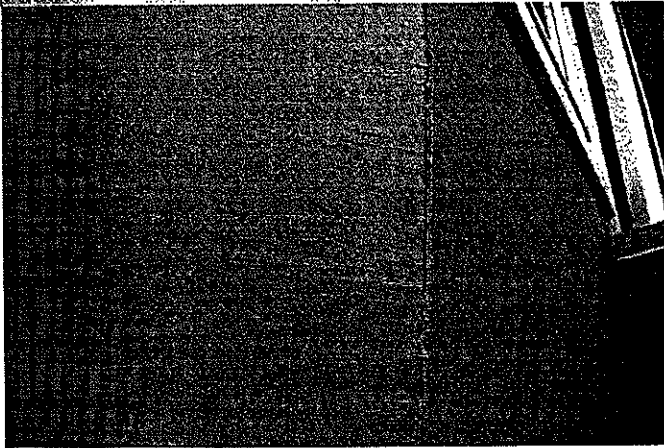
Photo V19: Unit 208 South

Exposed vertical joint

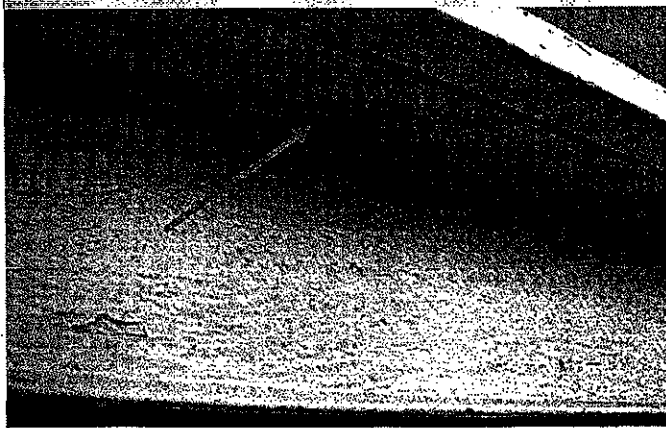
Photo V21: Unit 107 South

Moisture ingress past deteriorated eyebrow

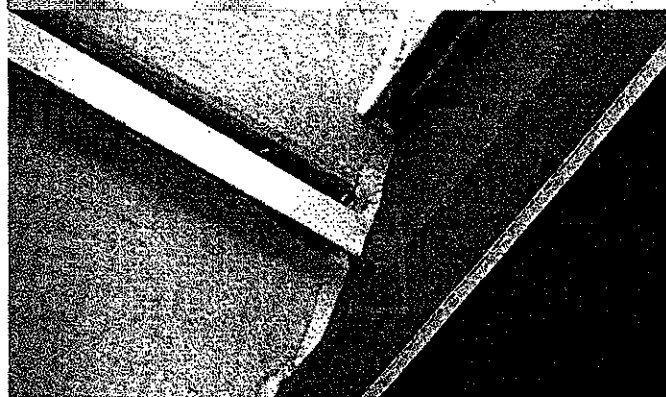
Photo V23 : Unit 209 North

Failed sealant

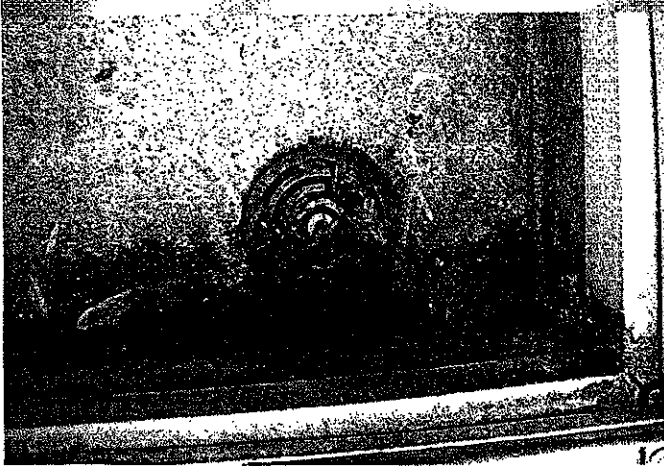
Photo B1: Unit 304 South

Partially blocked drain

The balcony drain on unit 304 balcony was found to be partially blocked. The balcony drains at Connought should be monitored periodically by the residents to ensure proper drainage. Ponding is an undesirable condition as standing water can exploit otherwise insignificant membrane deficiencies resulting in moisture ingress to underlying materials.

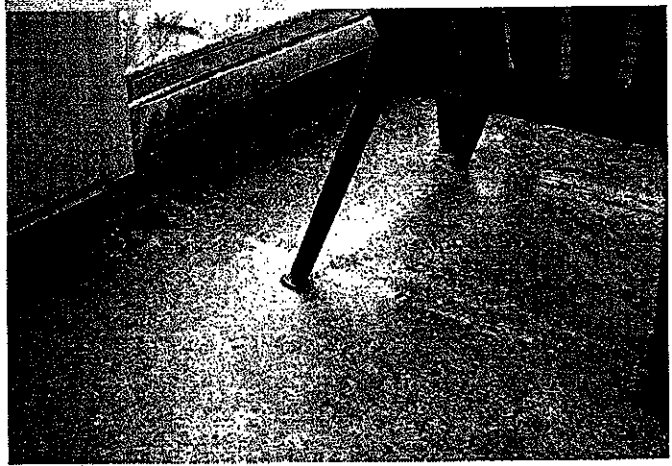
Photo B2

Accumulating algae and debris Typical of North elevation

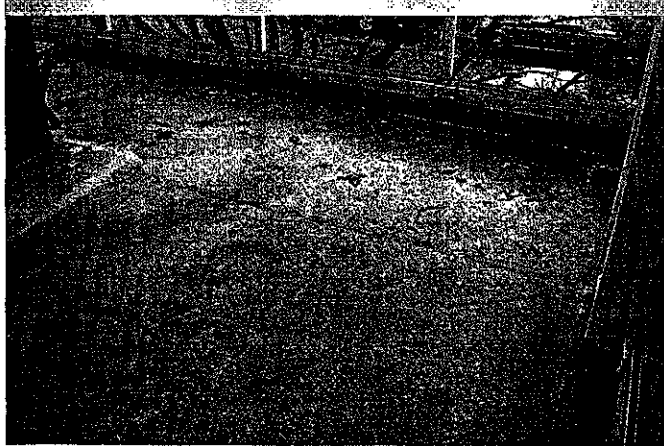
Photo B3

Accumulating algae and debris Typical of North elevation

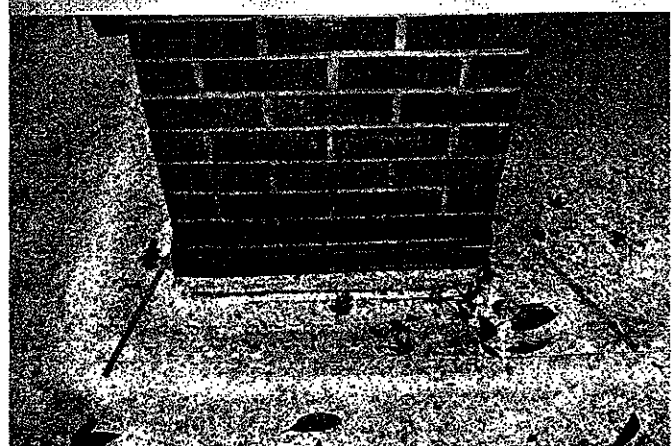
Photo B4: Unit 309 North

Minor membrane delamination

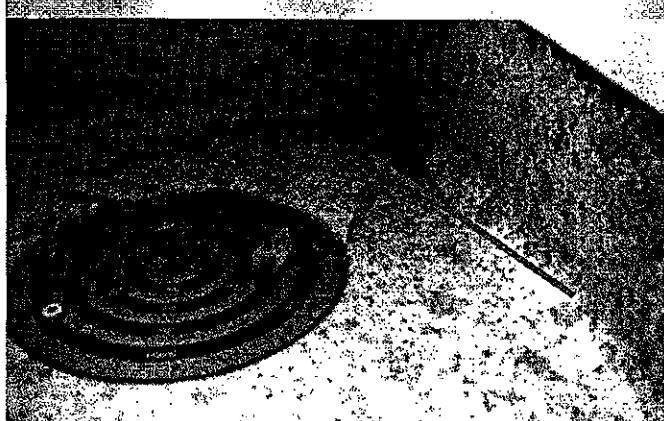
Photo B5: Unit 209 North

Minor membrane delamination

Two balconies had minor membrane delamination issues; units 209 (at drain), 301 (at brick pillar). These areas should have the cause determined and the membrane repaired to lengthen the serviceable life of underlying components.

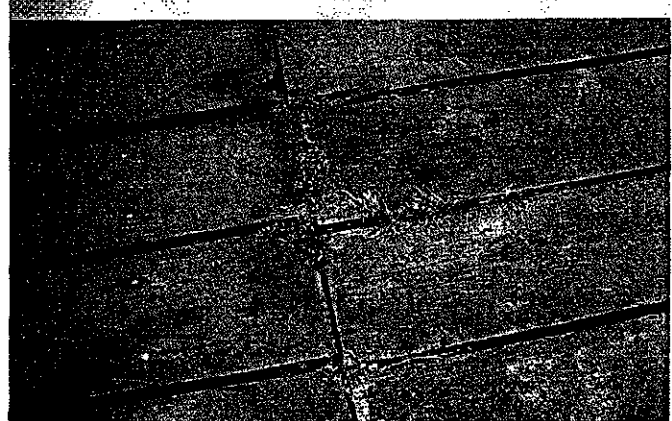
Photo B6 : North

| OBSERVATIONS DURING REVIEW | | Picture | Level |
|---|---|---|---|
| Deteriorating Duck Board Decks | Units 402, 407, 412 | B6 | 2 |

Deteriorating duck board deck

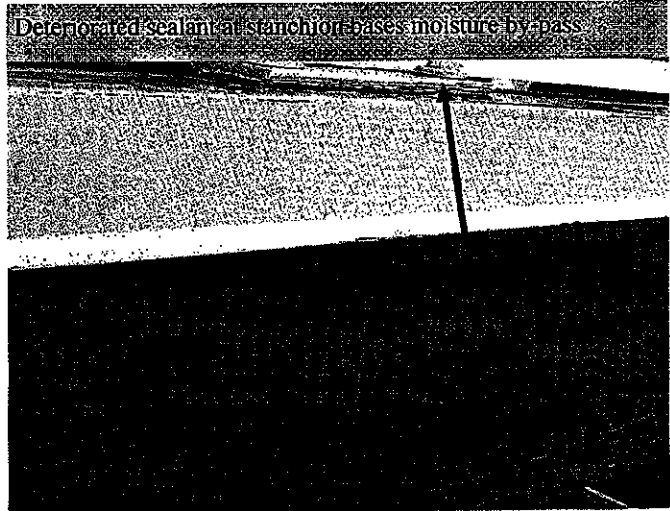
| OBSERVATIONS DURING REVIEW | | Picture | Level |
|---|---|---|---|
| Failed sealant at handrail stanchion bases | Unit 310 | B7 | 1 |

Unit 310 was mentioned in the previous section as having a panel separation on the balcony face. Sealant on the balcony stanchion bases was found to have failed and may be contributing to moisture ingress beneath the flashing (see B7, B8). This same sealant detail is reaching the end of its service life on other elevations at Connought. PBEM recommends sealing the stanchion bases at 310 immediately and having a program to renew this detail on all elevations within two years to avoid compromising underlying components.

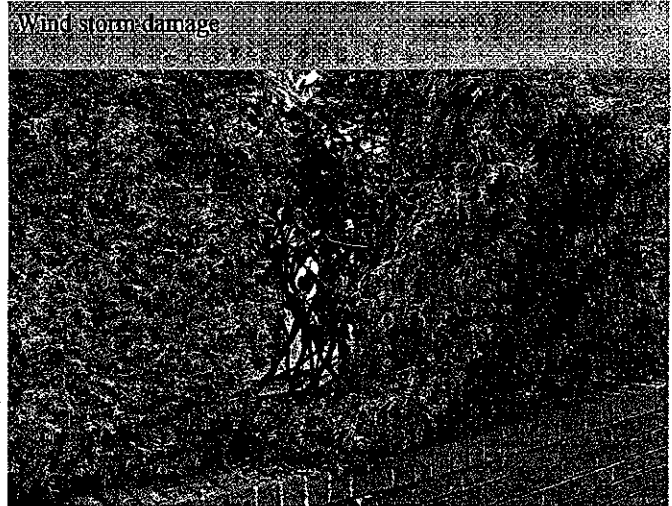
Photo G2: Unit 104

| <b>OBSERVATIONS DURING REVIEW</b> | <b>Picture</b> | <b>Level</b> |
|---|---|---|
| Wind damaged privacy shrubs | G2 | 3 |

Wind storm damage

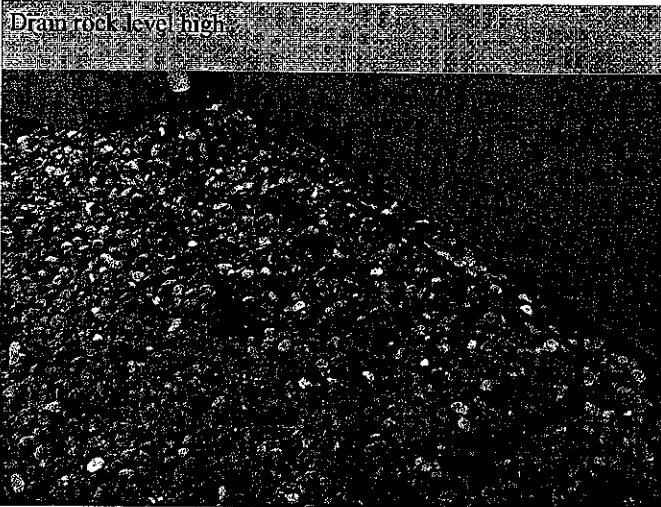
Photo G3: East

Drain rock level high
