Inspection Report  
Vintage Eastside  
688 East 16th Avenue

Re: Vintage East Side, Strata Plan LMS 3868  
688 East 16<sup>th</sup> Avenue, Vancouver B.C.  
- 1 Year Deficiency Review - Deficiency List

Re: Strata Plan LMS 3866, Vintage East Side  
688 East 16<sup>th</sup> Avenue, Vancouver, B.C.  
- 1 Year Deficiency Review

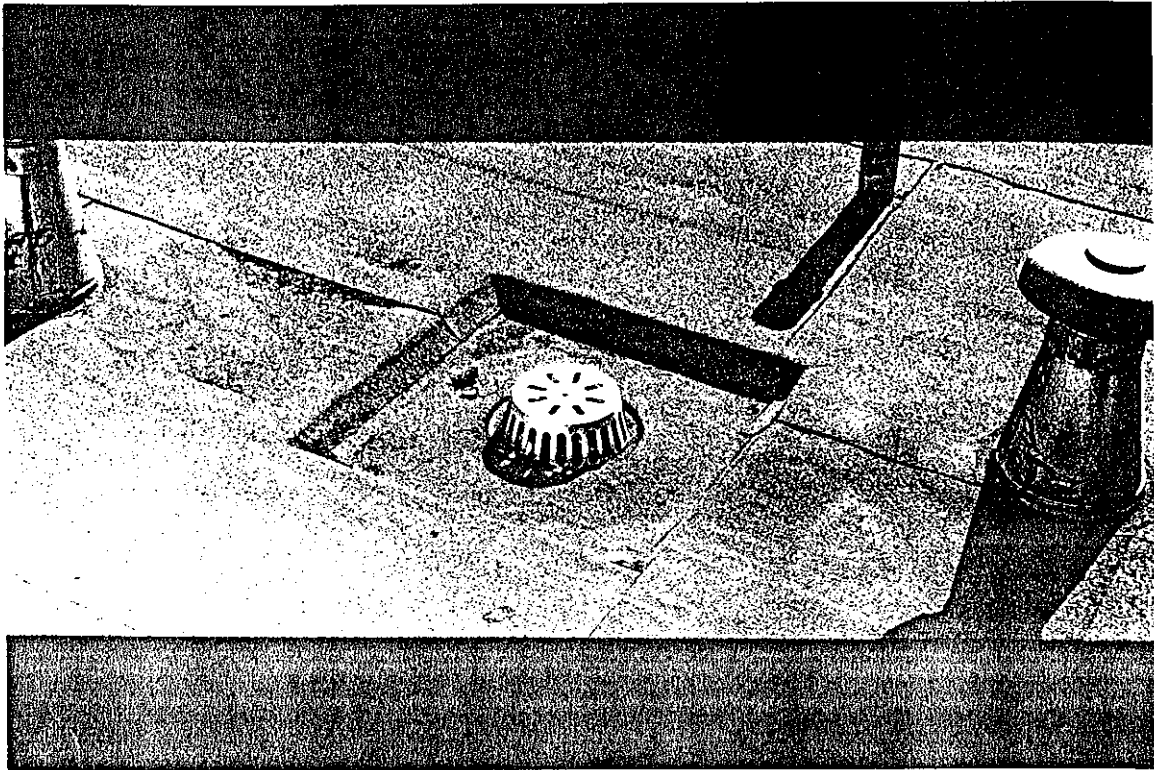
GOOD DETAIL

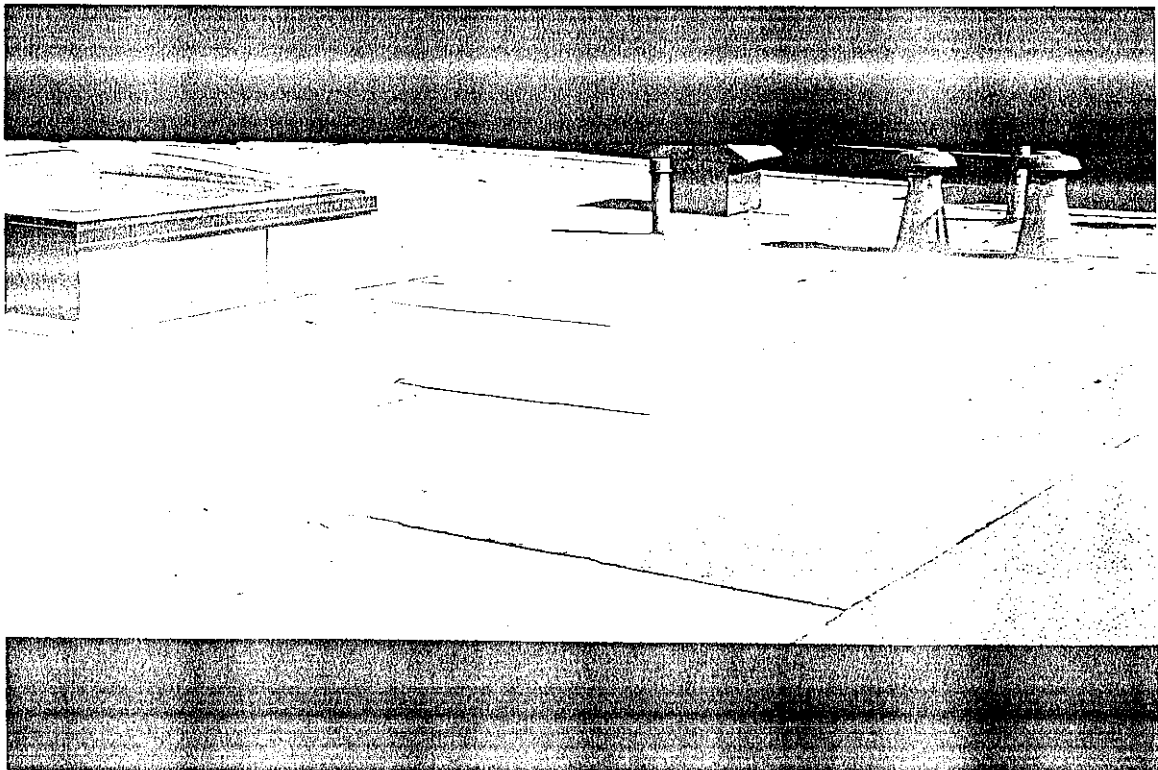
ROOF MEMBRANE - GOOD DETAIL

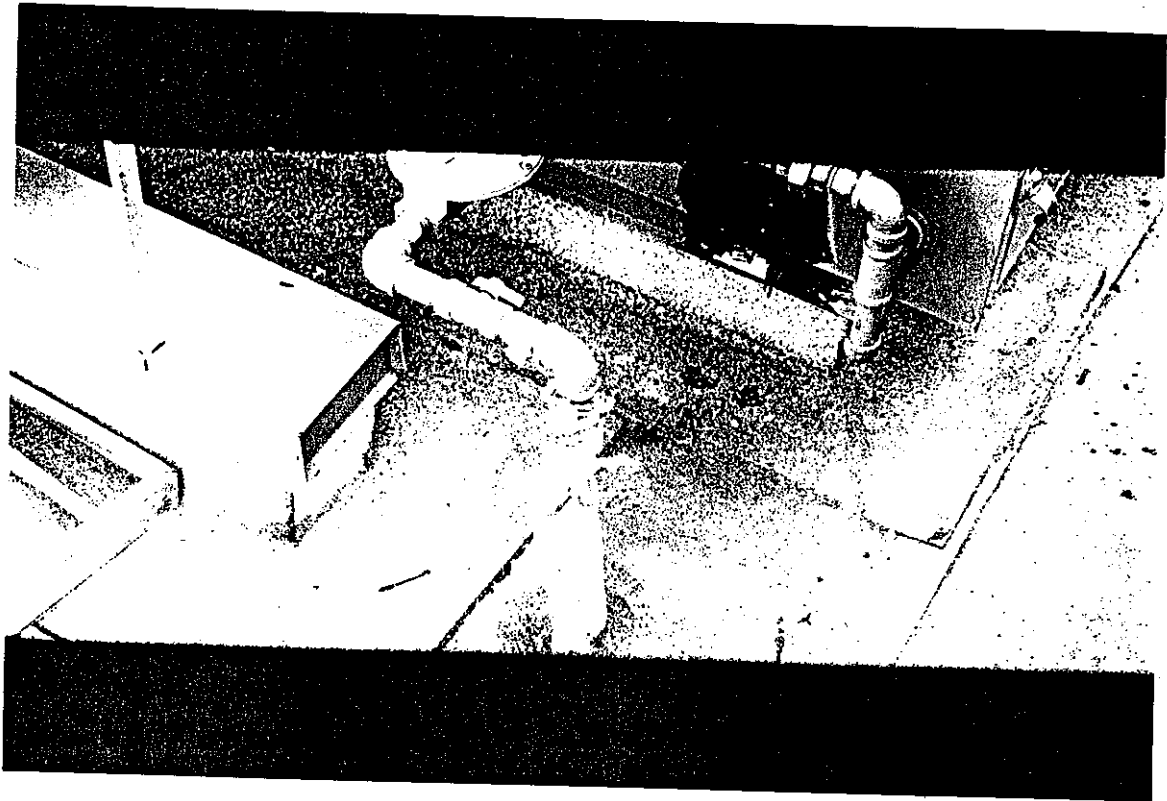
NEED CAULKING

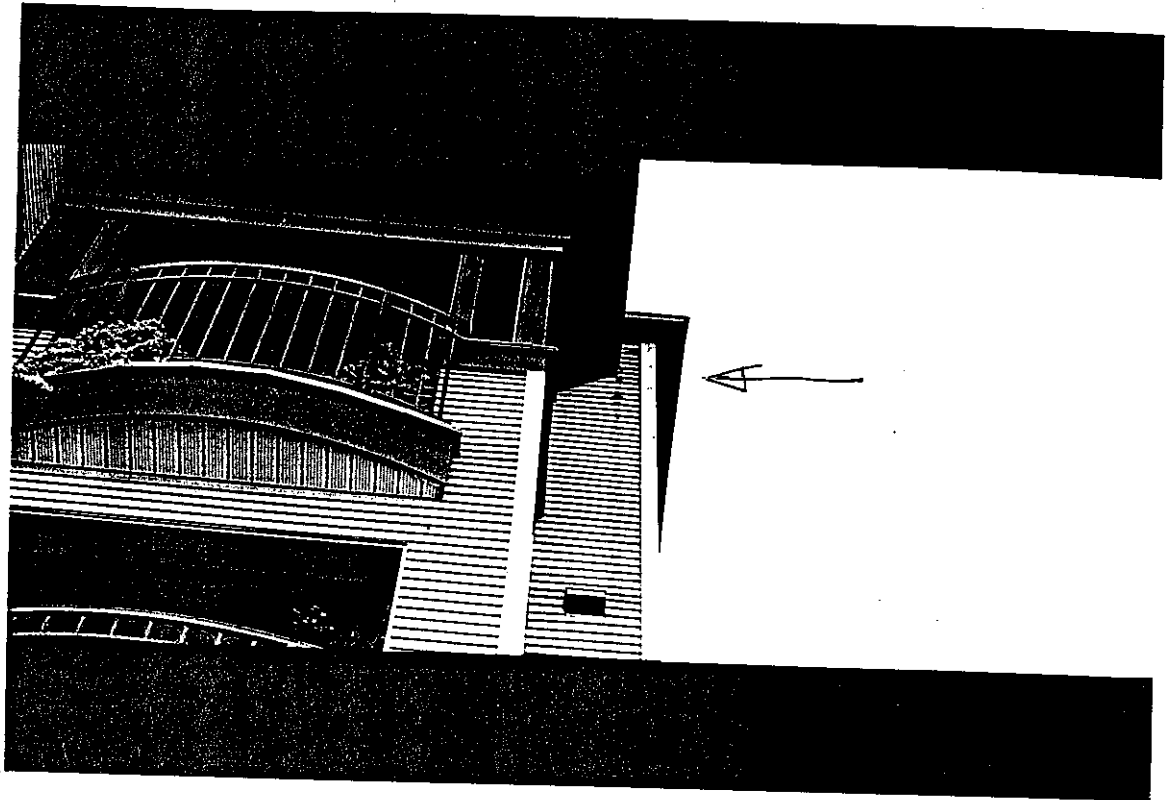
GUTTER OVERFLOW — STAINING

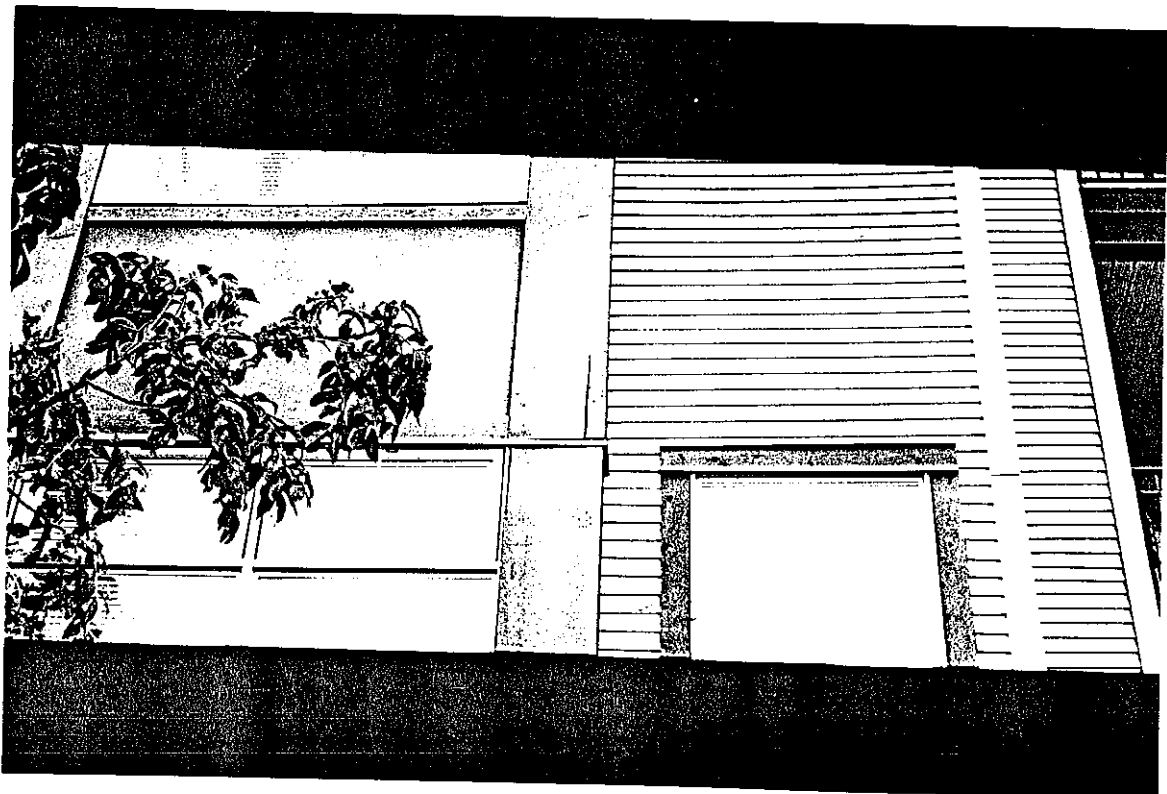
SIDING CRACKS

| 2) | replacement of cracked siding pieces at rear of building | \$ 1,500.00 |

WILL BE FINISHED IN MAY/4  
( BY CAROL CONSTRUCTION )

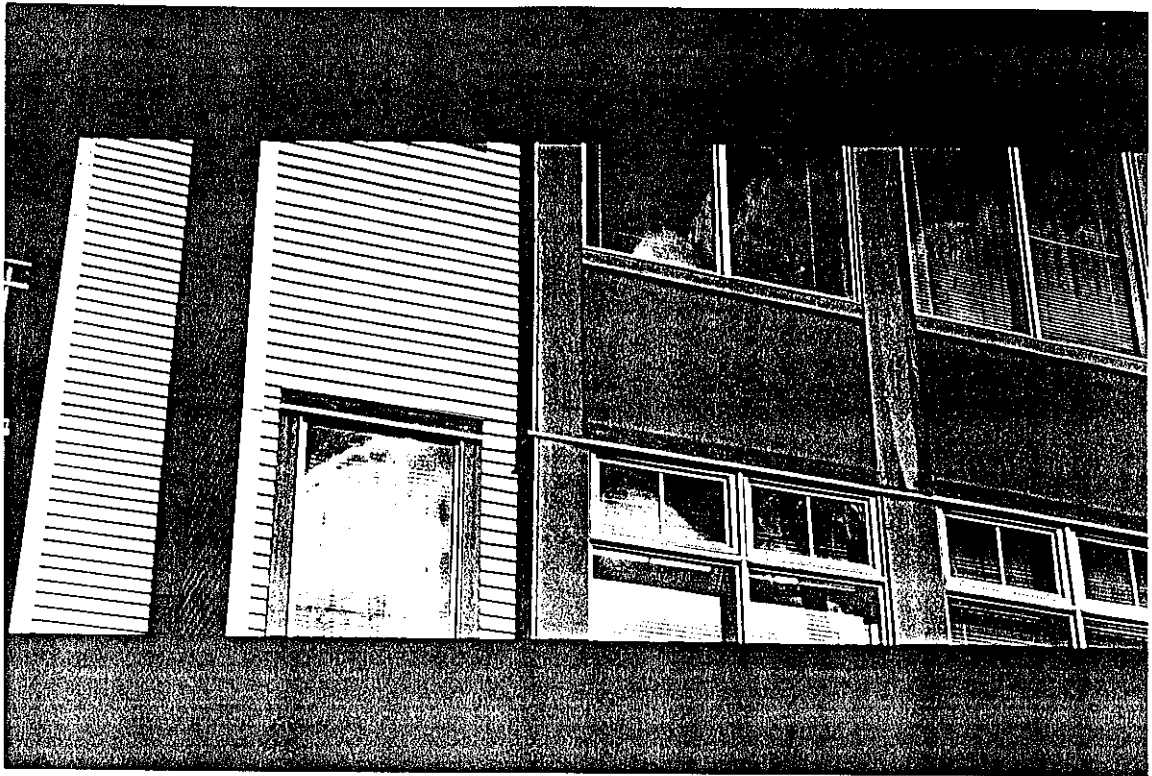
SIDING GAP

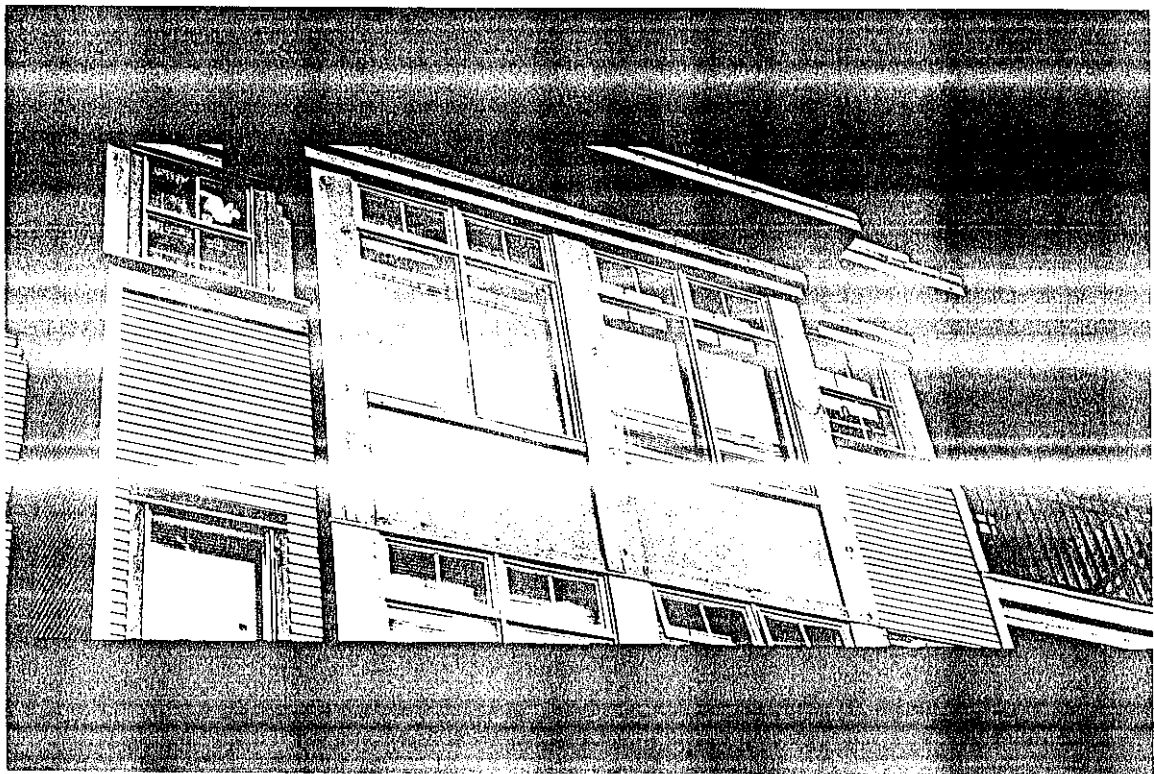
MINOR CRACKS IN TRIM

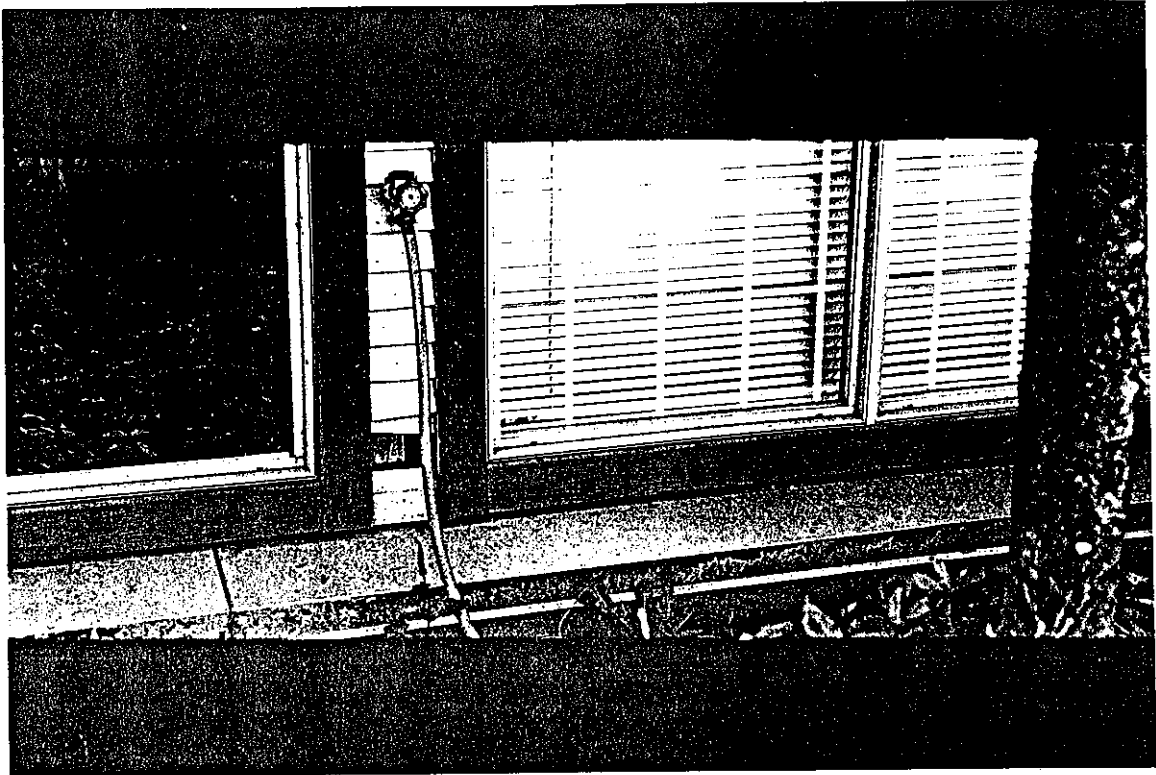
MISSING SIDING

| 1) | repair to missing siding in walls near hose bibs | \$ 500.00 |

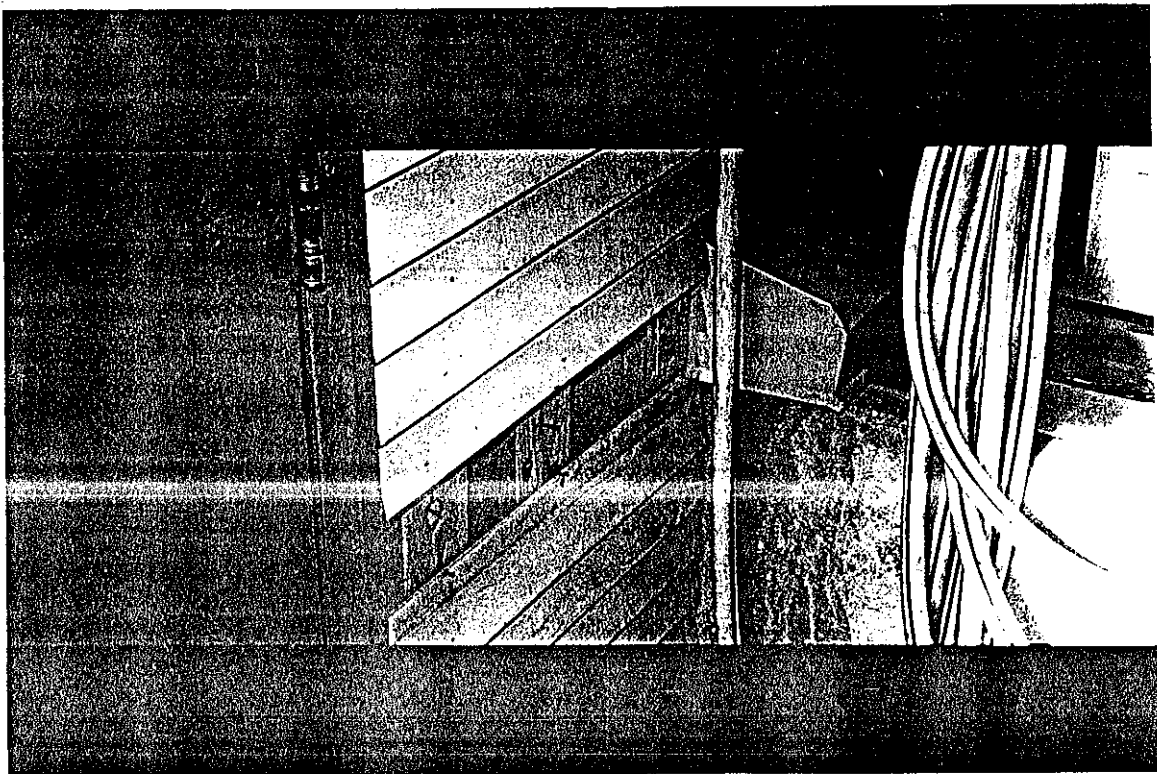
MISSING SIDING

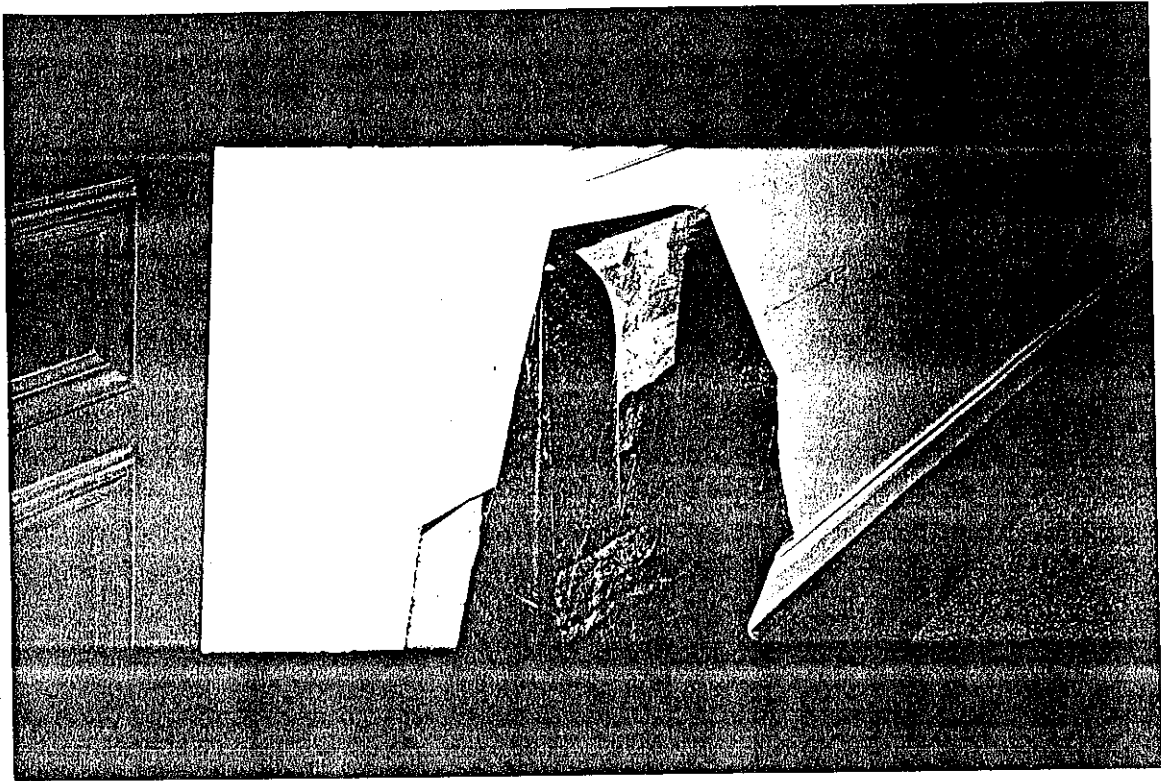
5.0 First floor hallway shows repair work going on. This needs to be completed.

HALLWAY WORK — NEED COMPLETION ✓  
by 11:00 AM  
2000

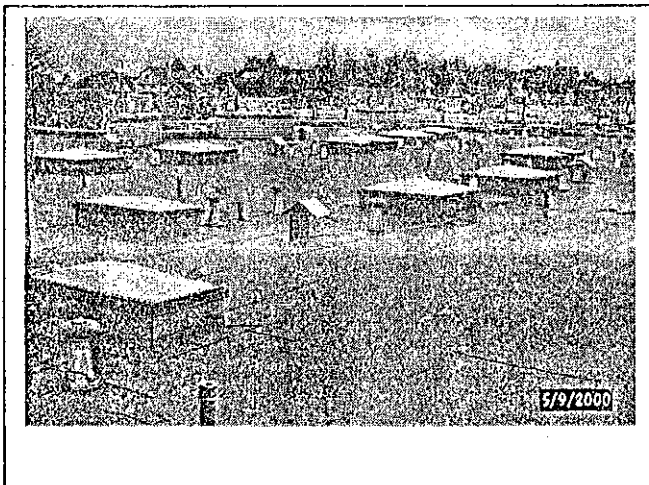
Photo # 3

Typical roof membrane, showing minor standing water.

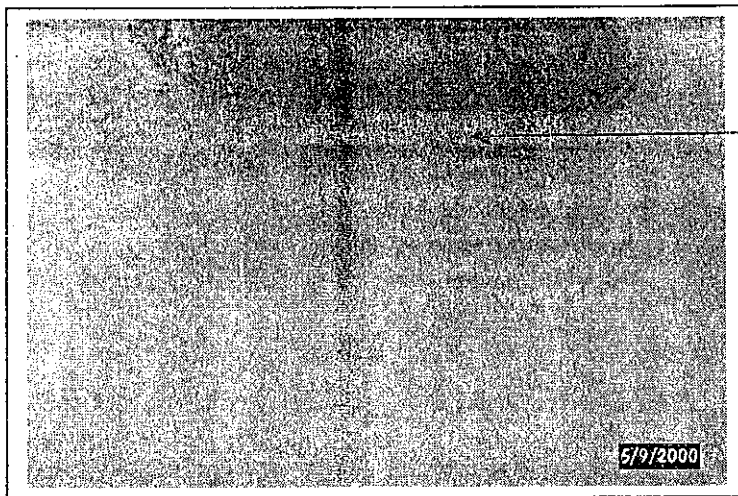
Photo # 5

Typical caulk joint at the base of projections through chimney cap. This joint as opposed to a solder joint will require maintenance.

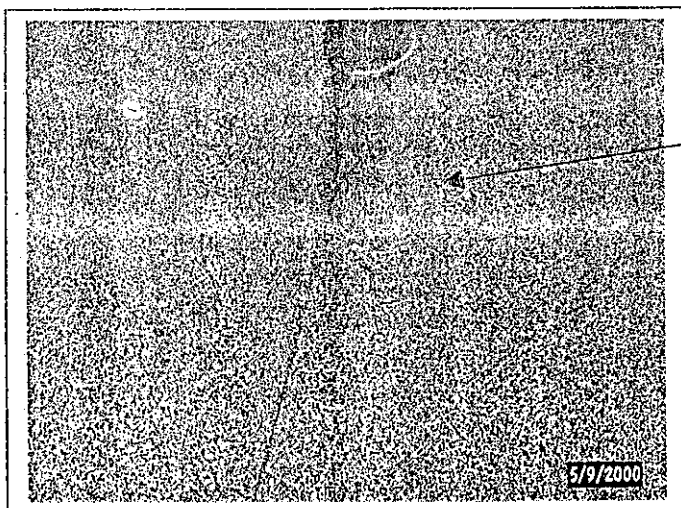
Photo # 6

- .9 The roof membrane was observed to be tenting at the base of most plumbing stacks.
- .10 The upturned sheet metal flange surrounding projections through the caps have been sealed at the horizontal surface with caulking as opposed to solder. Sheet metal chimney caps are positively sloped to allow water to drain away.

Tenting in membrane at the base of plumbing stack flashings.

- .4 The surface elements of the roof examined by JRS generally appear to conform to R.C.A.B.C. 5-year guarantee standards.
- .5 The tenting observed surrounding plumbing stacks should not affect the performance of the roof unless the severity of the tenting increases. We recommend the owners monitor this situation and report the problem should the tenting become more pronounced.

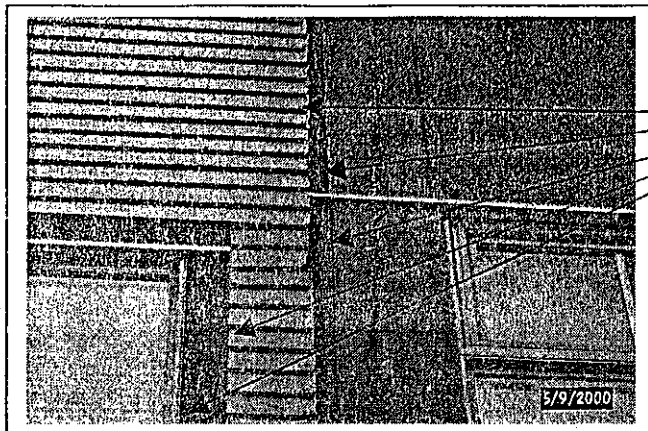
Photo # 7

- .1 As noted there are many open joints and gaps in the cladding assembly that have not been caulked or sealed. These may permit moisture to penetrate the siding and contact the sheathing paper.

Typical non-sealed gaps or opening in trim boards that may permit water penetration.

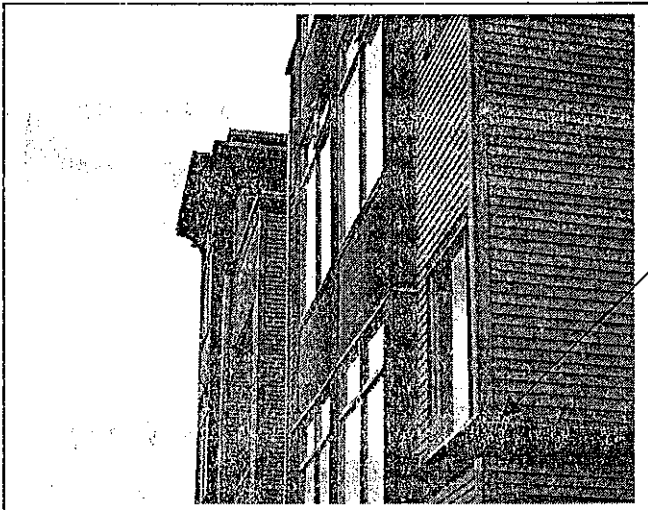
Photo # 8

- .7 Horizontal through-wall flashings have been placed in some areas but they have not been consistently placed at each floor level.
- .8 The through system flashing above the 1st floor (2nd floor level) is noted to have a flat lap seam, which was open; and to be not continuous at the end leaving a gap.

Typical through system flashing at first floor level used to discharge moisture in the cavity behind the siding.

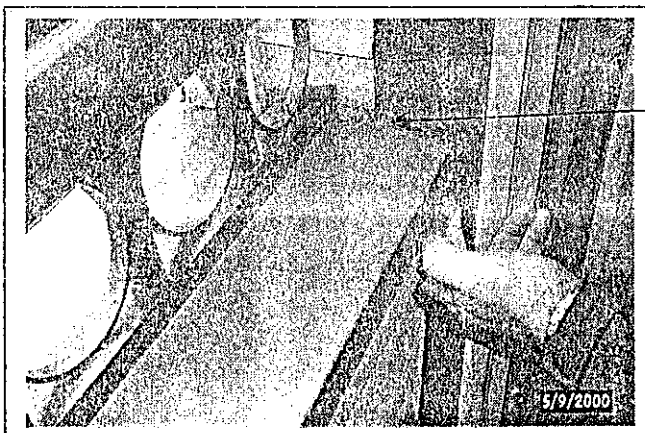
Photo # 9

Typical saddle flashing detail that does not incorporate an up-turned flange behind the cladding.

- .1 The most significant concern is the absence of three dimensional saddle flashings. Although there is a membrane underlayment we are not able to verify the integrity or complete installation of the same. We recommend these areas be closely monitored for any signs of water ingress problems.
- .2 Decks surrounded by high up-stand walls as opposed to open railings must have a primary drain as well as an over-flow drain. This is to prevent the back up of water on the decks should the primary drain become blocked. Some decks do not appear to have overflow drains.

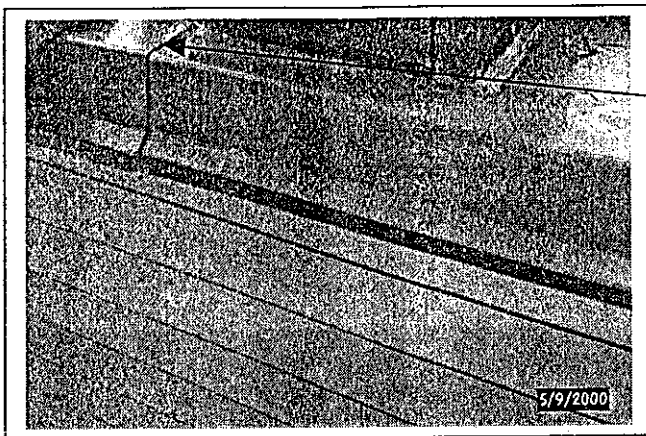
Photo # 10

Typical flat lapped joint  
/ seam in sheet metal  
cap flashing.

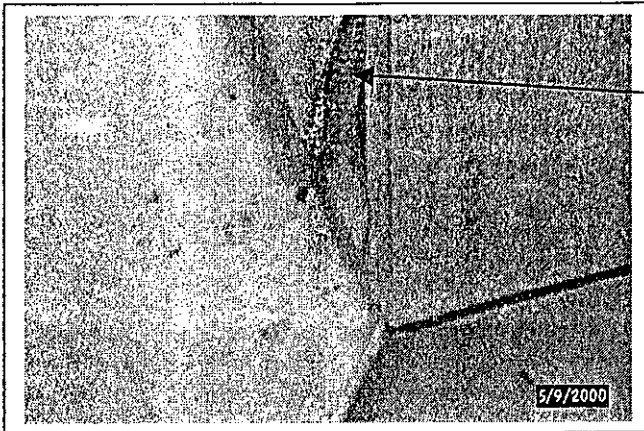
Photo # 13

- .3 Wood siding or trim that is not fully back-primed or painted may cause several different problems. The wood siding will absorb moisture through the unprotected surface of the panel. Thermal cycling can cause moisture in the siding to permeate to, or through, the exterior paint. This in turn may cause a premature failure of the surface paint.

Typical non-primed cut end of wood siding.

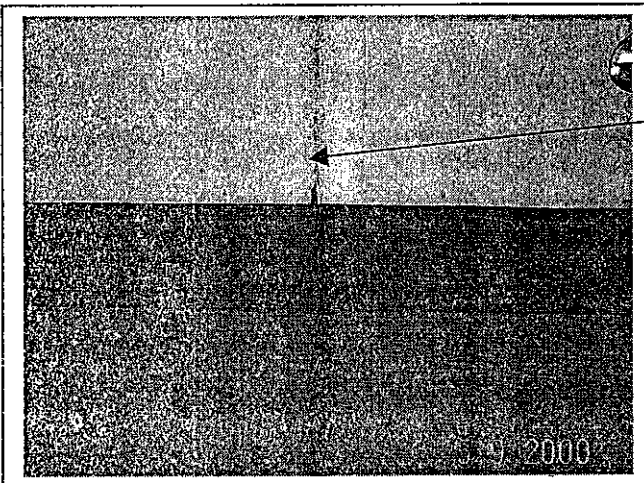
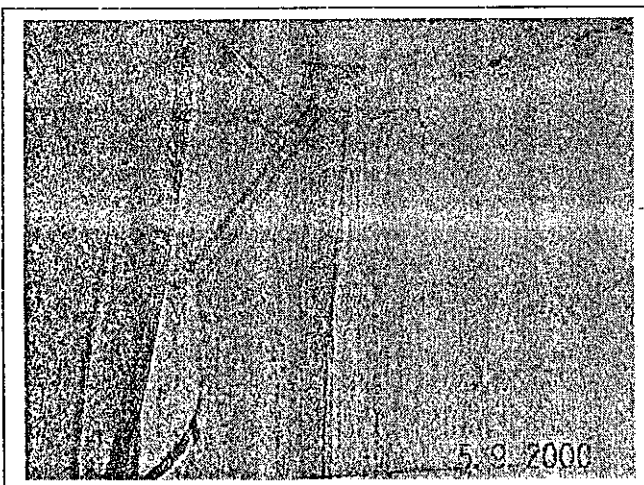
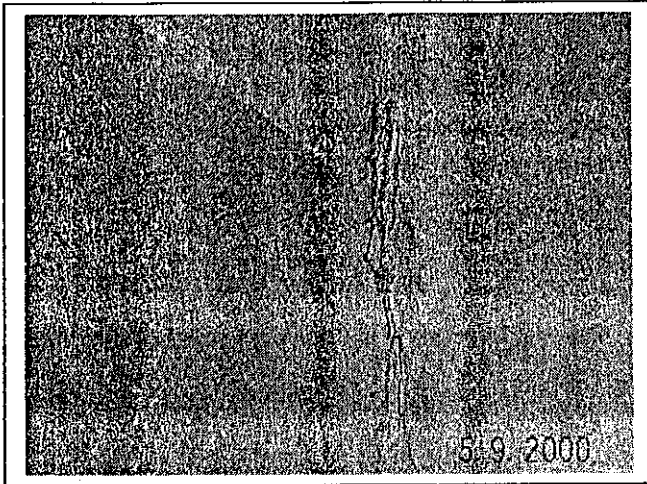
- .3 Leakage evidenced by rust coloured efflorescence in a vertical crack (adjacent to vertical reveal) and diagonal crack from corner of slab-band parking stall # 1.

- .1 The parking area is displaying signs of minor leakage problems. It is difficult to tell whether the staining caused by the water ingress is current or whether it occurred during construction. The weather at the time of our examinations was overcast and raining.
- .2 Defects in the slab membrane or below grade damp-proofing are extremely difficult and costly to resolve. This is primarily due to the excavation of landscaping and backfill covering the membrane or damp-proofing in order to gain access to the same.
- .3 Complete repairs will require excavation of the fill above the affected area to access the membrane or damp-proofing and complete repair or replacement of all defective areas.

Water staining and efflorescence visible on wall of parking garage.

- .4 An alternate method of addressing the leakage which may be considered is urethane crack injection. This will effectively stop leakage only through the cracks where it is applied. Water migration past the membrane or damp-proofing will not necessarily be stopped, and other cracks not currently exhibiting signs of leakage may begin to leak.
- .5 The architectural drawings and design describing the slab membrane are consistent with current building science practice.

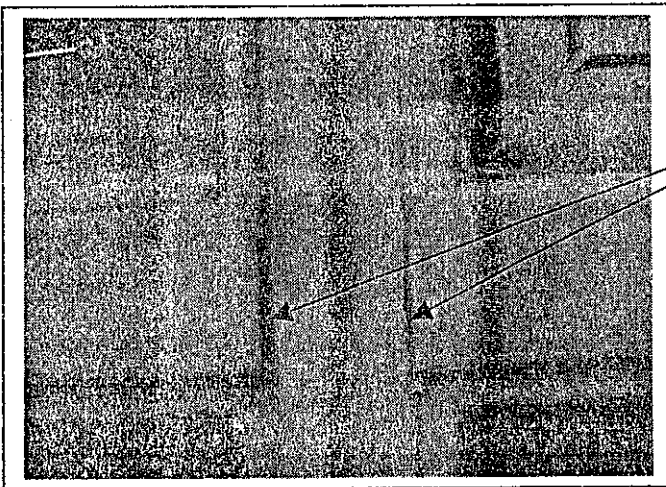
Photo # 17

- .2 It was observed that some of these joints were not fully sealed. Open gaps on outside and inside faces were noted.

Window exterior. Unsealed butt joints at transom-mullion interfacing.

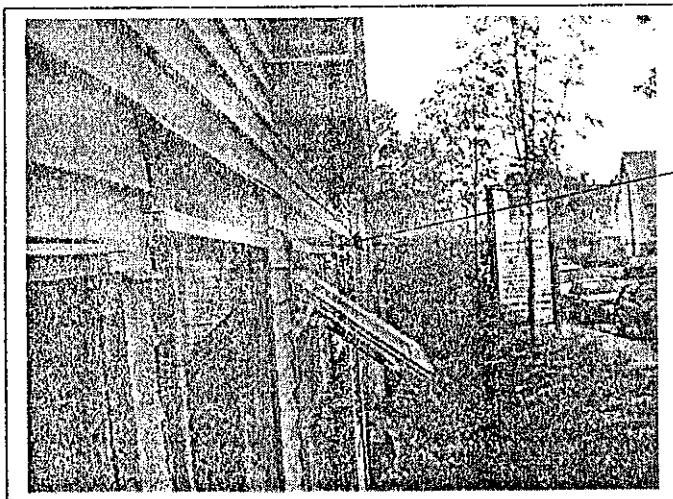
Photo # 18

- .2 Noticeable deformation of head flashing, may be related to deflection of wall / floor structure above the windows. Further movements, ultimately, may result in unacceptable load bearing on vinyl framing, malfunction of operable vents, damage of framing and glass units.

Typical deformation of head flashing.

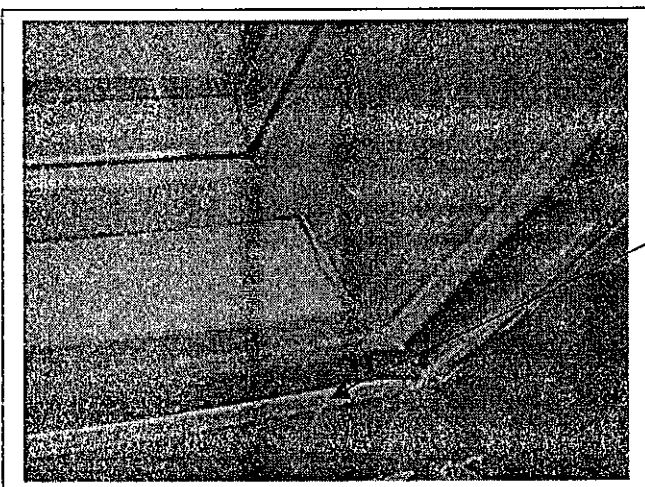
Photo # 20

- .4 It was observed that the above casement windows could not be sealed / closed on sash lock side at lower corner, providing no compression of the interior gasket. Up to 1/2" inconsistency of the frame-vent joint was measured.

Casement window. Sill at sash lock side. No or inappropriate offset between frame and edge of exterior gasket.

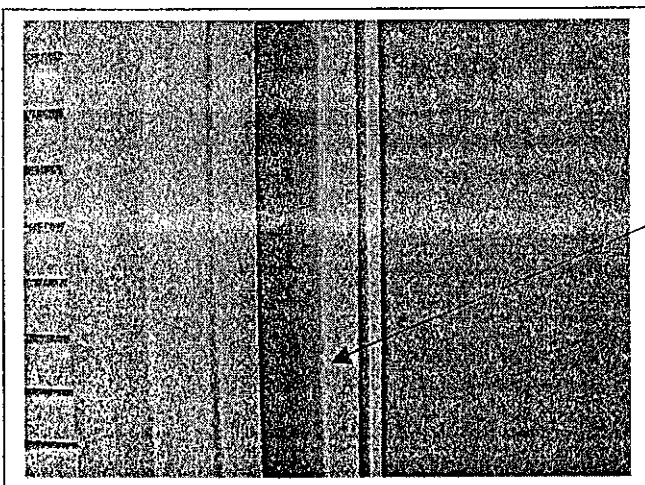
Photo # 21

- .3 Excessive deformations at jamb and vent profiles at the 2' vent casement windows was typically observed. The deficiency may be related to the quality of window assembly itself, to installation methods / techniques or post-construction deformations of the building wall structure at specific locations.

Casement window. Jamb. Excessive offset between mainframe and operable vent.

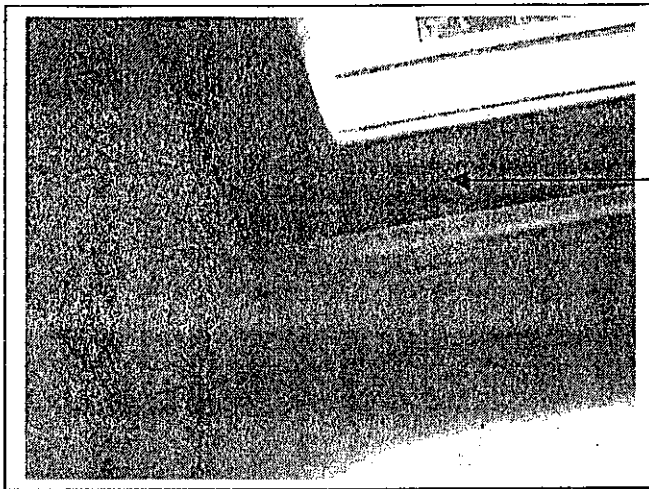
Photo # 22

Casement window. Sill at sash lock side. Open gap at inner gasket-to-operable vent interfacing.

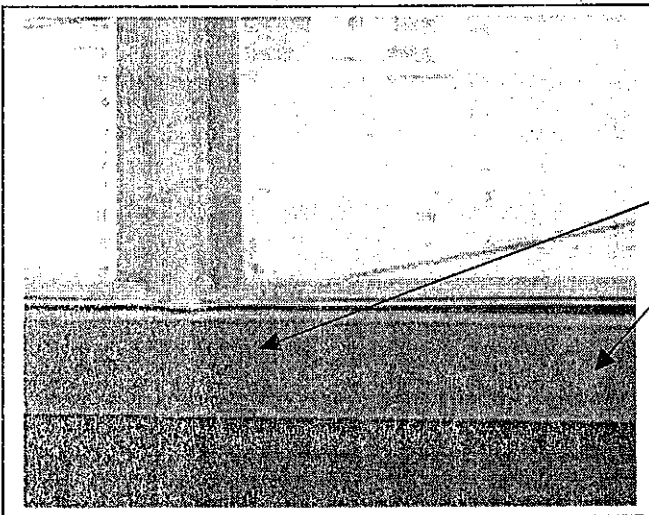
Photo # 23

Noticeable deformations of sill profile.
