**Company:**  
**Attention:** Bruce Pomeroy  
**Reference:** Brickwood Place  
Project No. 50-211

On Friday we began the process of performing a Building Envelope Inspection to the South and East elevations of the above noted project. These elevations are stucco clad and viewed as a higher priority than the North and West elevations which are vinyl siding clad. The time frame for the completion of this report was very short and the process of the investigation was therefore modified to concentrate on those areas which have already been identified as troublesome to determine whether these problems are widespread on these elevations.

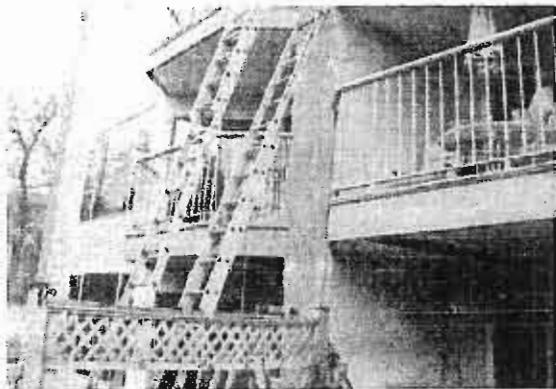
#### **Moisture Level Readings**

- 1) At the time of report preparation, 29 of 40 coring holes have been performed and documented. Of those 29, the following moisture levels were recorded using a Belmhorst - J Lite wood moisture meter. A reading below 19% is considered acceptable, readings from 19% to 22% are troublesome and deserve some attention, readings above 23% represent areas where active mould growth and structural decay are underway aggressively. The maximum reading the meter can record is 30+% which indicates a moisture saturated environment.

3" round holes were cored through the stucco to record moisture levels and to inspect the structure beneath

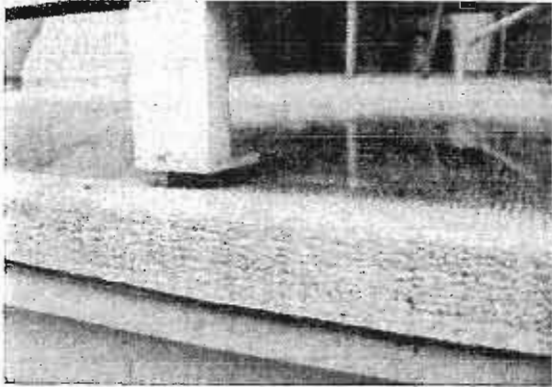
#### **Deck Rail Mounting**

In 3 cases, additional structural decay was a result of water penetration through the deck rail mount location. At these areas the deck sheathing was deteriorated and "spongy" when stepped upon. In many cases the water damage from the deck edges was also visible from the underside with the sheathing water stained and deck joisting showing water damage as well.

The rail foot here is actually raised off of the deck surface. The ponding water is able to penetrate the deck surface through the exposed penetrations

- 3) The existing rail configuration has proven to be troublesome in our experience and is no longer considered to be an acceptable detail in new construction and in building remediation. We would recommend a new, faced mounted rail system be considered which would see the rails mounted to the face of the deck edge and not through the top of the deck membrane.

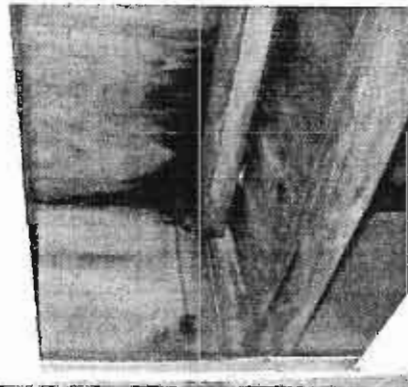
#### **Deck Rail Mounting**

The damage directly below the rail foot is very evident and can be seen to be actively leaking in this photo

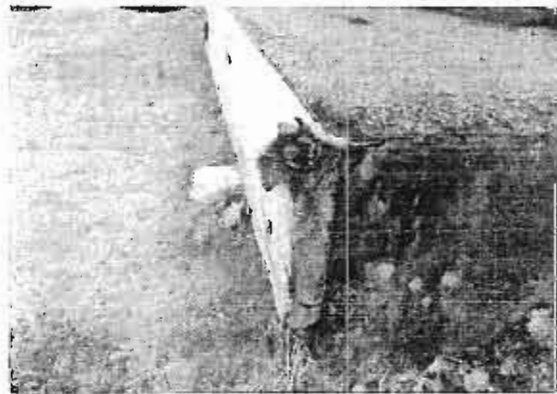
#### **Suspended Slab Edge**

- 4) The suspended slab was reviewed at the NE corner where it is exposed and its components are visible. It appears that the slab was covered with an built-up roofing based membrane and covered with a 2" asphalt top coat. At the slab edge a flashing was installed which acts as a finished edge for the asphalt top coat and a cover for the 2 x 12 trim board. The trim board runs continuously along the slab edge and the fence posts are mounted to the face of the trim board and anchored through the trim board into the structural slab. The posts and their bolts were not removed to determine the method or depth of fastening and these findings are based on observation only.

The edge flashing appears to be sealed into the slab surface membrane, however, it is evident that it is acting to retain water on the slab surface. This is quite clearly seen over the garage area entrance with water dripping behind the 2x12 trim board where the slab surface membrane has failed. During demolition of the asphalt topping at the base of the building wall, water pressure from under the membrane was pushing water back into the area of demolition.

The components of the slab edge can be seen here. The flashing configuration is acting as a dam and is causing water to back-up under the membrane.

- 
- 5) The slab edge detail should be reviewed more carefully to determine whether a change to its configuration is necessary. If the edge flashing is causing a water retention problem on the slab edge it may be leading to other problems not yet identified. These problems may include premature deterioration of fence posts and trim boards, water leaks in the underground parkade, etc. This issue should be considered with a longer range consideration to the asphalt deck topping repair and base of wall repair detailing currently underway at units 106, 108, 110.

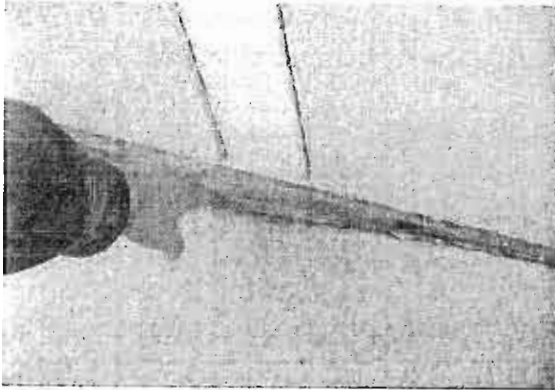
**Deck at unit 416**

- a) the vinyl had been replaced previously with a new surface placed over the previous surface. This installation terminated under the stucco stop only ( 1-1/2" upturn) and was debonded along its entire length allowing water easy access to the wall and deck surface below.

There is no upturn on the recent vinyl repair and the entire edge is debonded. Water is easily able to penetrate the surface to the structure below.

- 6) The deck at unit 416 is in serious condition. For safety reasons this deck should be closed off to access until the extent of damage can be determined more fully. Even though wall areas at units 106, 108 and 110 have already been opened up, this deck area should be given the highest priority in the continuing repair process. It is my opinion that the beam supporting the deck should be reviewed ASAP to make sure that it is structurally sound and not representing a safety hazard to the residents. The roof area adjoining this deck should be reviewed and its details should be inspected to ensure that non-compatible membranes and techniques are corrected.

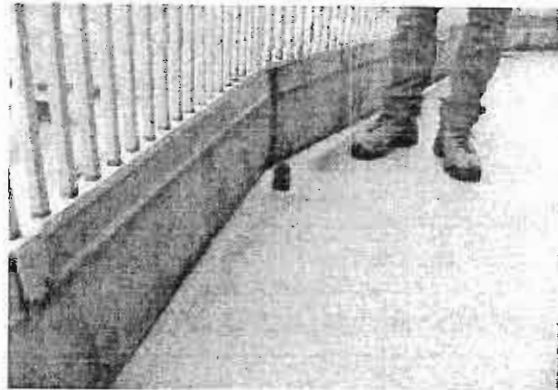
**Deck at unit 416**

- b) there were four large soft and "spongy" deck surface areas which indicate the deterioration of the deck sheathing below.
- c) there was no overflow scupper to the deck area

- d) this is a large cantilevered deck area with a support beam running perpendicular to the building at about the centre point. The soft deck areas are above this beam location and damage to this beam must be considered as serious.

Several areas of the deck surface are soft with water ponding. The cap and rail configuration do not shed water properly and the sealants have reached the end of their serviceable life.

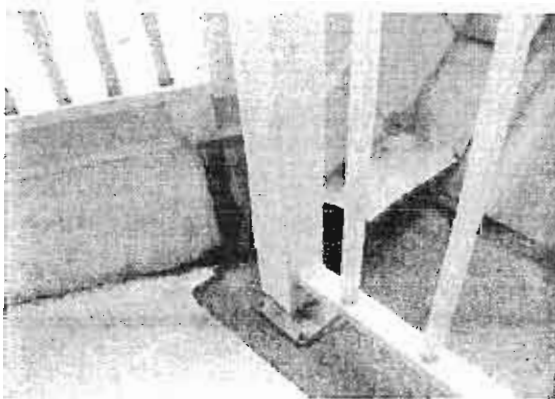
**Deck at unit 416**

- e) the pitched roof area to the south of the deck drains onto the deck surface and uses some questionable roofing and membrane practices. Roofing membrane has been bonded on top of the vinyl decking, there is back-lapped and loose roofing membrane allowing water penetration, and ill-fitted flashing components.

The pitched roof beside the deck runs onto the vinyl resulting in some very questionable detailing

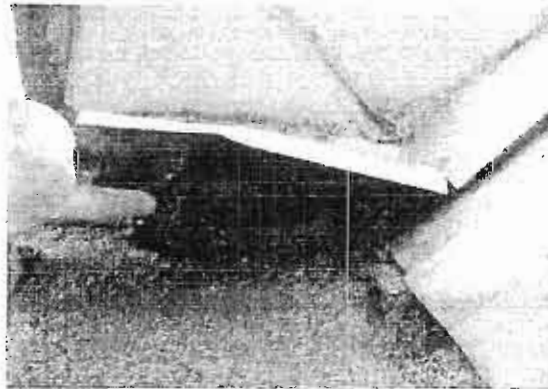
**Deck at unit 416**

This photo shows delaminated and back-lapped roofing membrane at this location
