# **Building Envelope Maintenance Report**

**June 2006**

**Norfolk House  
1675 West 10<sup>th</sup> Ave.  
Vancouver, BC**

**B E M C O**  
**Services Ltd.**  
Building Envelope Maintenance

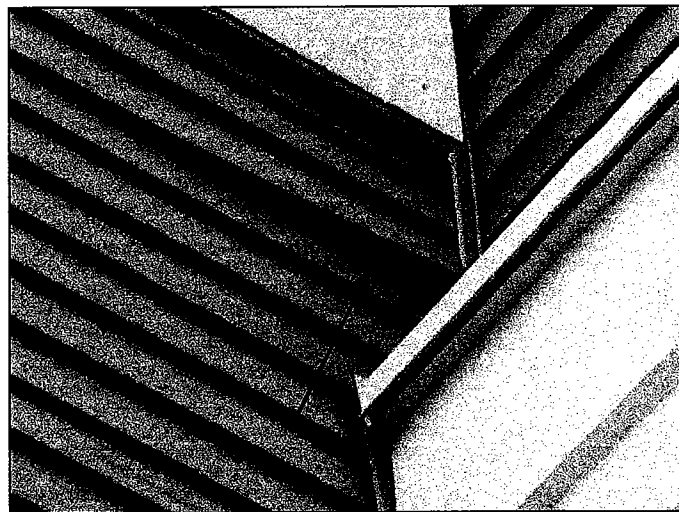
**Photo #4- Siding detached.**

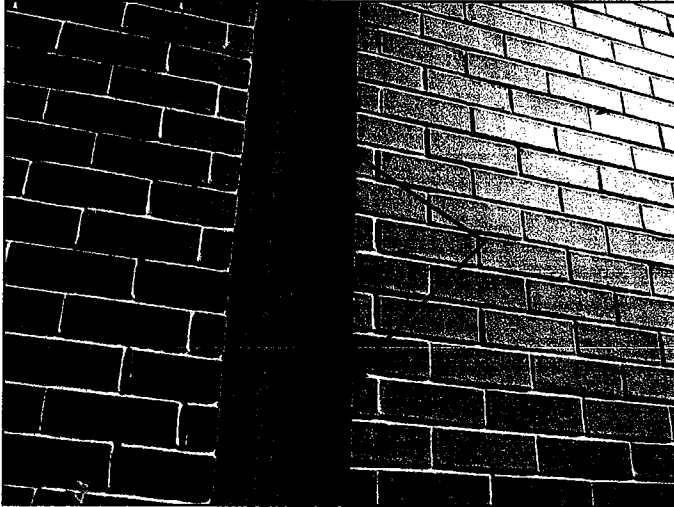
**Photo #5- Paint peeling beside down pipe.**

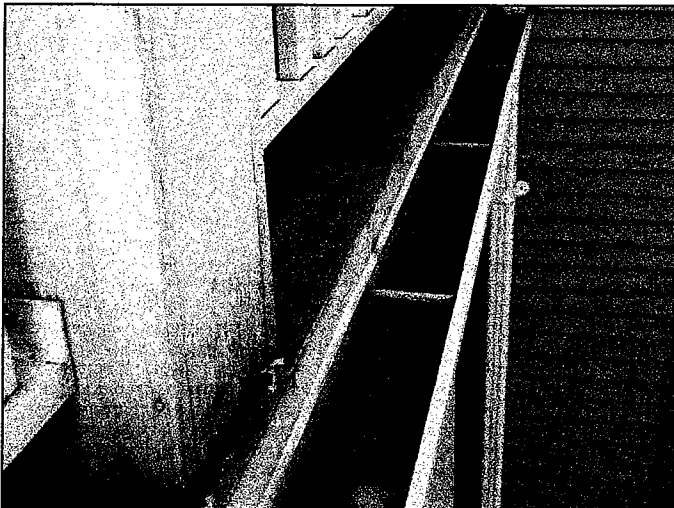
**Photo #7- Debris present in gutter.**

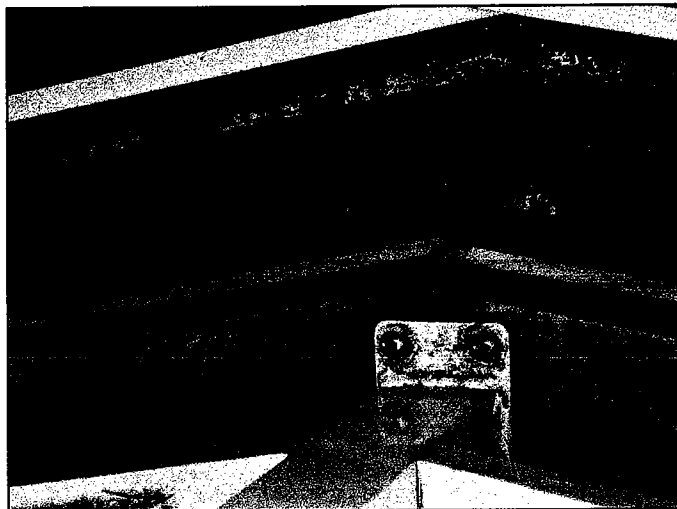
**Photo #9- Gutter full of debris.**

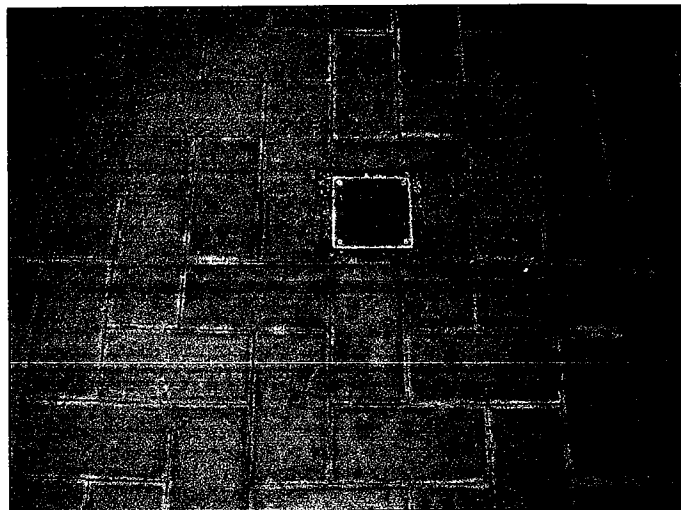
**Photo #10- Ground level deck drains clear.**

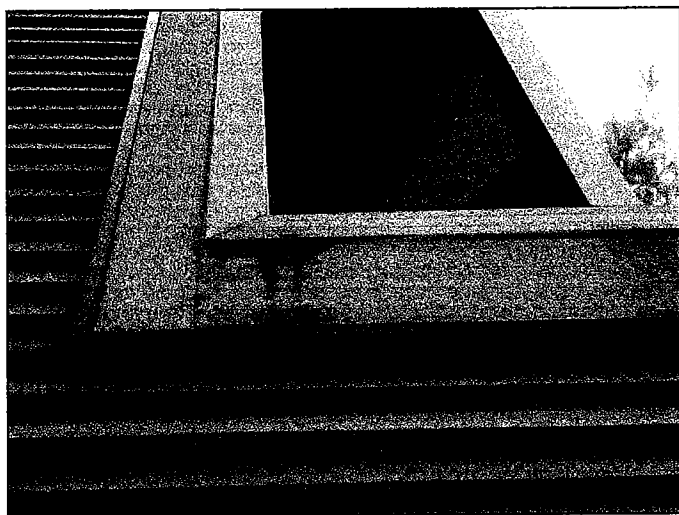
**Photo #11- Algae present.**

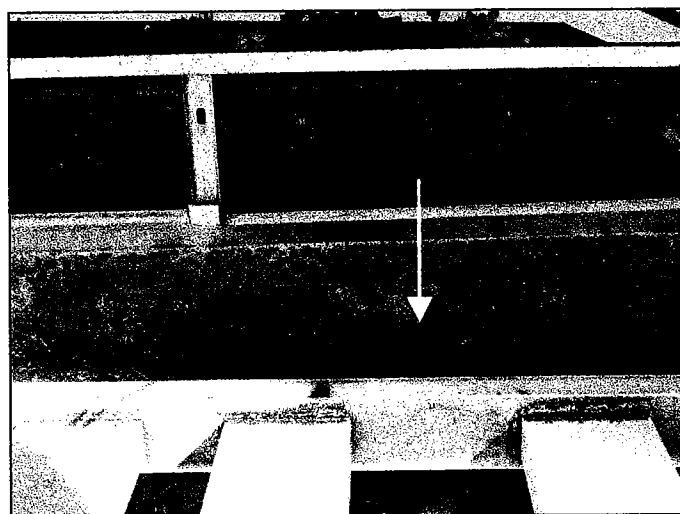
**Photo #12- Deck membrane breached.**

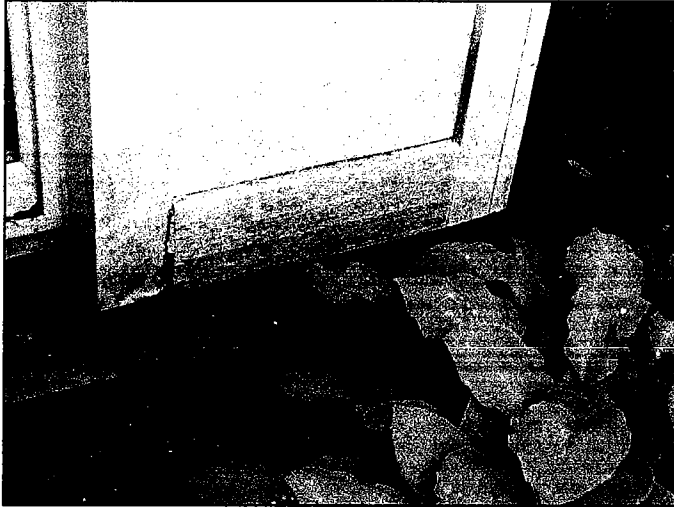
**Photo #13- Paint deteriorating.**

In order to protect wood, it should be kept clean, painted and sealed. It is important to repaint wood in a timely manner. Allowing old paint to crack, blister and peel permits moisture to penetrate the wood. This can lead to further paint failure, wood decay, and swelling or warping of the wood. Repainting should be considered when the exterior surface begins to show wear.

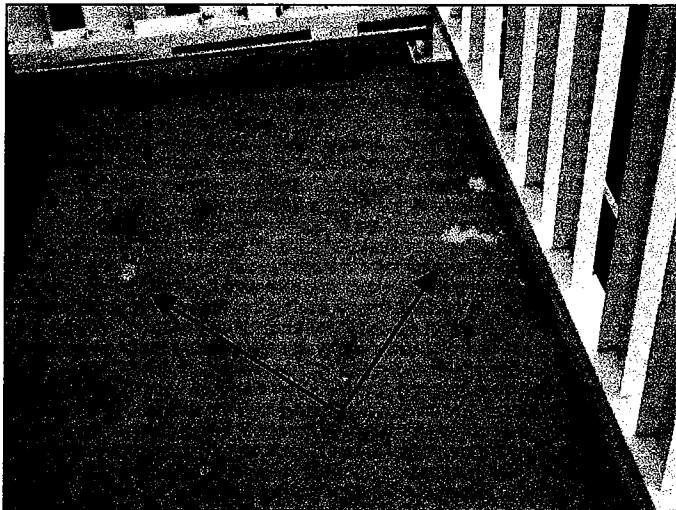
**Photo #15- Deck membrane is peeling.**

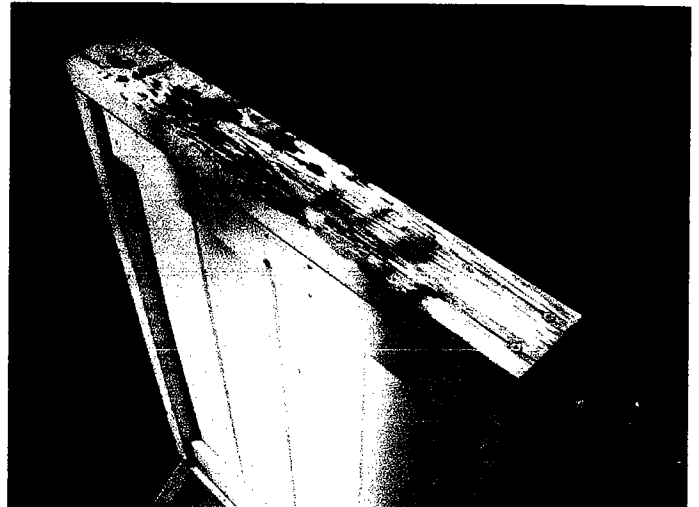
Although, not an envelope issue, it was noted that the paint was peeling in various areas of the wood fencing around the building.

**Photo #18- Paint peeling on fence and gates.**

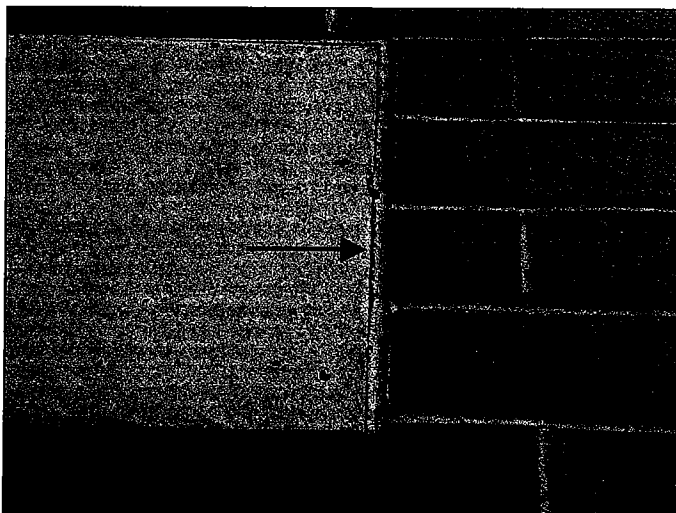
Overall, the brick walls appear in good condition, however the grout is cracking where it meets the concrete window head in some locations. Even though the masonry walls have been constructed as a rainscreen and there is a moisture barrier behind the masonry, it is good practice to repair any cracks that may develop in masonry walls.

**Photo #19- Grout cracking at concrete window-head.**

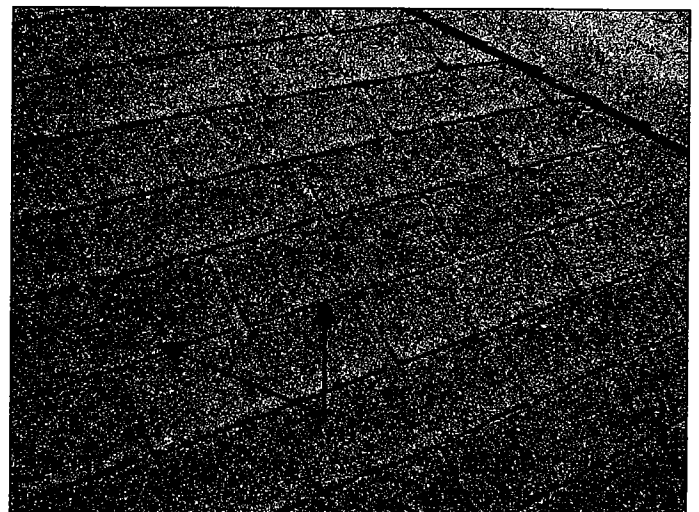
**Photo #20- Roof shingles starting to deteriorate.**

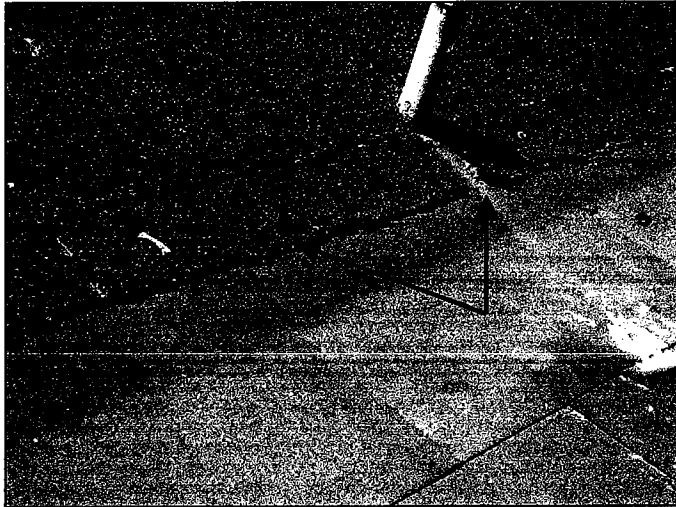
**Photo #21- Moss present on North facing elevations of sloped roofs.**

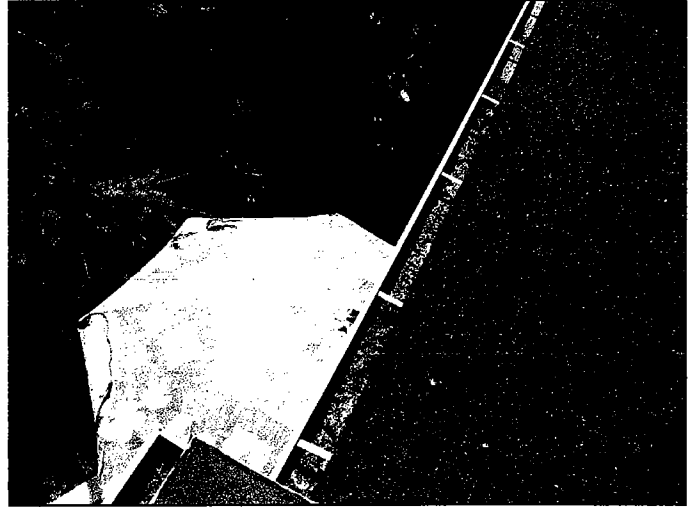
**Photo #22- Gutters have debris present.**

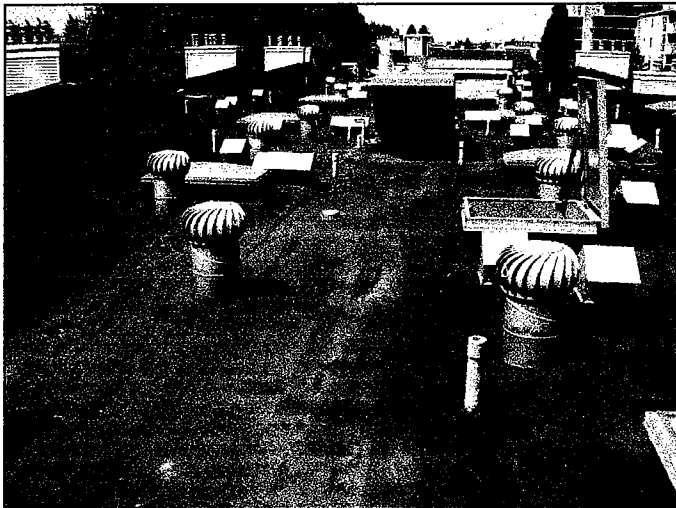
**Photo #23- Penetrations in good conditions.**

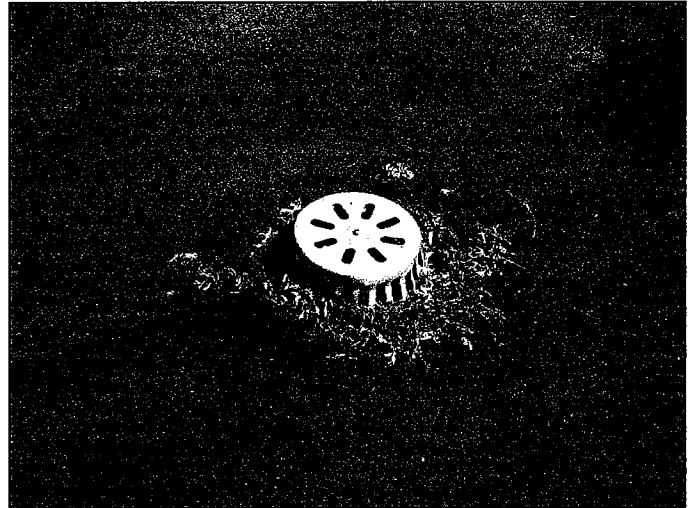
The flat roof of the building appeared to be in good condition from a maintenance perspective. The torch-on membrane appears to be in good overall condition, as do the flashings, vents, penetrations, skylights and sealant. The slope of these roofs is good and it appeared that water would be directed to the internal drains. The drains, themselves, have debris present at their perimeters.

**Photo #24- Debris present at perimeter of drain.**

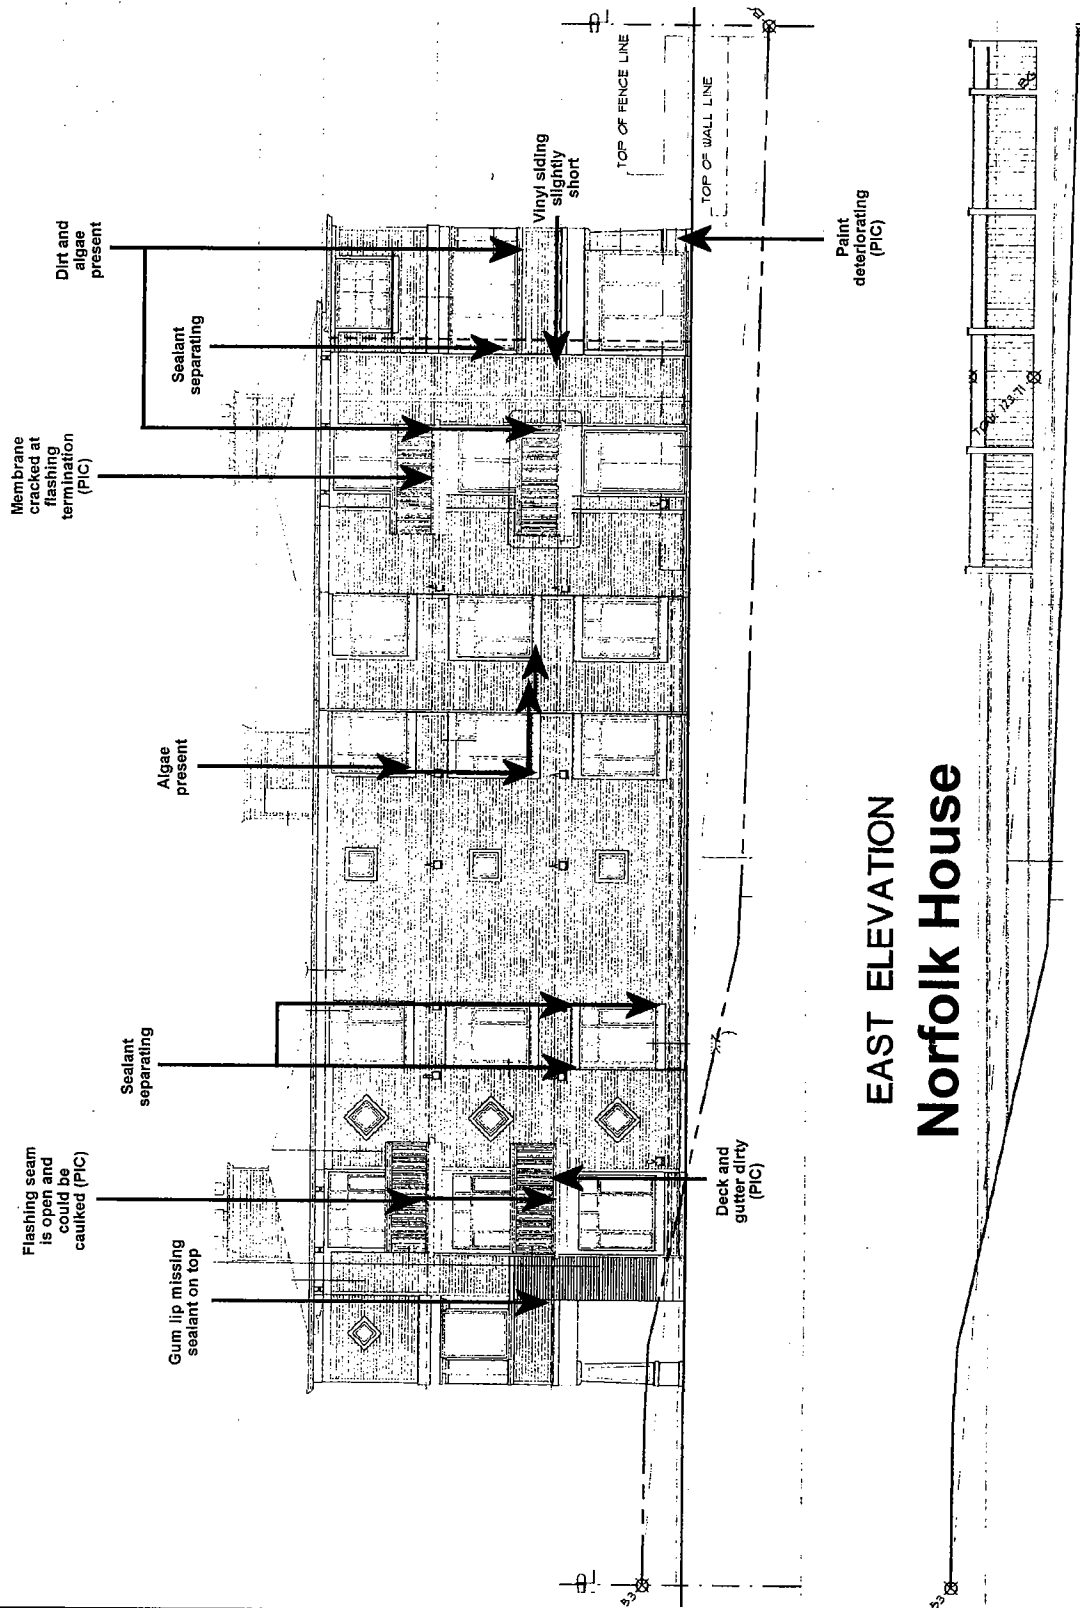
**EAST ELEVATION**  
**Norfolk House**

Thru wall flashings and gutters have dirt and algae present - most locations on this elevation

Sealant generally in good condition on this elevation

Some ground level patio decks have various amounts of organic growth between pavers

deck very dirty

Dirt and algae present at base of wood columns

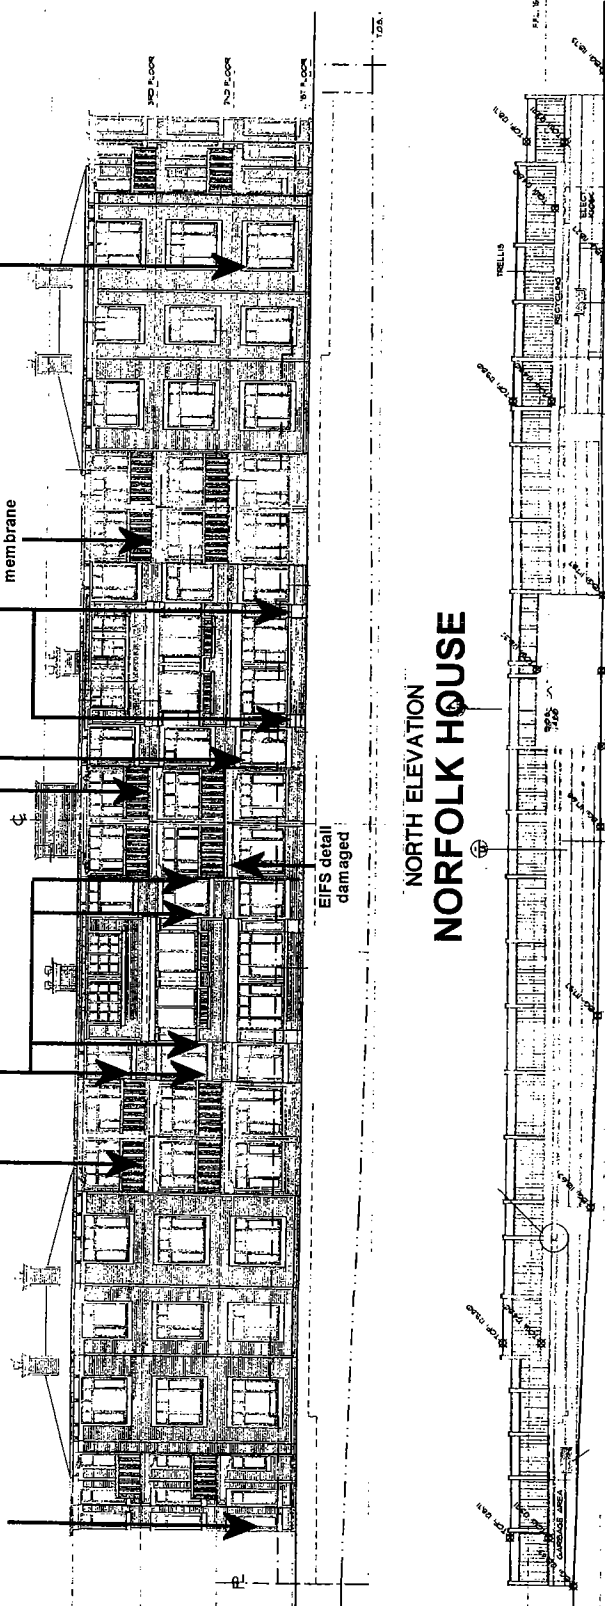
# NORTH ELEVATION NORFOLK HOUSE

Sealant separating

Cut in membrane

EIFS detail damaged
