## **Depreciation Report/Reserve Fund Study**

### **Aquarius Strata Corporation LMS 3903**

Tower A – 1199 Marinaside, Vancouver, BC  
Tower B – 198 Aquarius Mews, Vancouver, BC  
Tower C – 189 Davie Street, Vancouver, BC  
Tower M – 1111 Marinaside, Vancouver, BC

Report No. 5105557.00

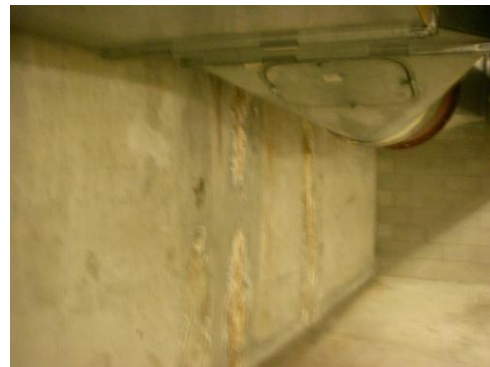
The exposed portions of the garage foundation walls were reviewed for obvious signs of deterioration (i.e., cracking, spalling and moisture penetration) from the garage interior. There are a number of full height cracks (e.g. stalls 372, 375, etc along Pacific Street wall) with staining and efflorescence. We noted a previous repair attempt at stall 342 has failed and the patch has become debonded. No active leakage was noted, however, our review was performed in dry weather.

Cracking of the foundation walls is common in parkade structures. As concrete is expected to crack, waterproofing methods such as waterstops at cold joints and dampproofing or waterproofing of the exterior walls are typically employed at the time of constructed. Once constructed, foundation walls are generally not easily accessible from the exterior, and repairs are limited to what can be done from the inside face.

Isolated repairs to areas of the foundation walls such as injecting cracks, spall repairs, application of sealers, etc are covered under the operating budget. No major repairs or replacements to the foundation walls are anticipated within the 30 year scope of this report.

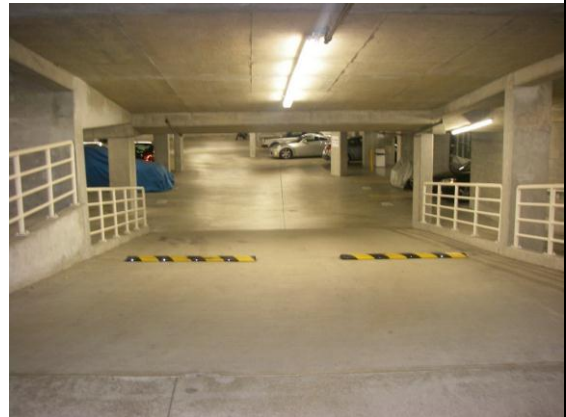
The suspended slabs in the parking garage have been protected with a liquid-applied elastomeric polyurethane waterproofing membrane system. Stall lines and numbers have been painted on the traffic membrane.

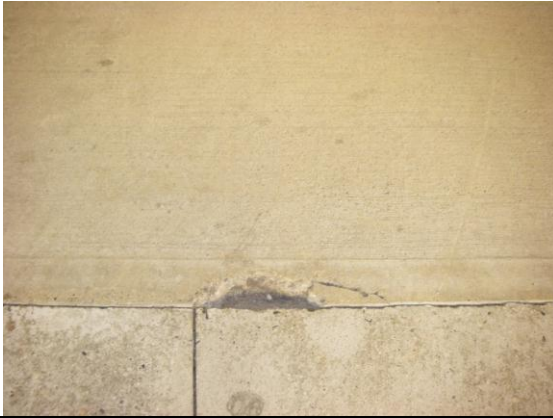
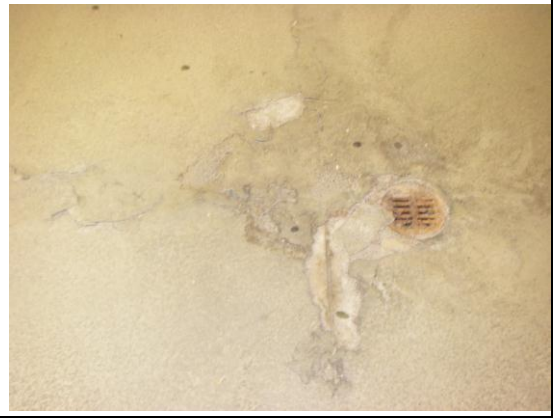
The concrete surface was generally in good condition. We did note an area of chipped concrete at the top of the ramp down to P3 lower.

The condition of the waterproofing membrane varied. We noted an area of failed membrane at the drain between stalls 262 and 285 on level P2.

We understand that concrete repairs to the suspended slab(s) (including through-slab, top surface and soffit repairs), as well as isolated repairs to the column bases, perimeter walls, and ramps will be covered under the operating budget.

- B.1 Complete replacement of the traffic coating is budgeted for every 20 years, phased over 3 years.

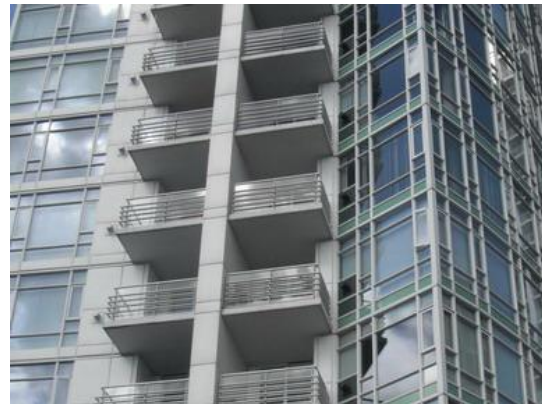
The PBEM report dated March 21, 2007 itemizes a number of deficiencies with balconies. We understand these were addressed in the 2012 repair program.

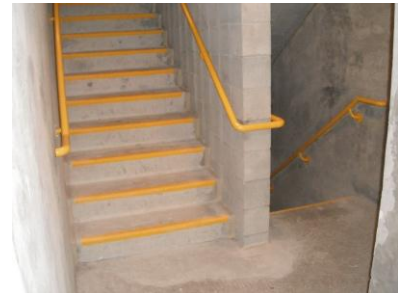
The stairs were observed to be in good condition.

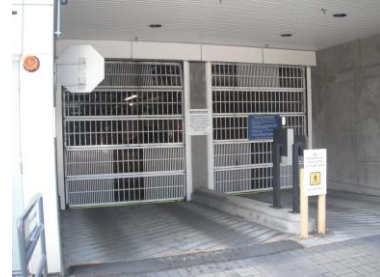
The doors are reportedly replaced frequently due to high traffic.

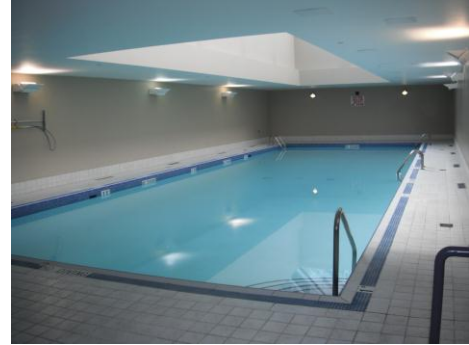
The heat exchanger serving the whirlpool failed and was replaced recently and the exchanger serving the main pool will need to be replaced within the next 2 years.

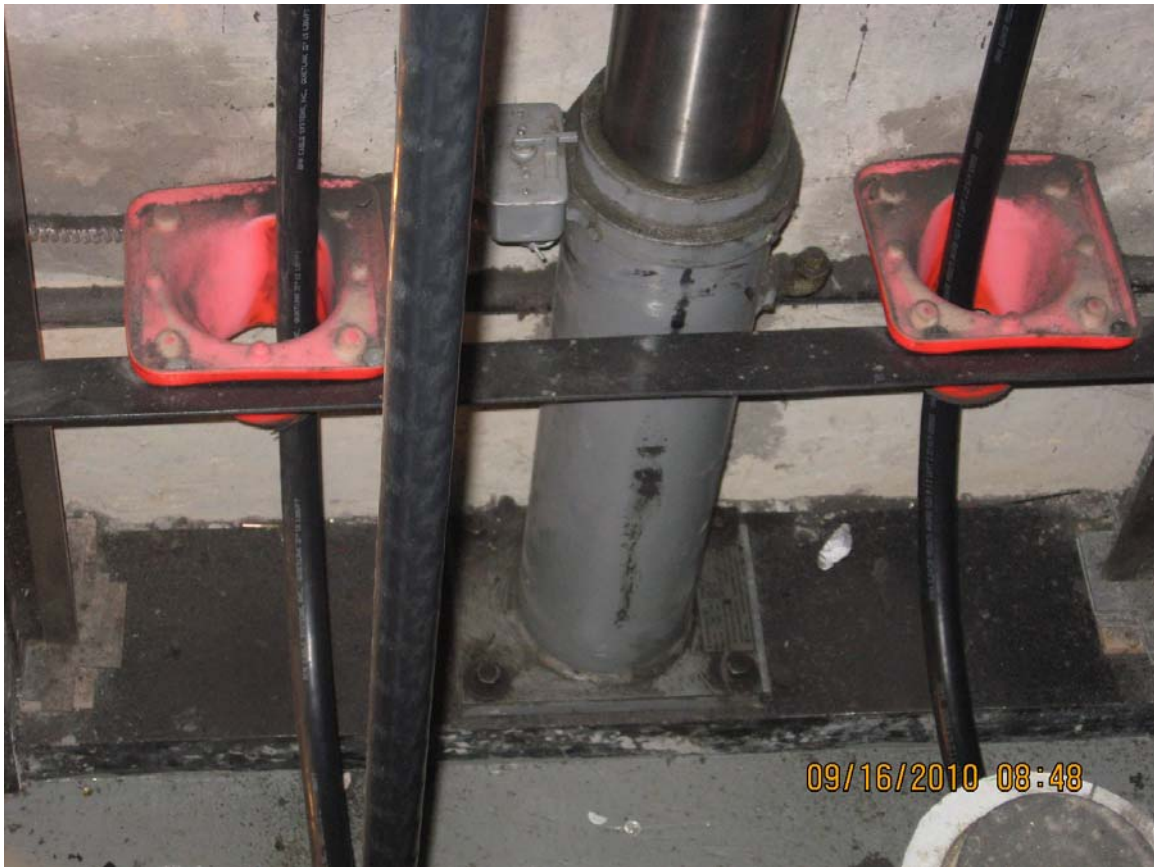
**Photo 3 – Elevator Pit - Note pylon used for compensation guides**

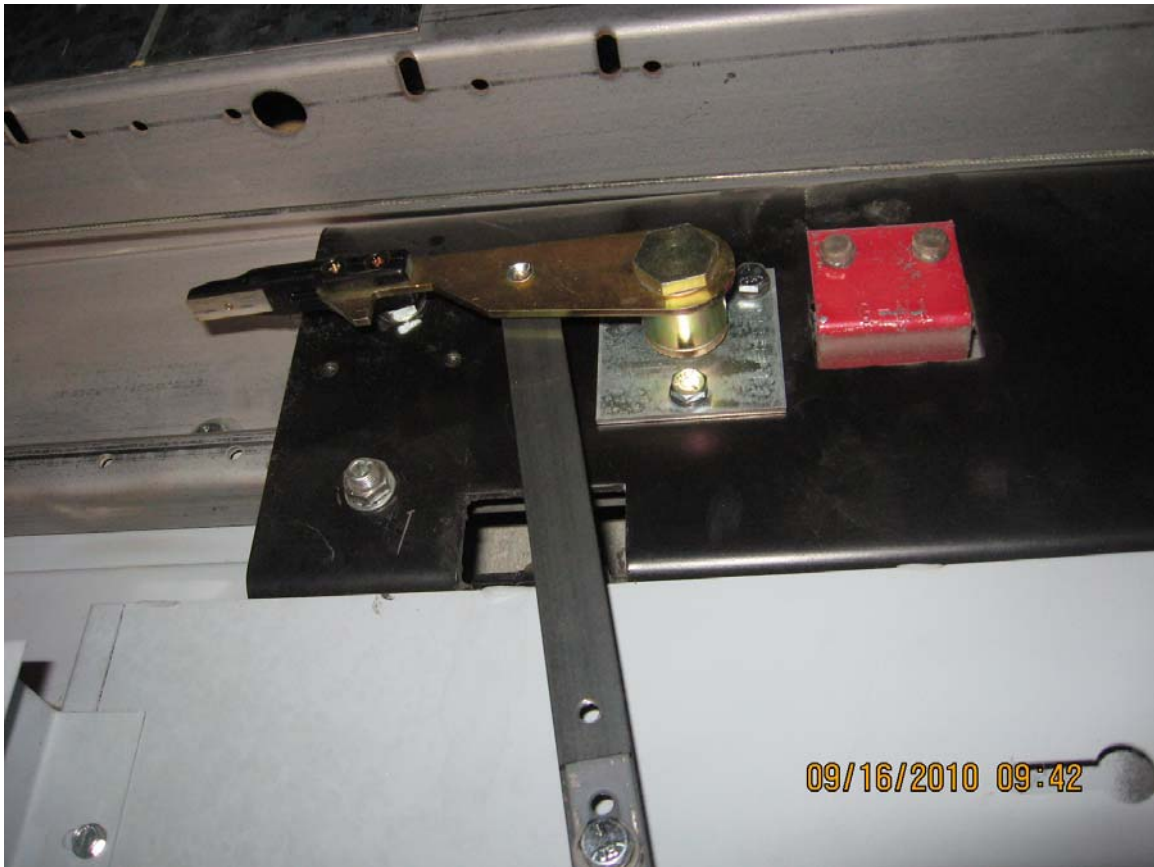
Photo 6 – Car 5 interlock

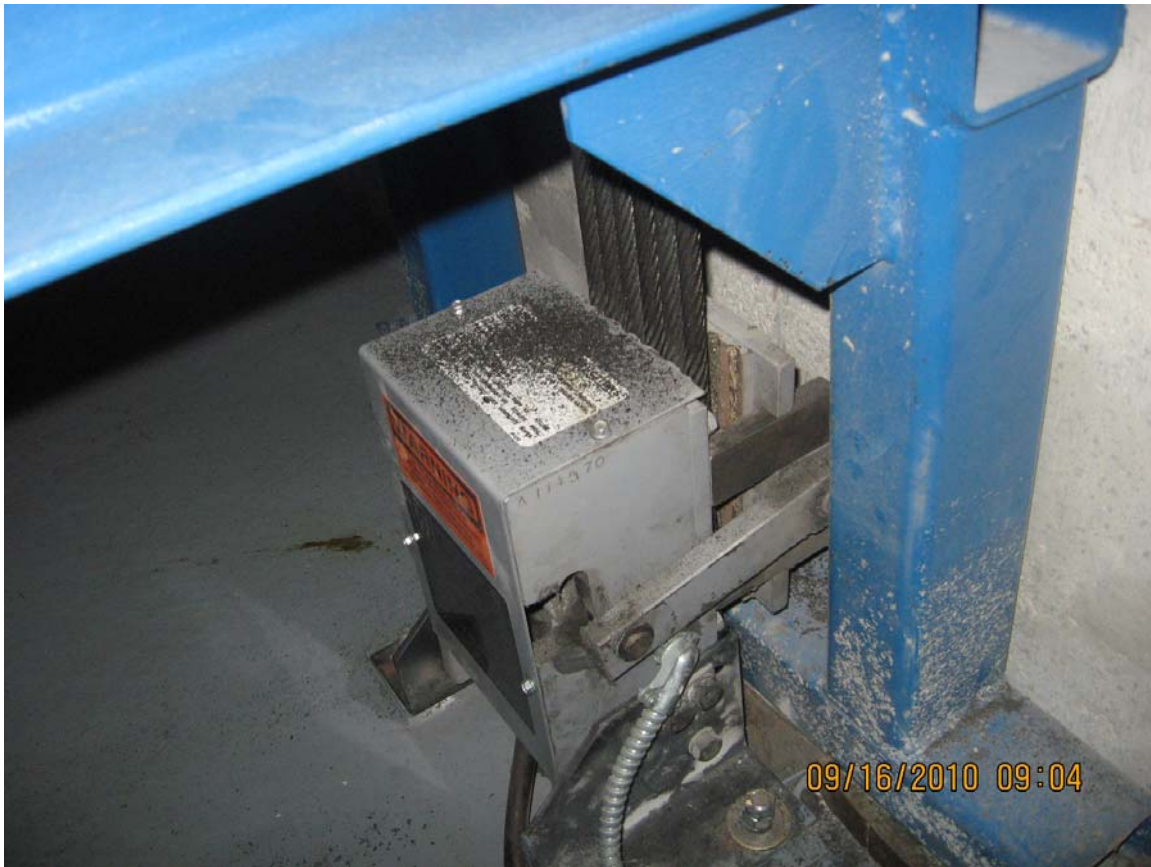
**Photo 9 – Auxiliary Brake - Rope Gripper**
