# Depreciation & Reserve Fund Study Consultation Appraisal Report

Strata Plan VIS 1177 - Cultra Court  
1950 Cultra Avenue  
Saanichton, British Columbia V8M 1Y9

as of January 1, 2015

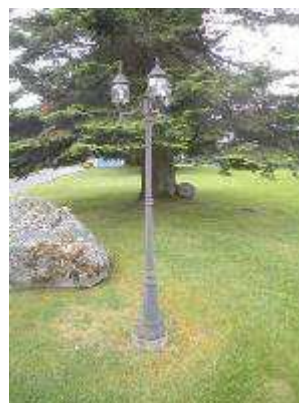
All exterior lighting shows to be in good condition.

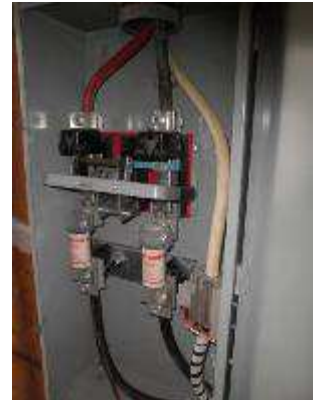
## Interior Electrical

No deficiencies were noted at the time of inspection. Strata is advised to periodically have the electrical connections inspected to ensure their continued correct operation.

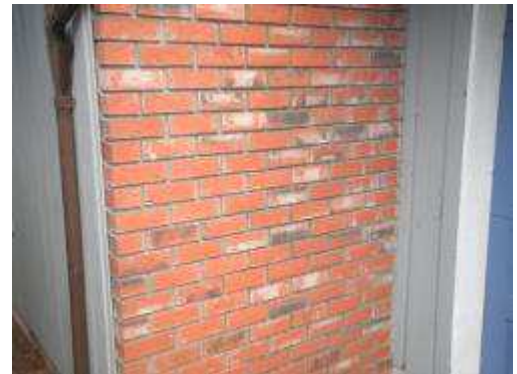
The brick walls show to be in average condition. An allowance has been included for their maintenance.

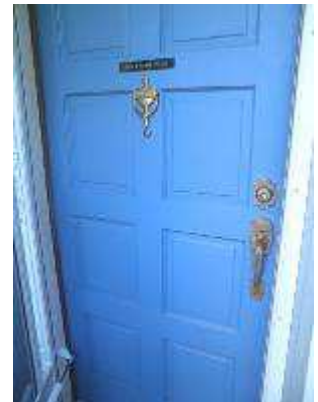
Similar to other original doors located throughout the subject property, unit entry doors appear to be in original condition however well maintained.

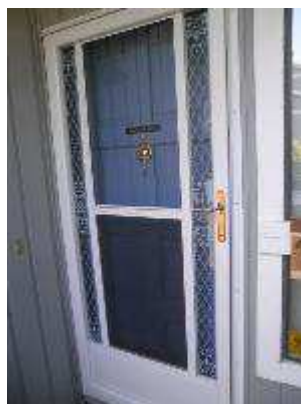
As with unit entry doors, the screen doors appear to be original however in average condition. Strata advises that these are owner improvements and not strata responsibility therefore no analysis or financial consideration has been given. This component is for information only.
