**Re: Building Envelope Review Proposal - "The Avanti" Strata Corp. LMS 3853  
3150-3188 West 4th Ave. and 2018-2028 Trutch St., Vancouver**

## APPENDIX B: Photographs

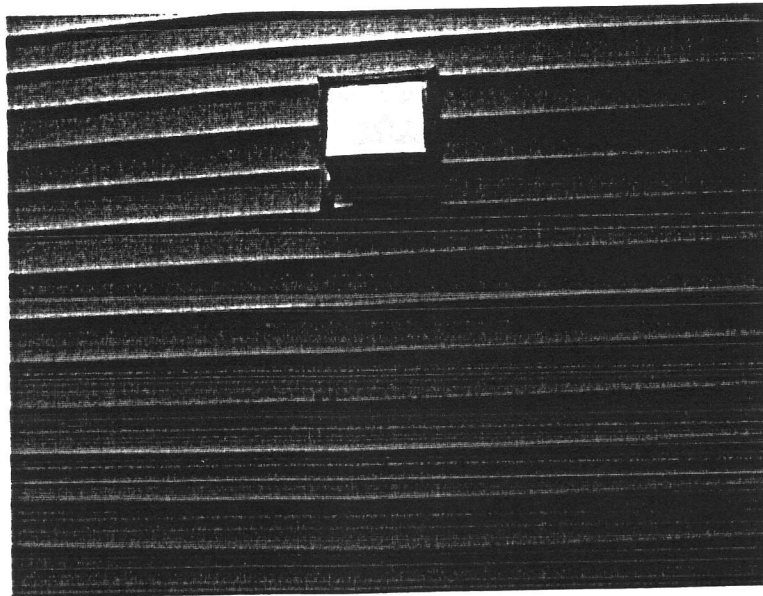
Photo 1.  
Staining on cladding from vent

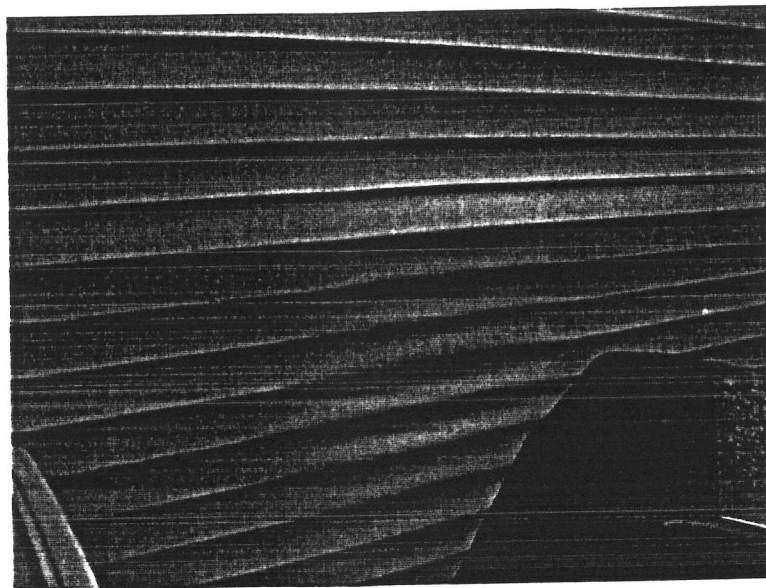
Photo 2.  
Deformed vinyl siding from heat of barbeque

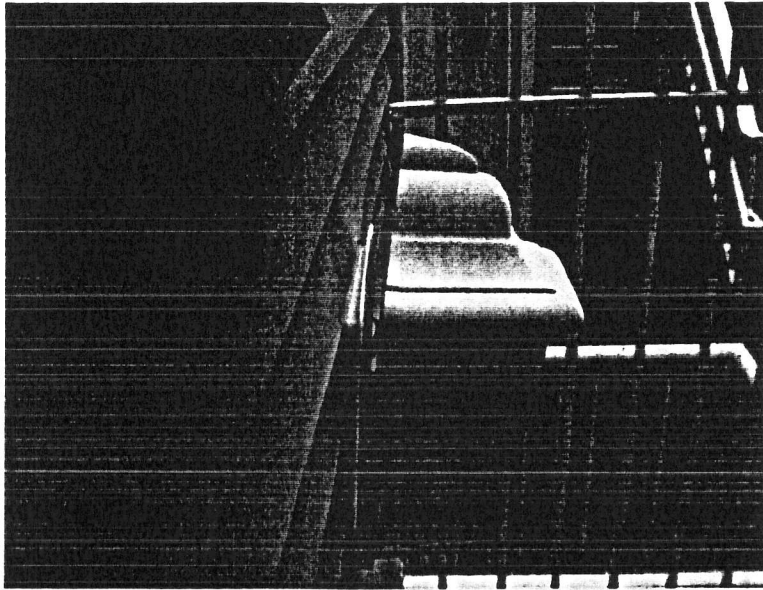
Photo 3.  
Loose light fixture, not sealed to cladding

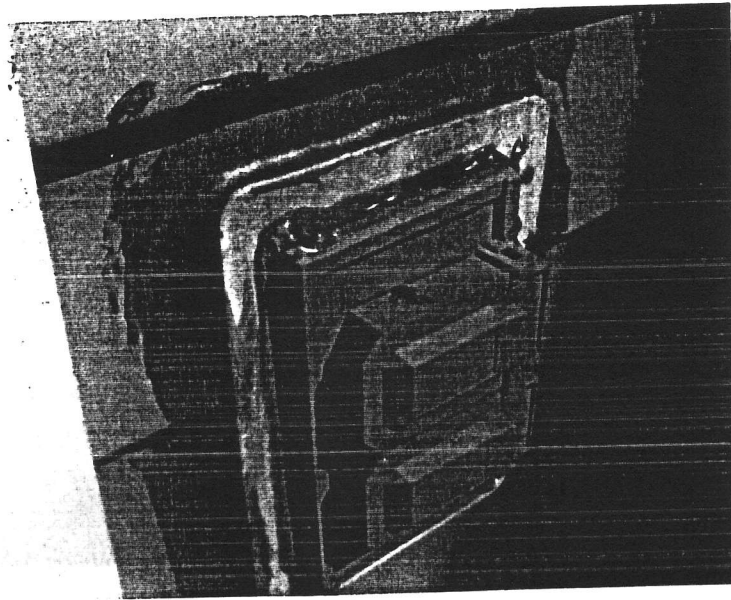
Photo 5.  
Sealed exterior receptacle box (unit 307)

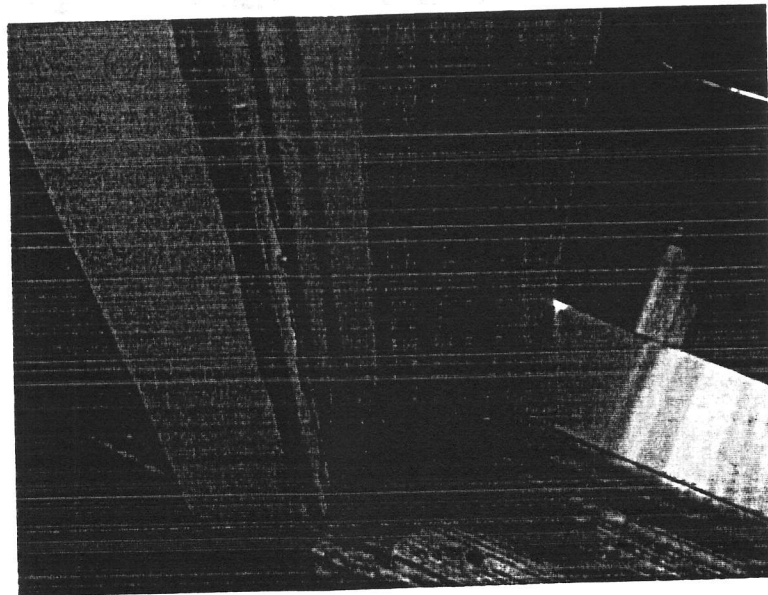
Photo 6.  
Deteriorated wood at door jamb (unit 304)

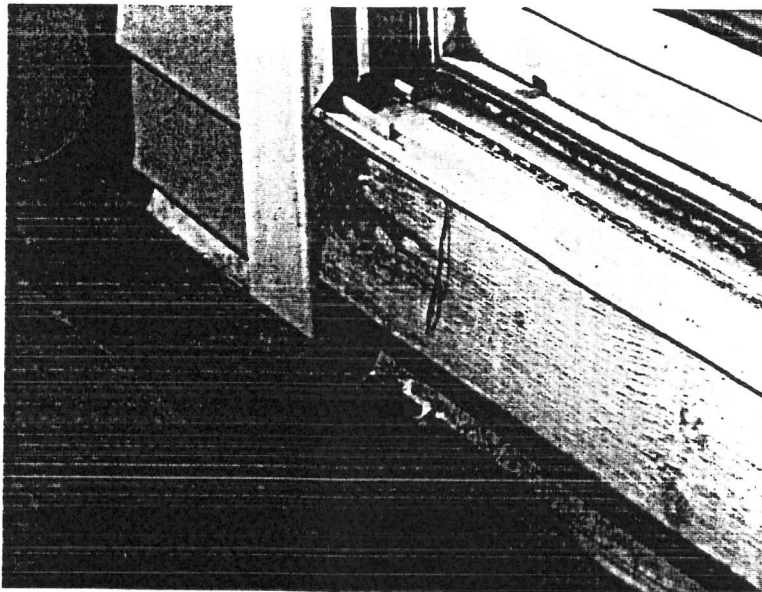
Photo 7.  
Deteriorated wood trim at patio slider door (unit 304)

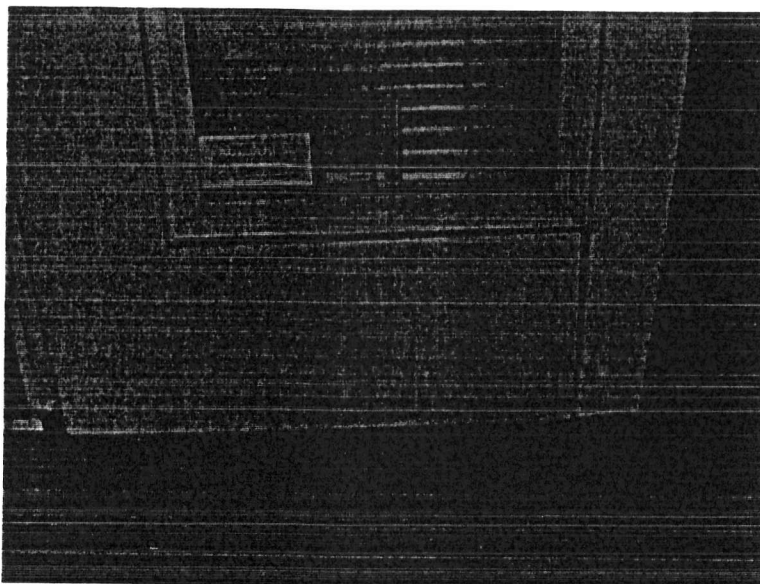
Photo 8.  
Unsealed and uneven joint

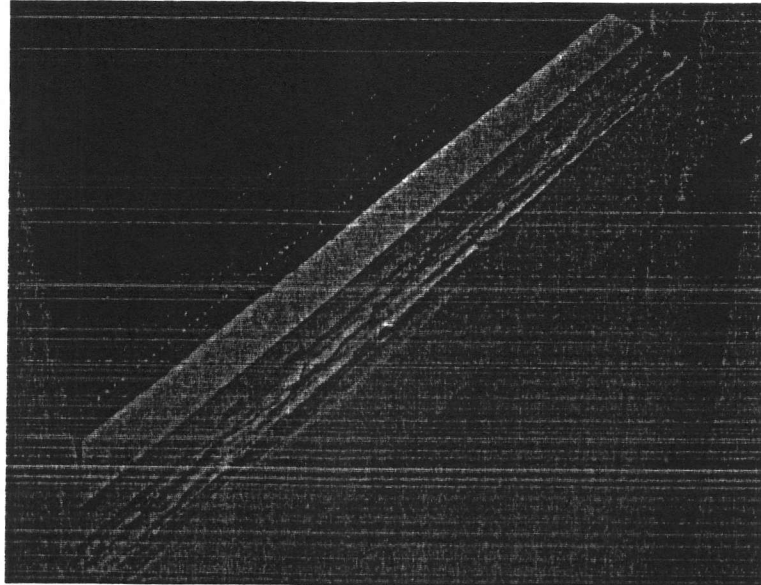
Photo 9.  
Failed sealant at 3<sup>rd</sup> floor window

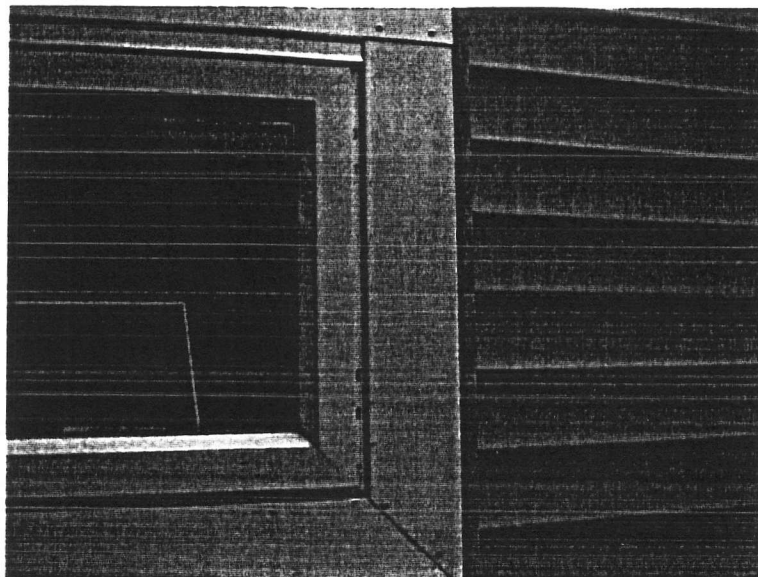
Photo 10.  
Incorrectly installed window – 3170 W. 4<sup>th</sup>

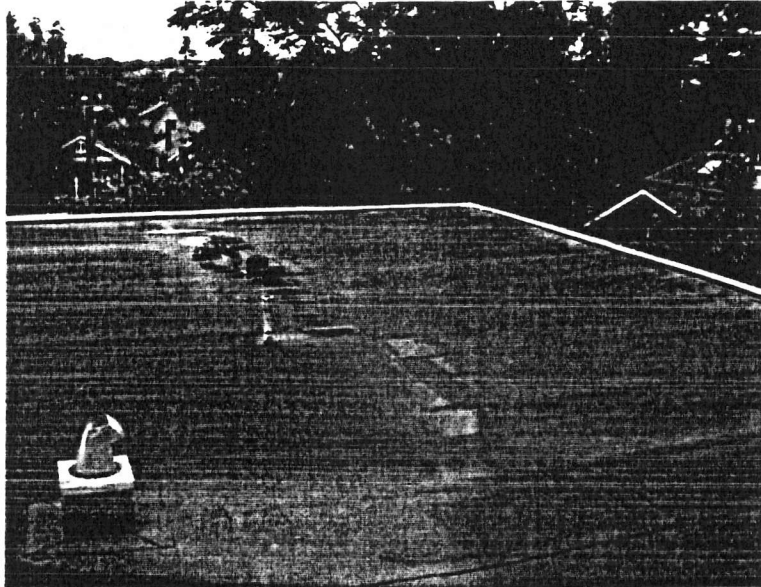
Photo 11.  
Well-sloped flat SBS roof

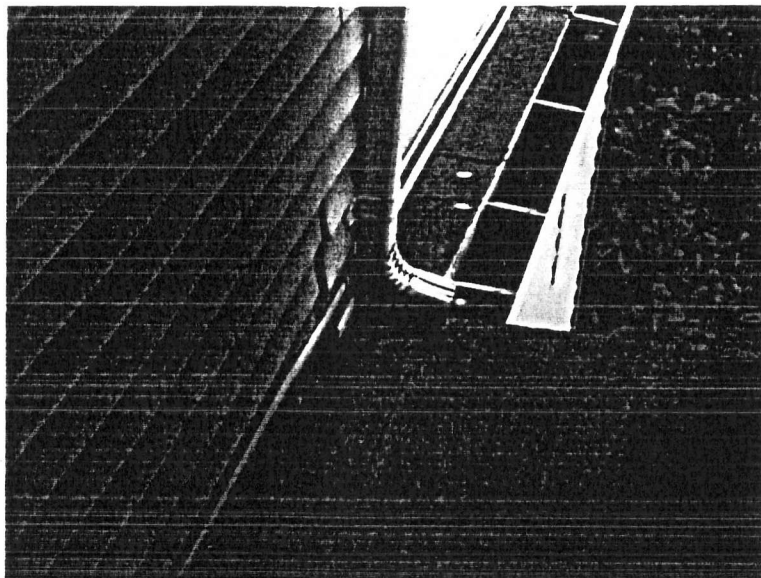
Photo 12.  
Downspout running directly onto roof

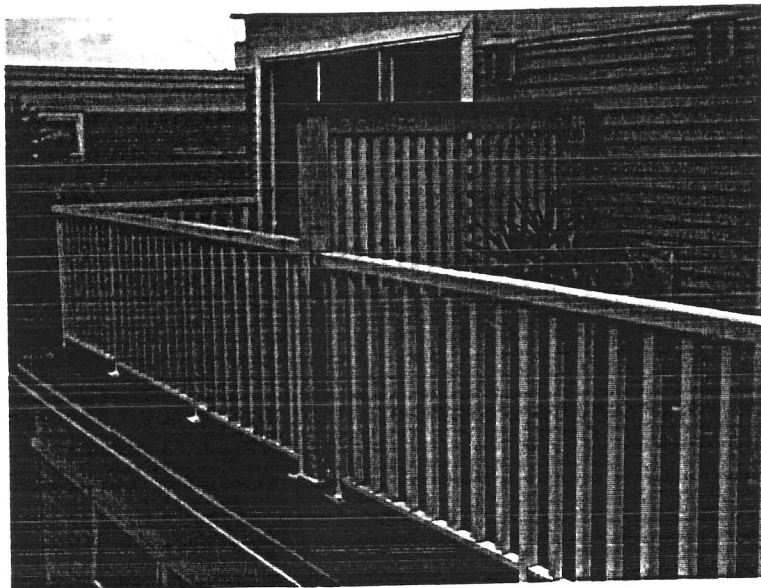
Photo 14.  
South-facing patio, guardrail attached to privacy fence

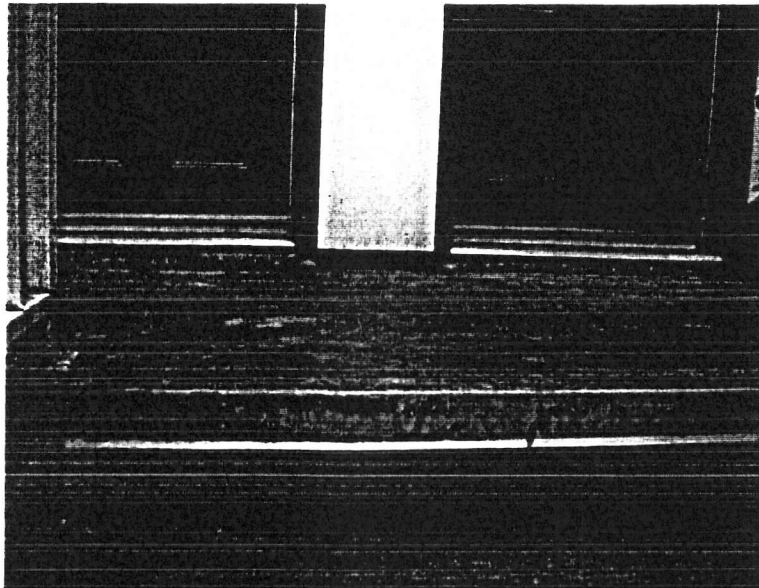
Photo 15.  
Staining and ponding water at landing

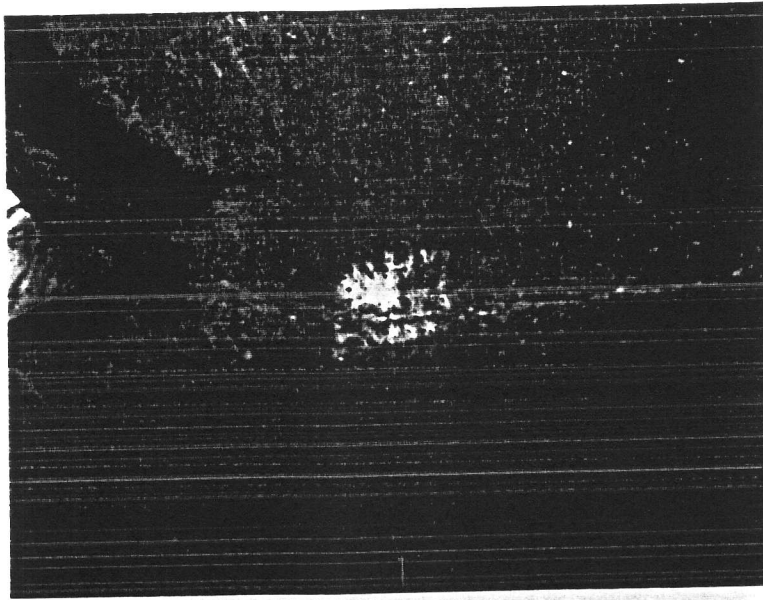
Photo 17.  
Efflorescence in garage ceiling

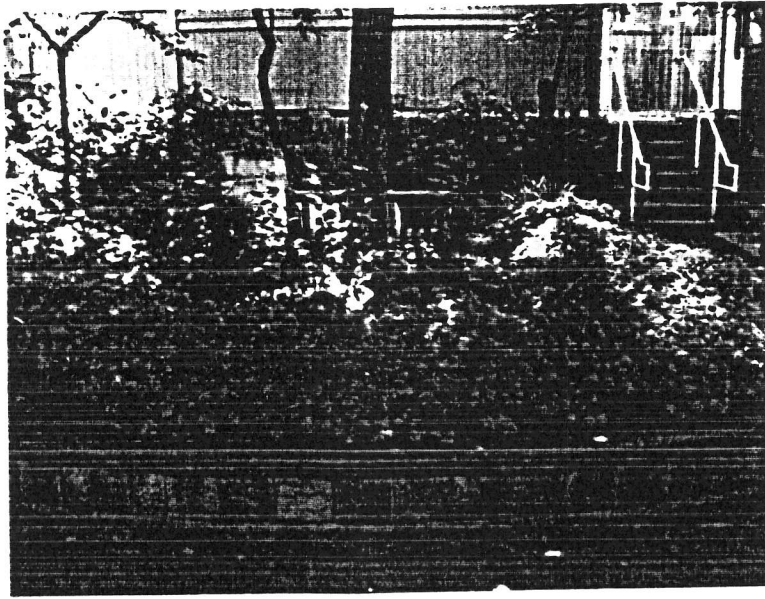
Photo 19.  
Tree at central courtyard
