## PARKING GARAGE CONDITION EVALUATION

1330 BURRARD STREET  
1333 HORNBY STREET  
950 DRAKE STREET  
VANCOUVER, BC

PREPARED FOR:  
THE OWNERS, STRATA VR 1182, 1183 AND 1184  
C/O ASCENT REAL ESTATE MANAGEMENT CORPORATION  
2176 WILLINGDON AVENUE  
BURNABY, B.C. V5C 5Z9

205VR012A.R1  
SEPTEMBER 30, 2005

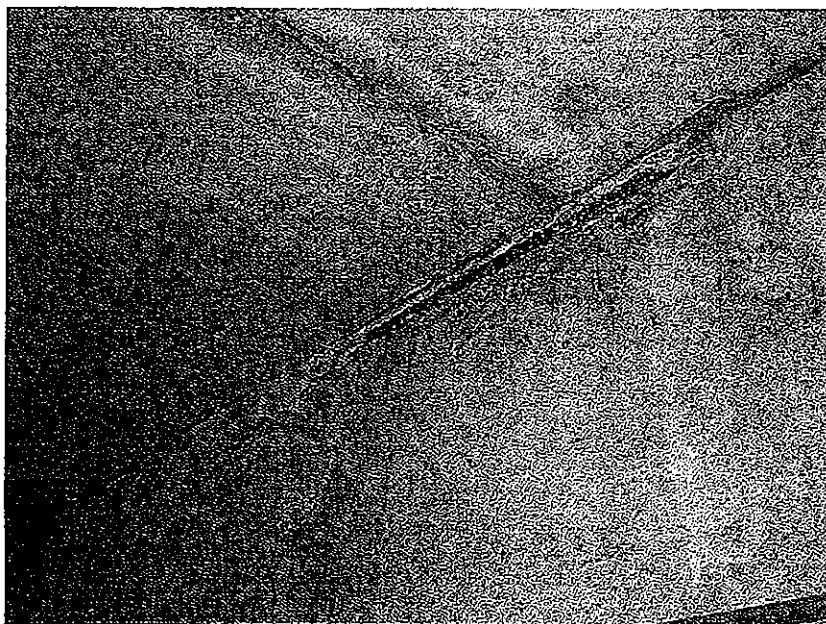
**Photo 5: Reinforcement Corrosion**

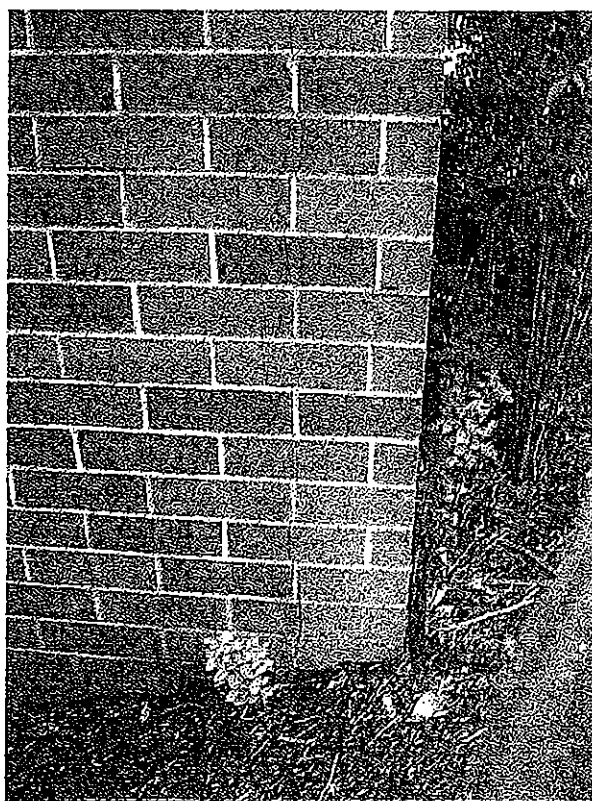
**Photo 6: Stairwell Masonry Cracks**

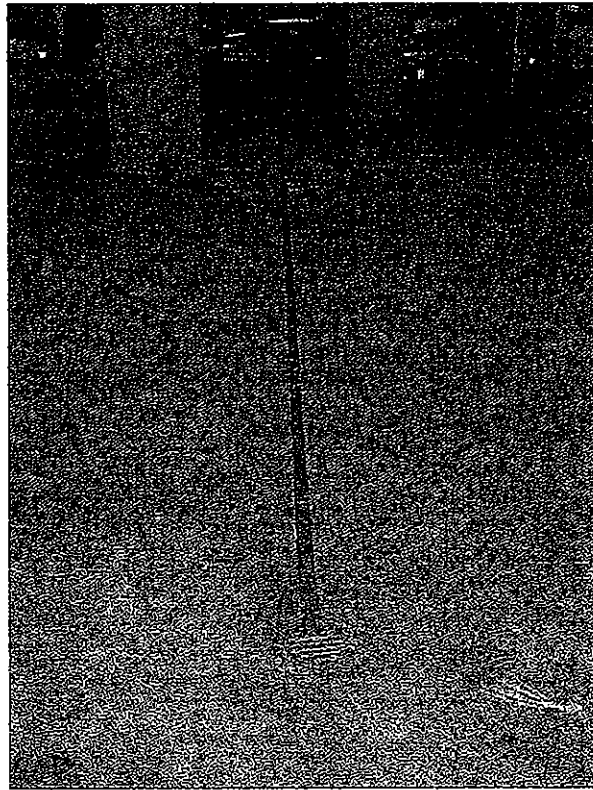
**Photo 3: Slab on Grade Drainage**

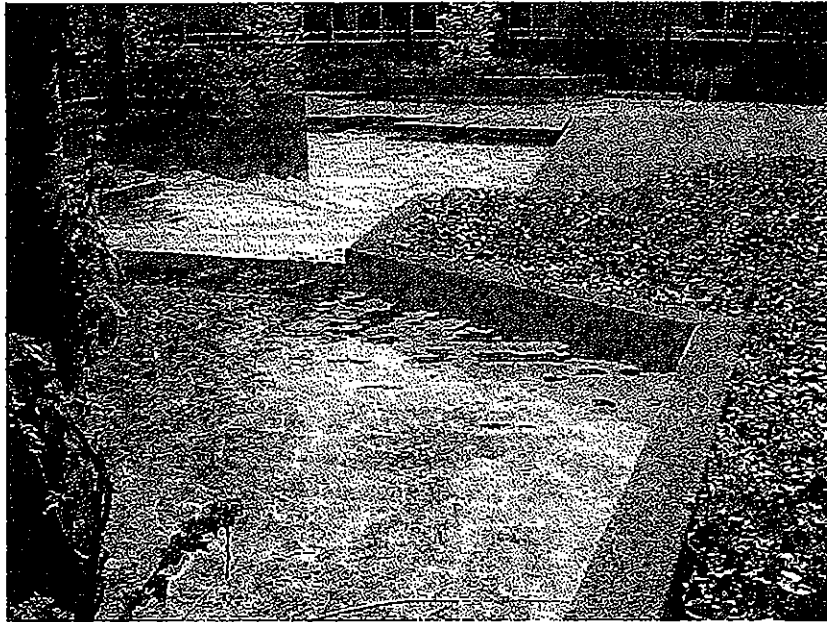
**Photo 7: Roof Slab Cover**

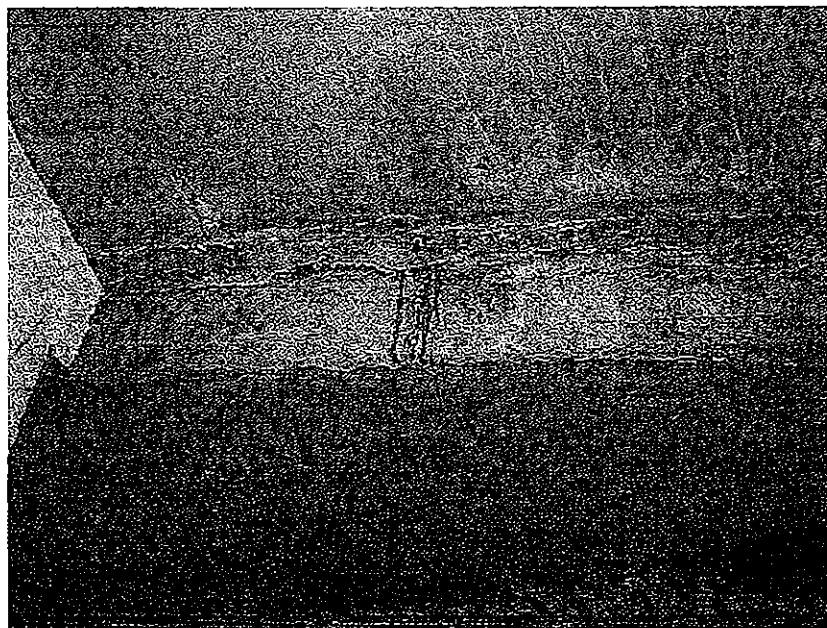
**Photo 8: Injection Ports**

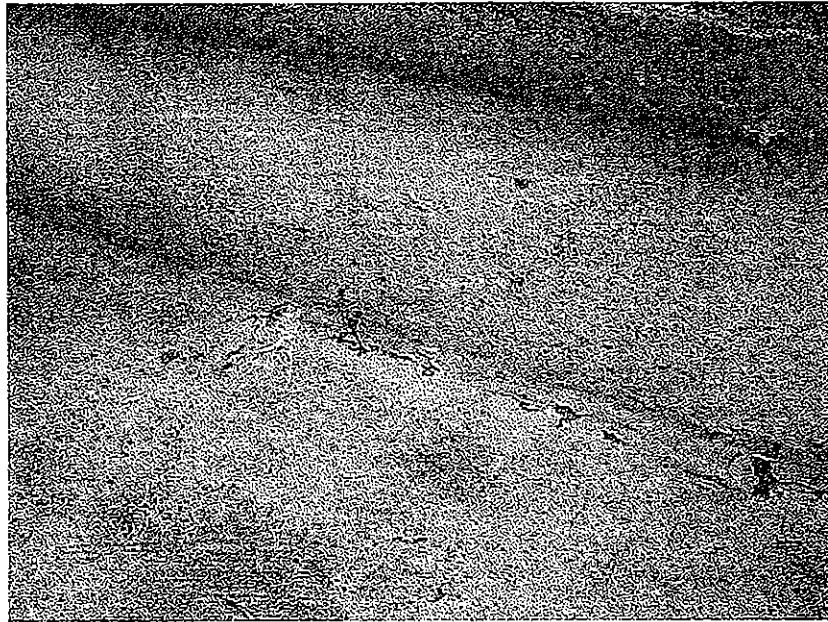
**Photo 9: Elastomeric Coating Peeling / Cracked**

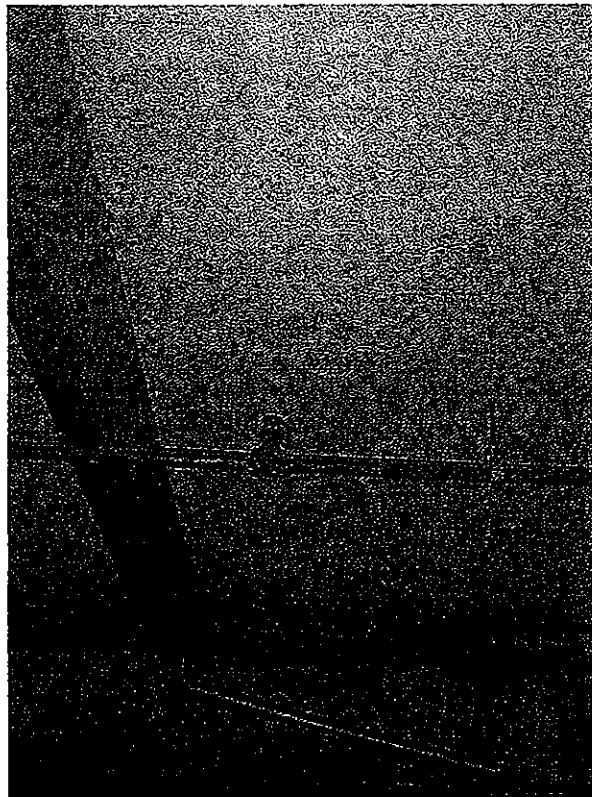
**Photo 10: Trough Installation**
