**DOMUS  
STRATA CORPORATION BCS528  
1055 HOMER STREET  
VANCOUVER, B.C.**

-----  
**MINUTES OF THE STRATA COUNCIL MEETING OF THE OWNERS OF STRATA  
PLAN BCS528, "DOMUS", HELD IN THE LOUNGE AREA, 2<sup>ND</sup> FLOOR, 1055  
HOMER STREET, VANCOUVER, B.C., ON MONDAY AUGUST 25<sup>TH</sup>, 2008 AT 7:00  
P.M. WITH ADDITIONAL FOLLOW-UP BY EMAIL AND IN PERSON.**  
-----

Morrison Hershfield (MH) was retained by the Owners of Domus (Strata Plan BCS 528) to undertake a visual review of the building envelope of their building complex located at 1055 Homer Street, Vancouver. The purpose of the review was to identify possible deficiencies that may be covered by the five-year warranty, which expires October 28, 2008.

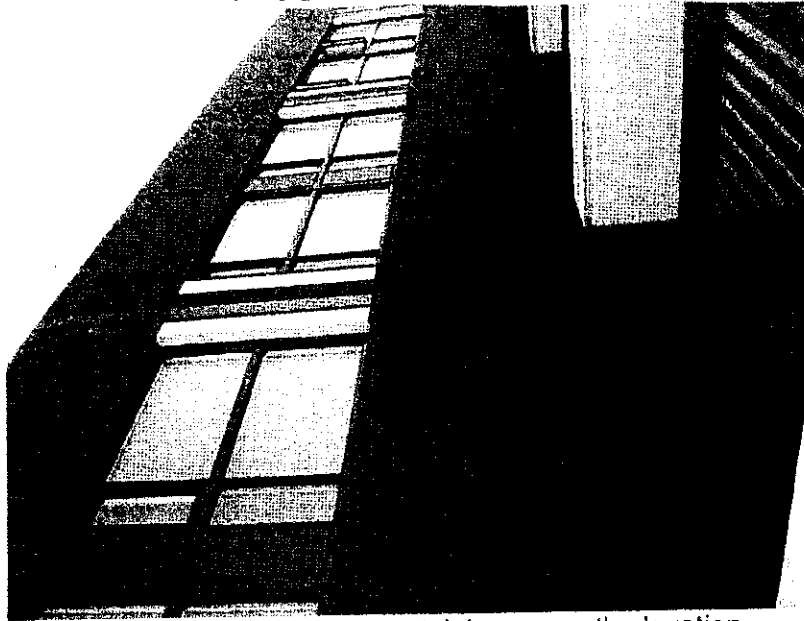
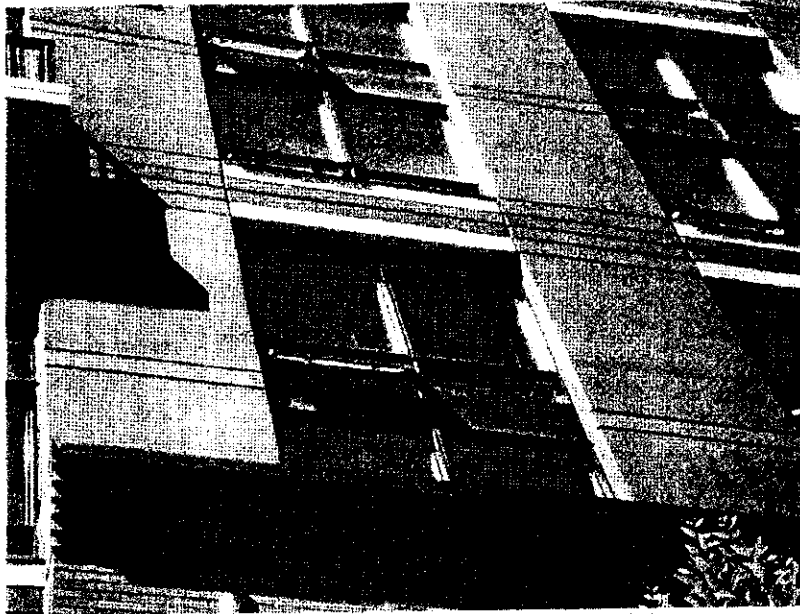
| Item/<br>Photo | Deficiency Description | Category | Corrective Action |
|---|---|---|---|
| 1a, 1b,<br>1c | <p>Efflorescence staining on the outside of the building. This has been ongoing since construction and was reportedly cleaned last year, however has reoccurred in various locations.</p> <p>The pattern of staining suggests that there may be some cracking in the horizontal concrete reveals. Water getting into the cracks, is leaching out the salts in the concrete and dripping down the side of the building leaving white streaks. Further indication of cracks in the reveals was noted at a test opening in unit 705.</p> | D | The building should be reviewed for cracking in the reveals and the cracks repaired. |

Photo 1a : Efflorescence staining on south elevation.

Photo 1b : Efflorescence staining under reveals.

Photo 1c : Efflorescence staining on east elevation (above entrance).

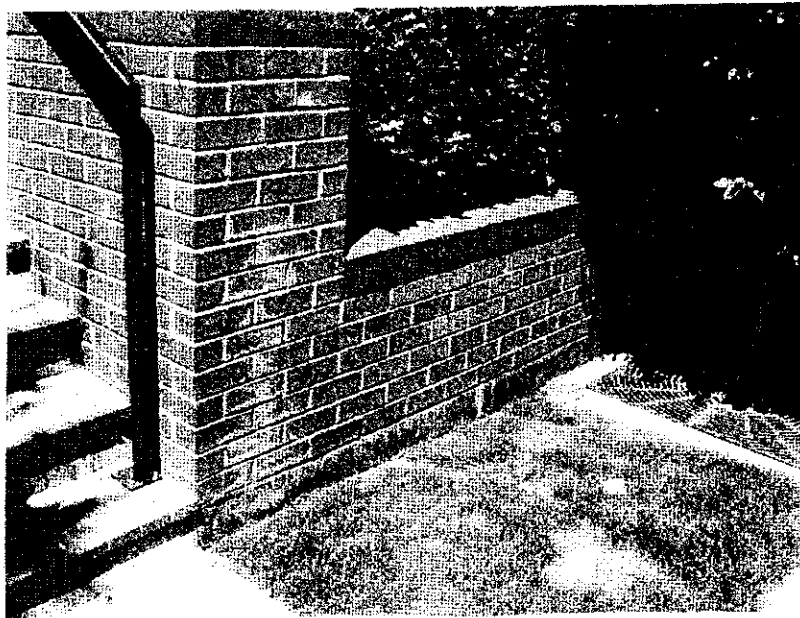
| Item/<br>Photo | Deficiency Description | Category | Corrective Action |
|---|---|---|---|
| 2 | <p>Efflorescence staining at brick along sidewalk in front of townhouses.</p> <p>Efflorescence is indicative of water getting into the brick cladding, likely from the top of the walls.</p> | M | Bricks should be cleaned regularly. The Strata may want to provide a metal cap flashing over the top of the walls to reduce the amount of water getting into the wall assembly from the top. |

Photo 2 : Efflorescence staining of brick at townhouse entrance.

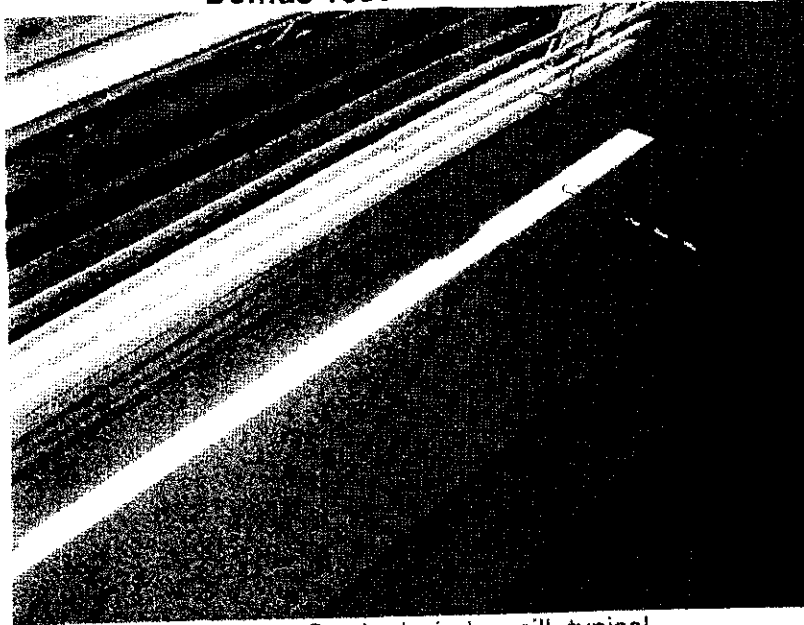
| Item/<br>Photo | Deficiency Description | Category | Corrective Action |
|---|---|---|---|
| 3 | Typical- cracking along window sills between the window frame and the wood stool. This is likely due to shrinkage. | M | Aesthetic issue. Individual owners may choose to seal. |

Photo 3: Cracked window sill- typical

| 3 | Cracking along interior window sills | 3 | Aesthetic only; no further action required |

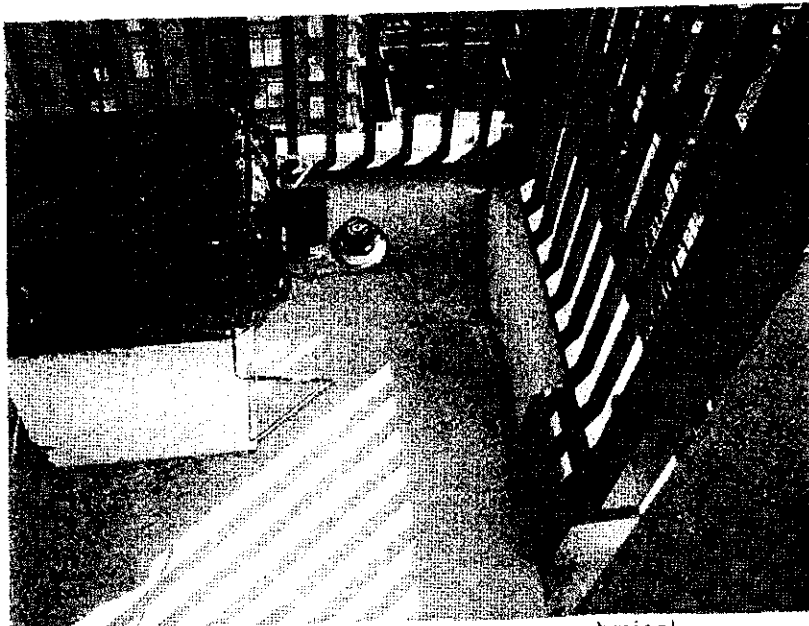
Photo 4: Dirty balcony membrane- typical.

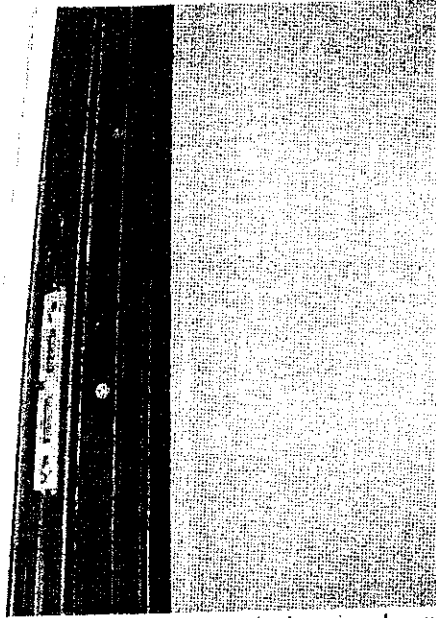
Photo 5: Chipped paint at window jamb, unit 2103.

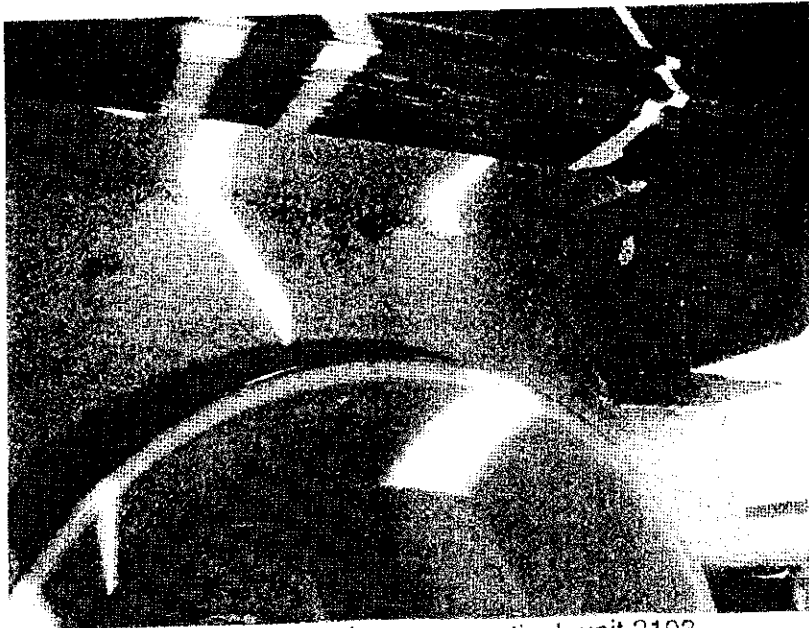
Photo 6: No membrane on vertical- unit 2103.

| 6 | Missing membrane (paint) on Juliet Balcony wall | 3 | Use elastomeric paint during next overall building paint job |

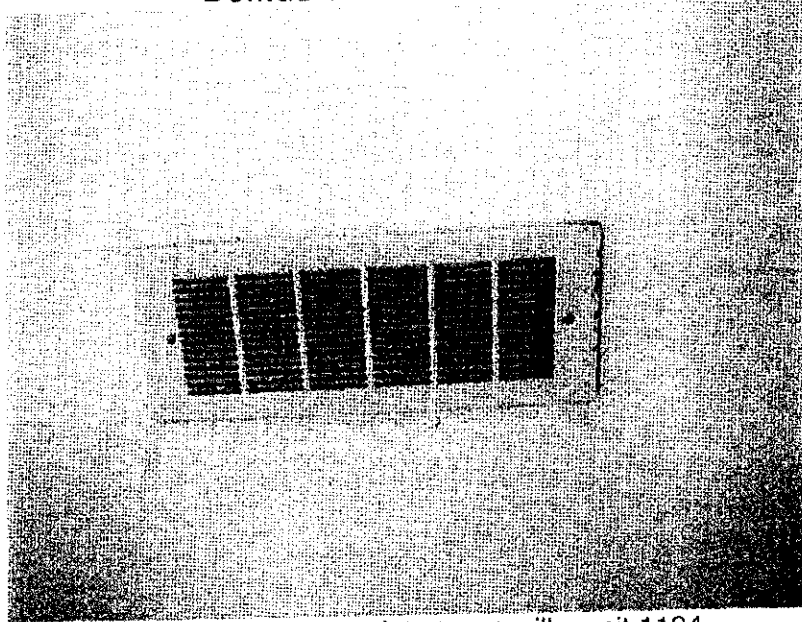
Photo 9: Bubbling paint at vent grille- unit 1104.

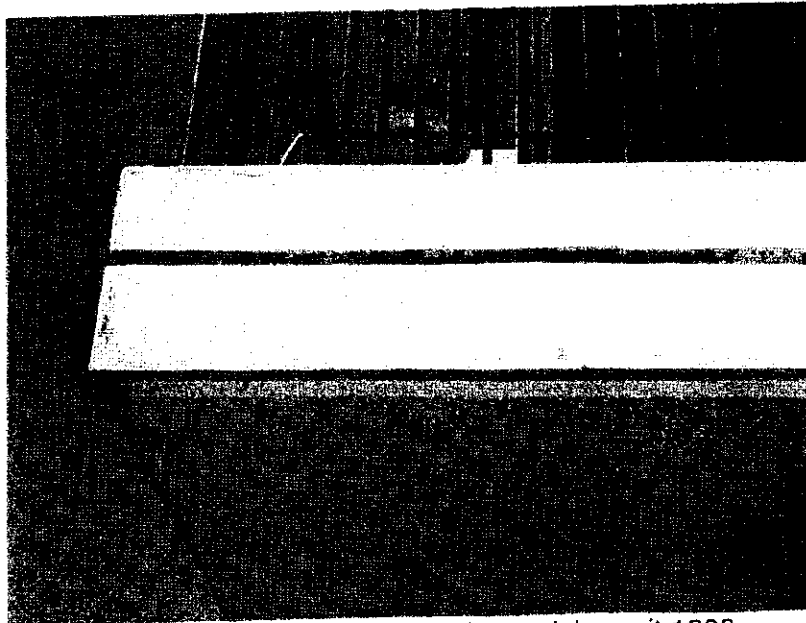
| Item/<br>Photo | Deficiency Description | Category | Corrective Action |
|---|---|---|---|
| 10 | 1203- Paint peeling on balcony slab edge (as observed from 1104) | M | Touch up paint as required. |

Photo 10: Chipped paint at balcony slab - unit 1203.

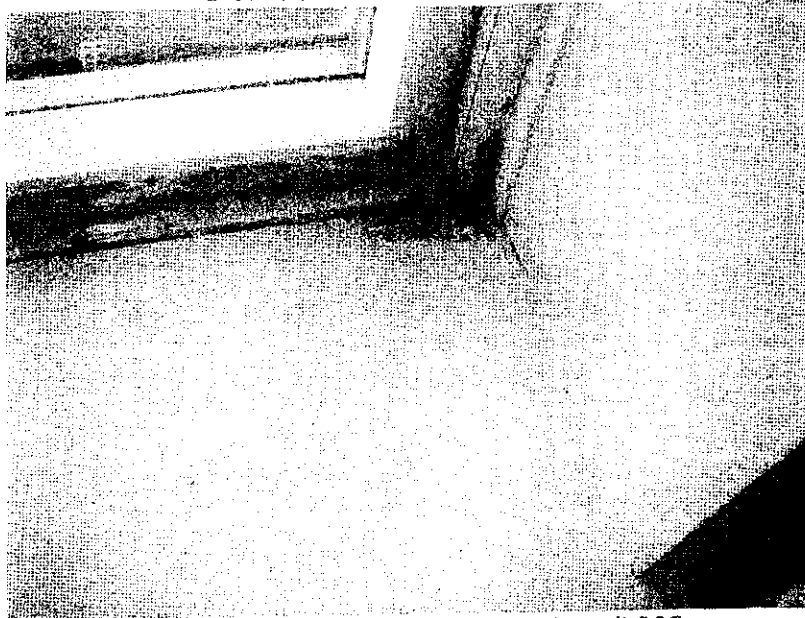
| Item/<br>Photo | Deficiency Description | Category | Corrective Action |
|---|---|---|---|
| 11 | 902- Mold, soft drywall at master bedroom window sill. | I | Further investigation into source of moisture (condensation or leak). |

Photo 11: Damaged window stool - unit 902.

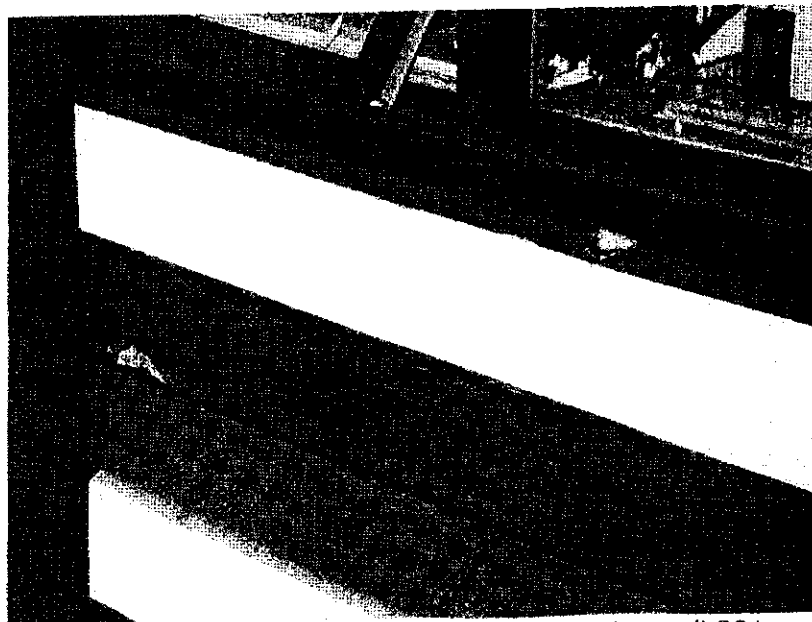
| Item/<br>Photo | Deficiency Description | Category | Corrective Action |
|---|---|---|---|
| 12 | 901- Impact damage to metal sill flashing and concrete. | M | Patch concrete and recoat. Provide sealant at flashing hole. |

Photo 12: Damaged sill flashing and concrete - unit 901.

| 12 | Damaged flashing and concrete | 2 | After next exterior inspection, patch concrete; provide sealant at hole |

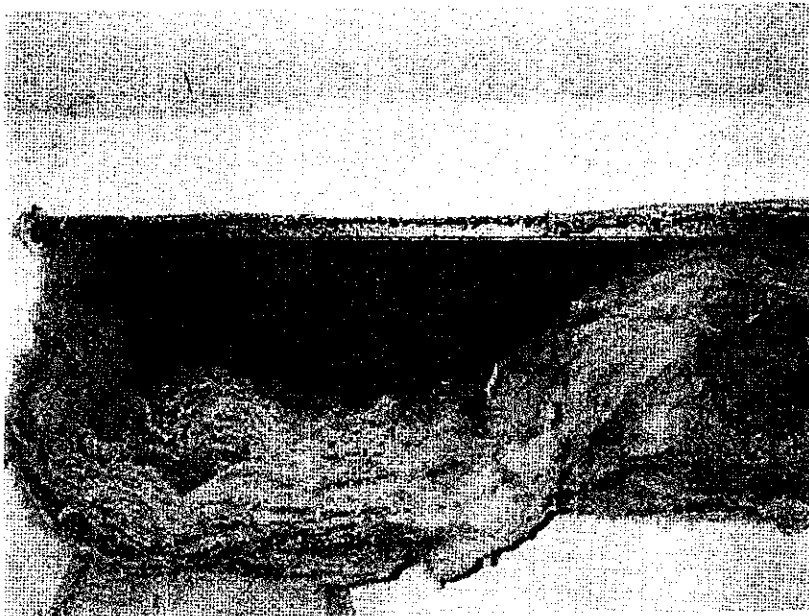
| Item/<br>Photo | Deficiency Description | Category | Corrective Action |
|---|---|---|---|
| 14 | 705- Staining on ceiling in living room.<br><br>Exploratory opening revealed wet concrete and insulation. Likely related to cracking at the cold joint (reveals). | D | Seal crack and repair interior finishes. Refer to July 31, 2007 report for further details. |

Photo 14: Stained ceiling and wet concrete and insulation - unit 705.

| <u>Item</u> | <u>Description</u> | <u>Priority</u> | <u>Action</u> |
|---|---|---|---|
| 14 | Stained sealing; wet concrete and insulation | 1 | Initial claim denied; further Strata testing concluded there was no water intrusion |

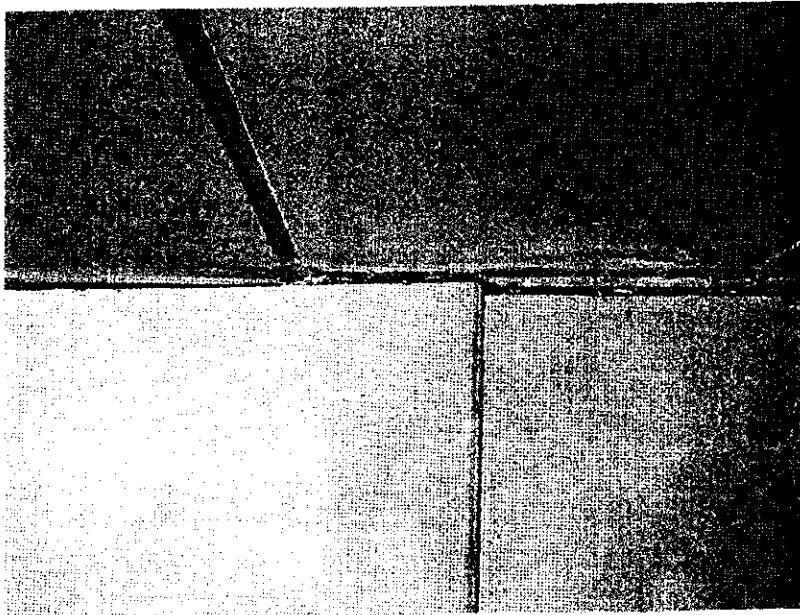
Photo 19: Missing sealant at base of wall flashing - TH 1059.

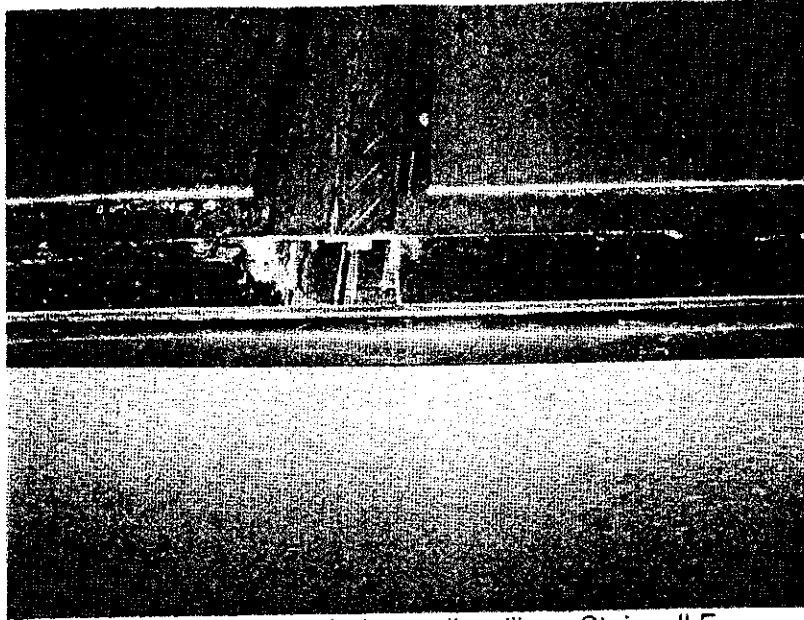
Photo 20: Open window wall mullion - Stairwell E.

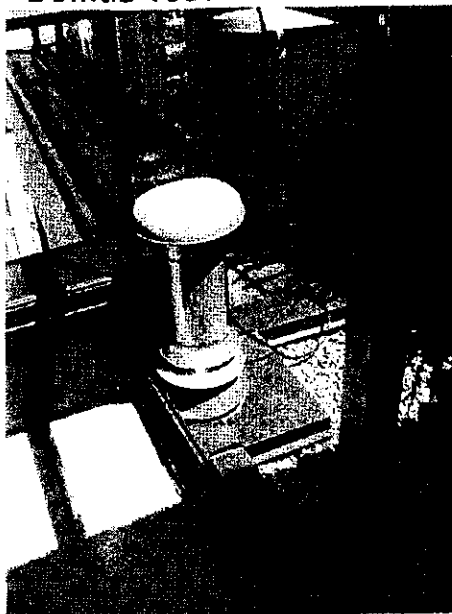
| Item/<br>Photo | Deficiency Description | Category | Corrective Action |
|---|---|---|---|
| 22 | Glass panel at deck railing missing to accommodate vent stack. | M | Suggest modifying railing to prevent passage through opening. |

Photo 22: Missing glass at penthouse level 28.

| 22 | Missing glass panel at railing | 3 | Aesthetic only; no further action required |

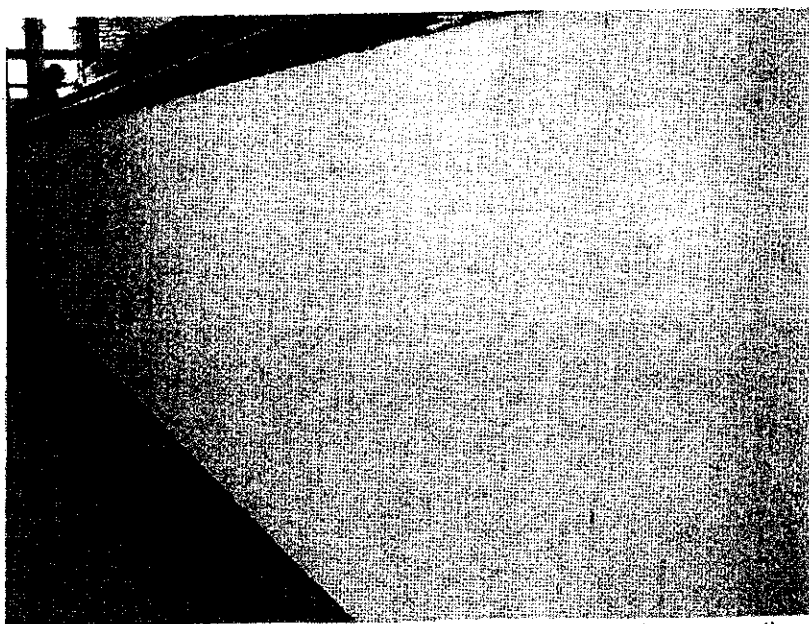
Photo 23: Streaking of paint on mechanical penthouse walls.

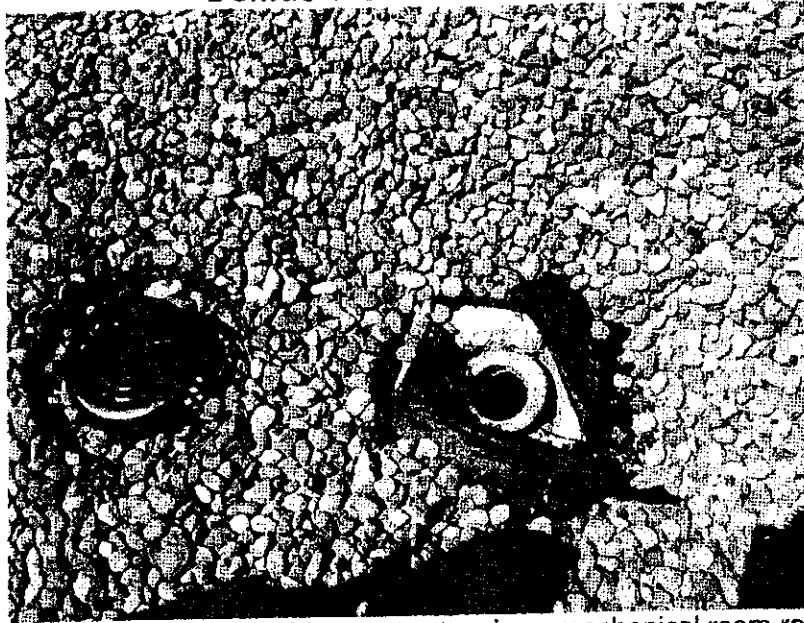
| Item/<br>Photo | Deficiency Description | Category | Corrective Action |
|---|---|---|---|
| 24 | Mechanical room roof- Missing vent pipe extension. | M | Provide vent pipe to extend above finished roof level. |

Photo 24: Missing plumbing vent extension - mechanical room roof.

| 24 | Missing vent pipe extension | 2 | Resident Manager to install cap (COMPLETED) |

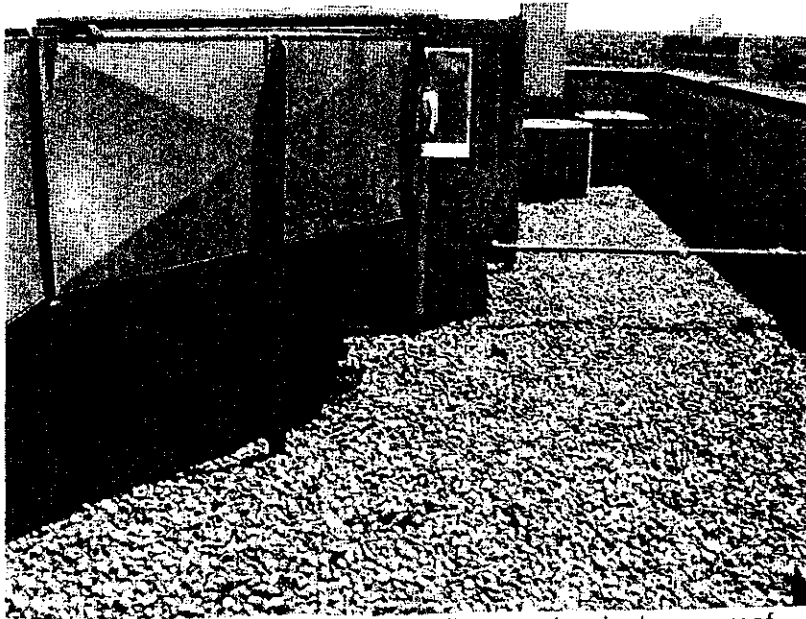
| Item/<br>Photo | Deficiency Description | Category | Corrective Action |
|---|---|---|---|
| 25 | Exposed concrete parapet walls. | M | Coat parapet walls to prevent moisture absorption and possible water infiltration behind roof membrane upturns. |

Photo 25: Exposed concrete walls - mechanical room roof.

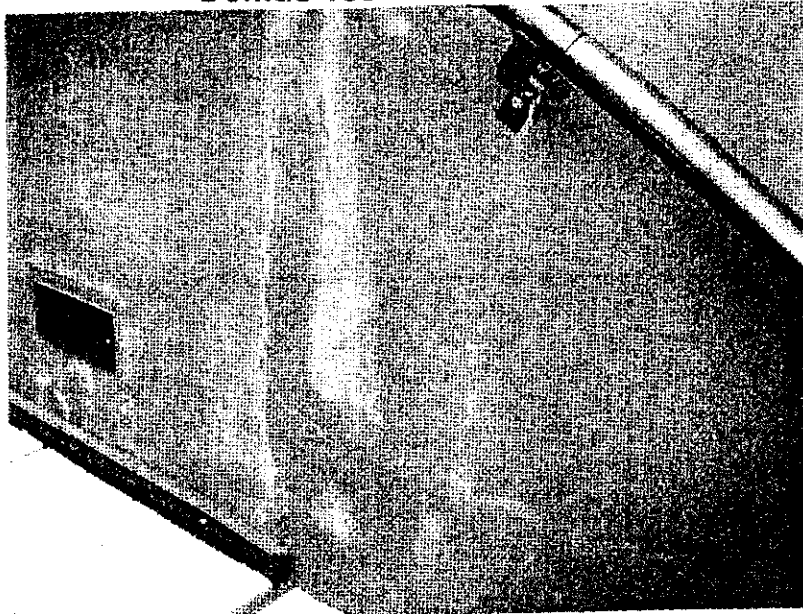
| Item/<br>Photo | Deficiency Description | Category | Corrective Action |
|---|---|---|---|
| 27 | Efflorescence staining and cracking along walls of exterior stairwells. | M | Seal cracks and clean. Recoat as required. |

Photo 27 : Efflorescence and cracking - stairwell D.

| 27 | Efflorescence and cracking exterior stairwells | 2 | Resident Manager to paint annually |

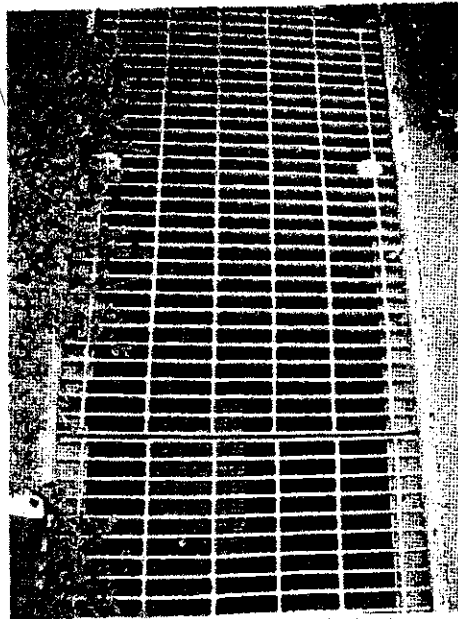
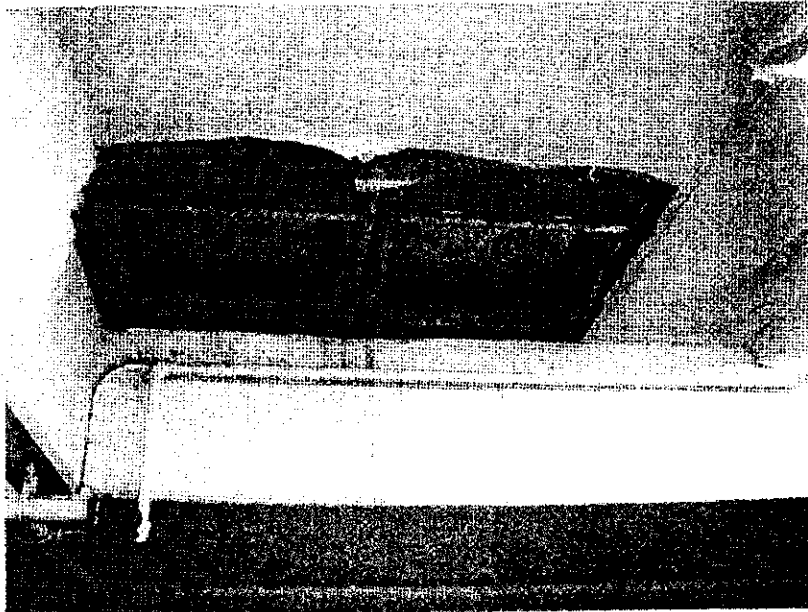
| Item/<br>Photo | Deficiency Description | Category | Corrective Action |
|---|---|---|---|
| 28a,<br>28b | Water pooling at base of vent shaft. Significant damage and constant leakage at PO level below. | D/I | It appears as though the vent may not be active. Verify if vent is active, and if not, cover and protect at grade level. |

Photo 28a : Ponding in mechanical shaft - rear entrance.

Photo 28b: Damage in P0 below mechanical vent.

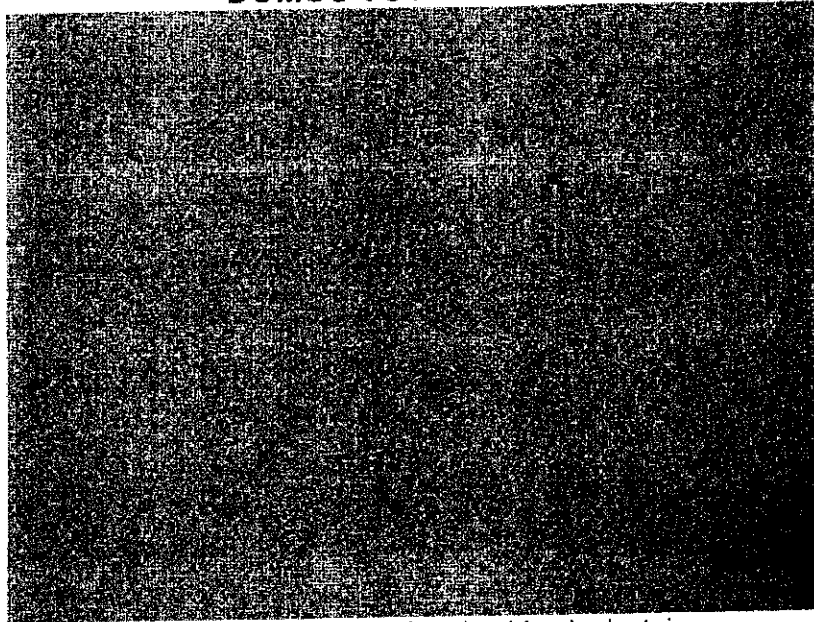
Photo 03 1053: Interior plumbing leak stain.

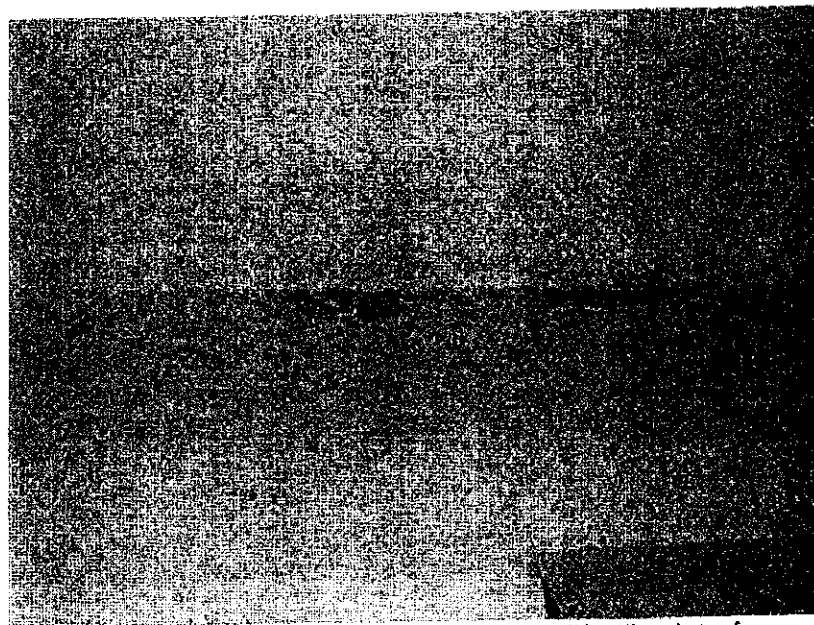
Photo 04 1063: Observed damage at wall/ceiling interface.

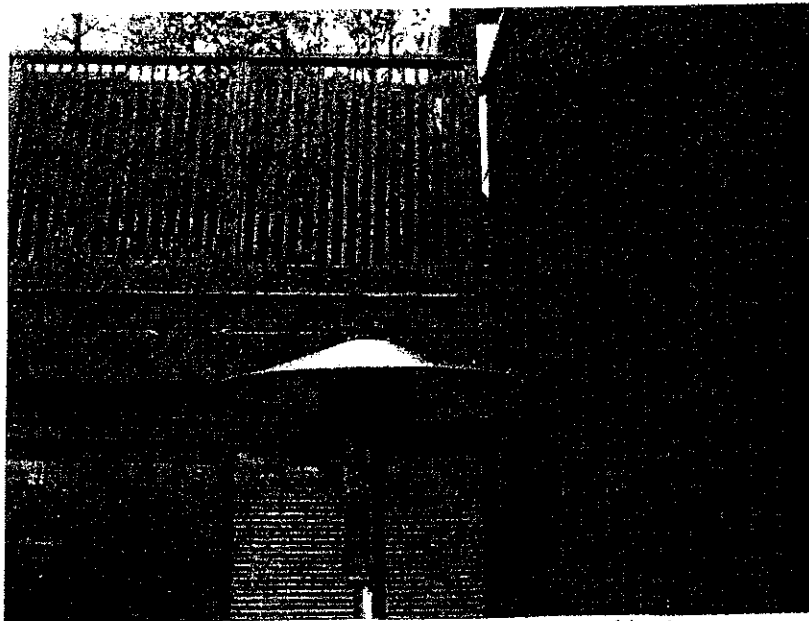
Photo 06 1063: Exterior at location of leak.

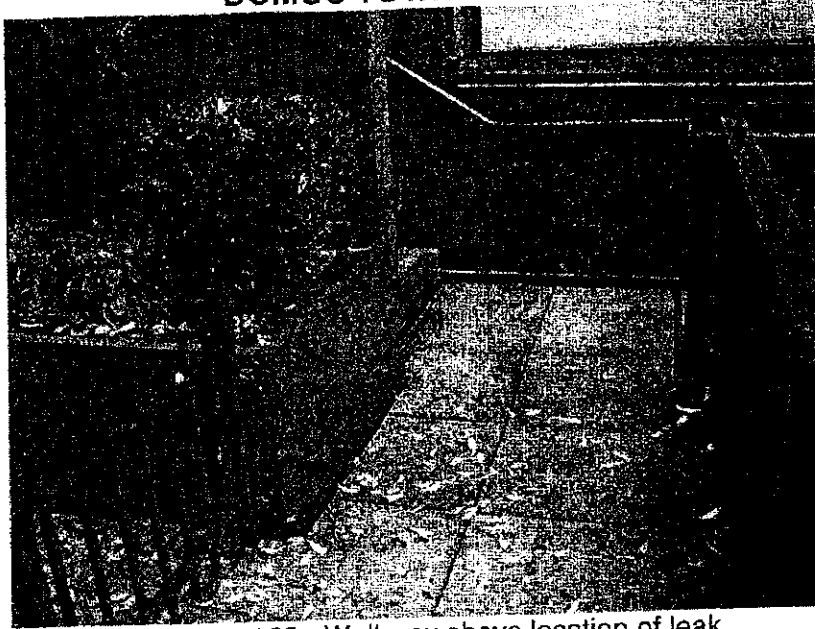
Photo 07 1063: Walkway above location of leak.
