Independent Bulling Consulting & Inspection

To: Mr. Tom Quinton
West Side Estates

Re: Deck Inspection

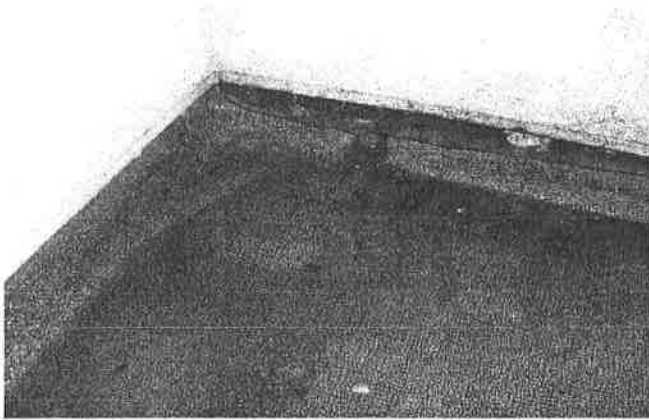
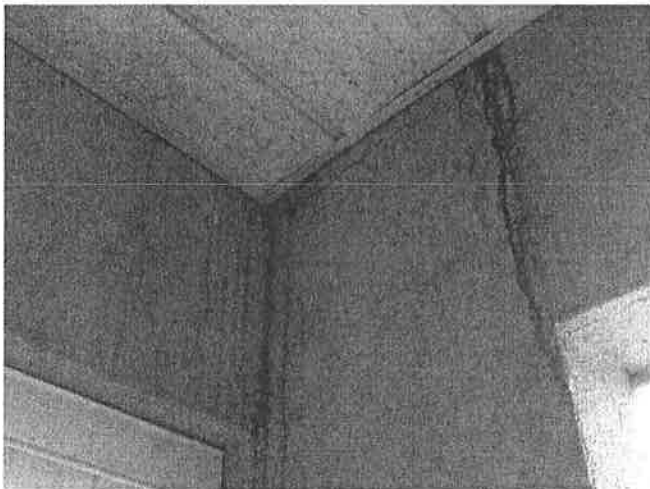
Unit #302:

It appears that the membrane is failing. In our opinion, the membrane should be replaced. There are also signs that leaks from the upper deck are showing through the soffit.

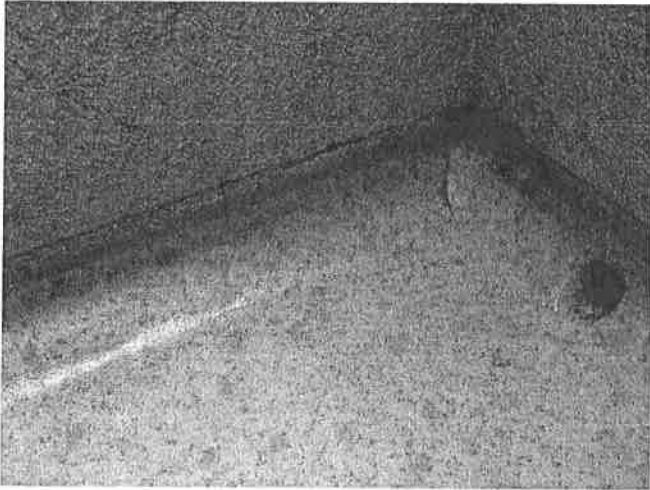
Unit #402:

It appears that the membrane is failing. Cracks were noted at the corners. The membrane should be replaced.

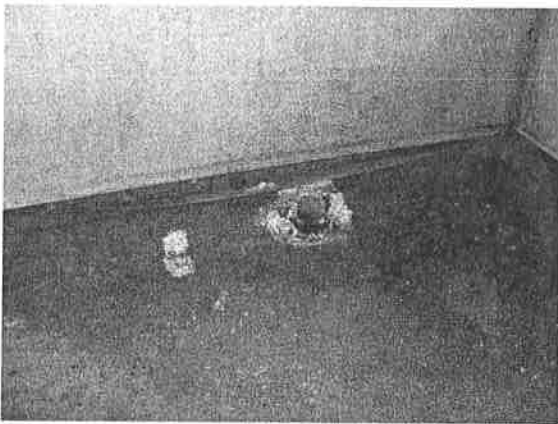
Unit #304:

The membrane is peeling back at the perimeter and mold is noted. The membrane should be replaced.

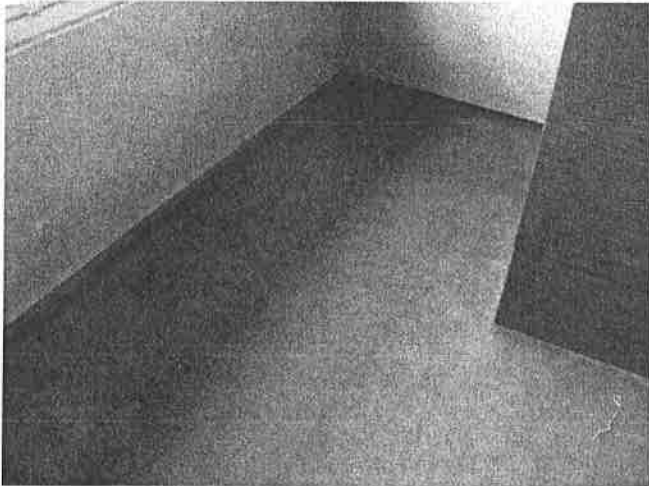
Unit #309:

The membrane is peeling back around the perimeter. Signs of standing water are noticeable.

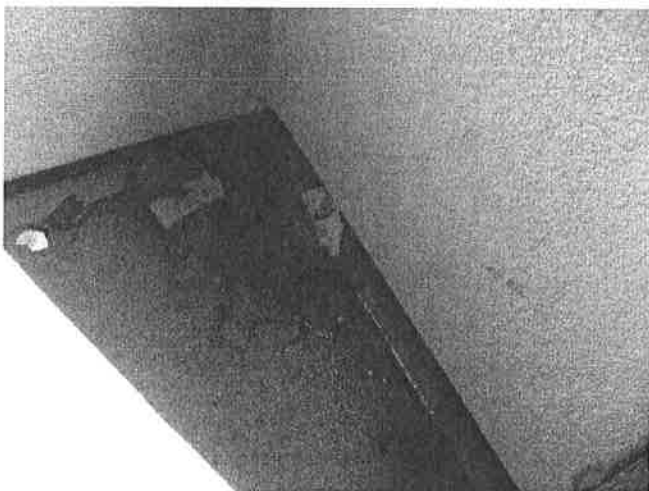
Unit #313:

We noticed standing water near the drain. It appears that there have been previous leaks around the drain. In our opinion, the membrane should be replaced.

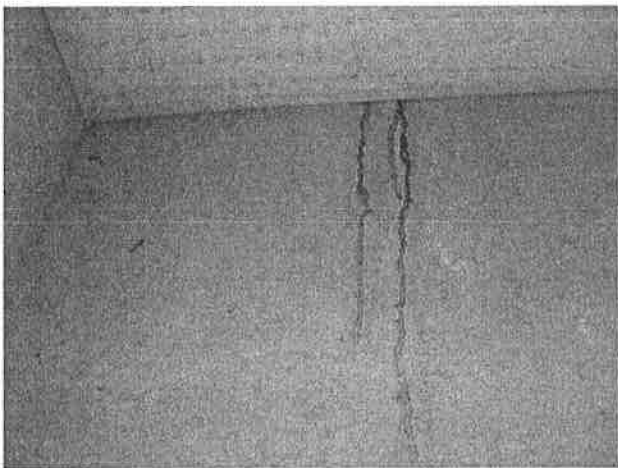
Unit #314:

We noticed that there is a leak from the deck above and wood rot can be expected. The deck membrane of this unit has failed and wood rot is noticeable under the membrane.

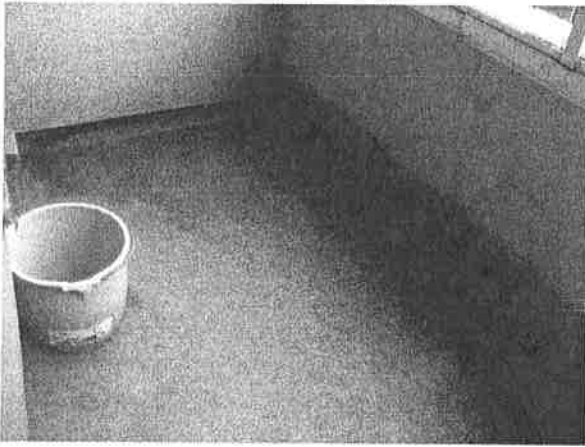
Unit #'s 213 & 216:

We noticed signs of standing water on these decks. However, we did not notice a direct failure in the membrane at this time. But replacement should still be considered.

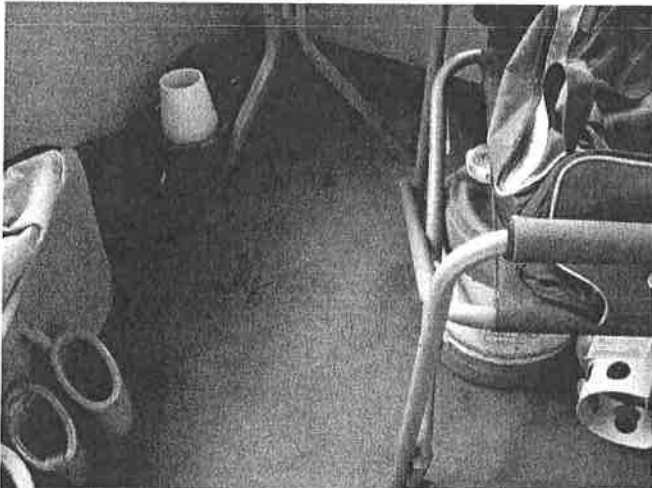
Unit #404:

It appears that the membrane on the deck is peeling around the perimeter. In our opinion, the membrane should be replaced.

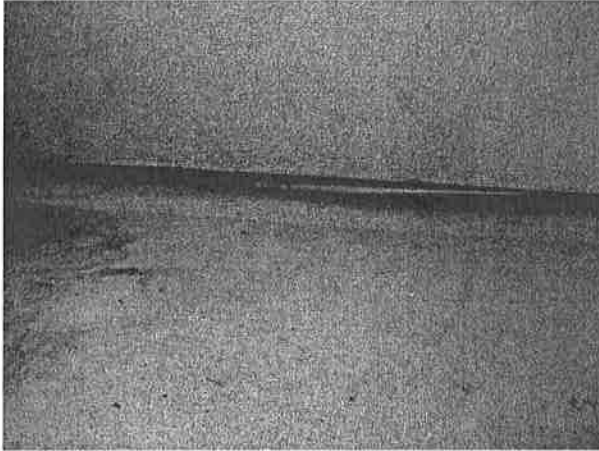
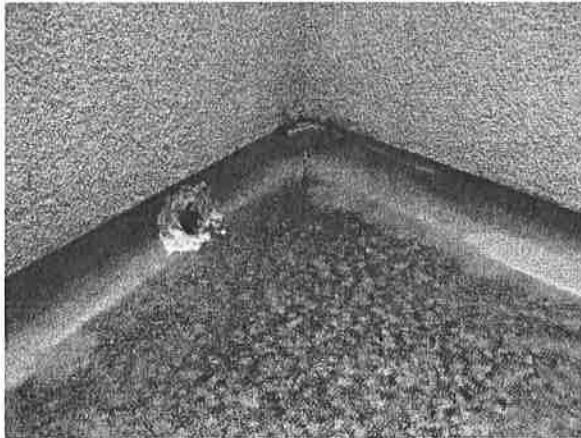
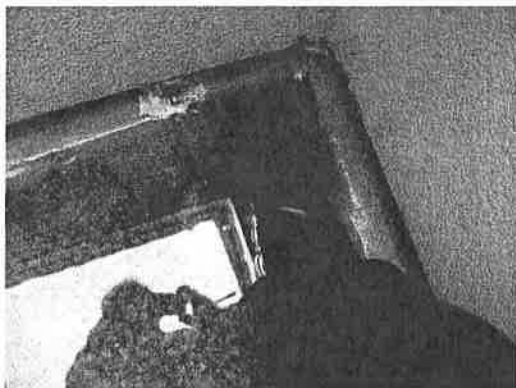
Unit #407:

The membrane is peeling around the perimeter. Some wood rot can be expected. The membrane should be replaced.

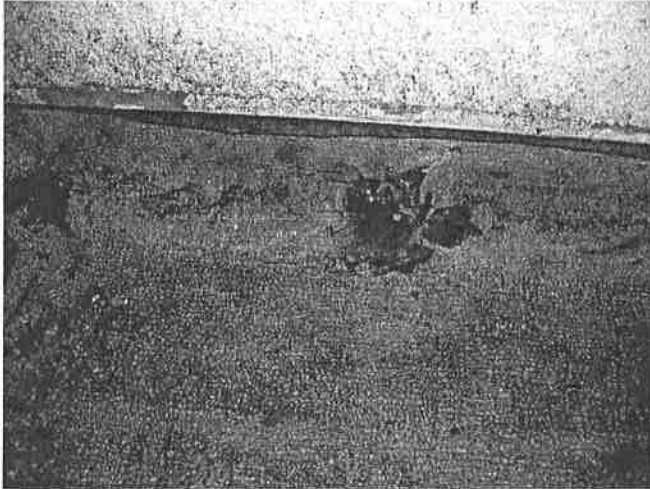
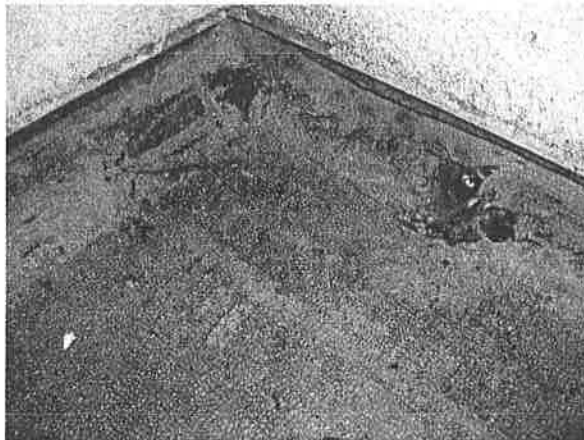
Unit #406:

We noticed peeling of the membrane around the perimeter and damage around the drain. The membrane should be replaced.

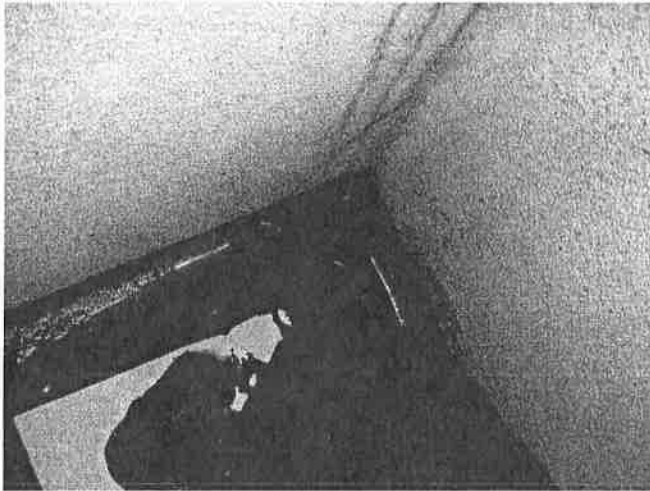
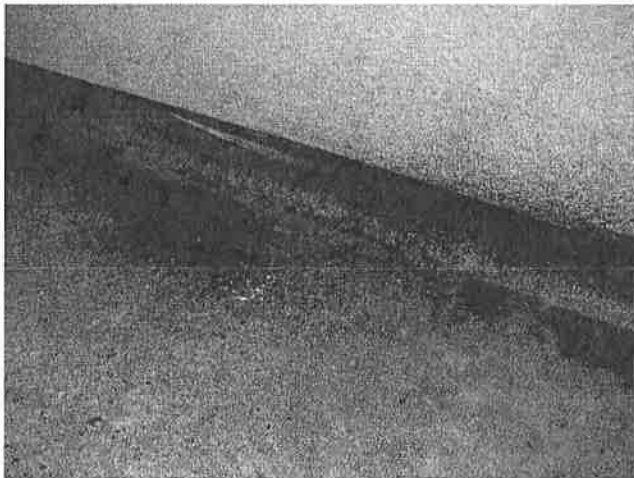
Unit #403:

The membrane is peeling around the perimeter and wood deterioration has been noticed under the membrane. The membrane needs replacing.

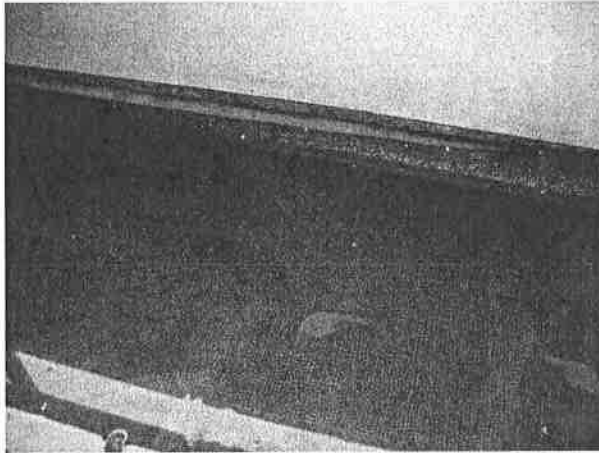
Unit #301:

The membrane is peeling around the perimeter. Wood deterioration can be expected under the membrane. The membrane should be replaced.
