REPORT

**Building Envelope Condition  
Assessment – The Sonesta**

1989 Dunbar Street  
Vancouver, British Columbia

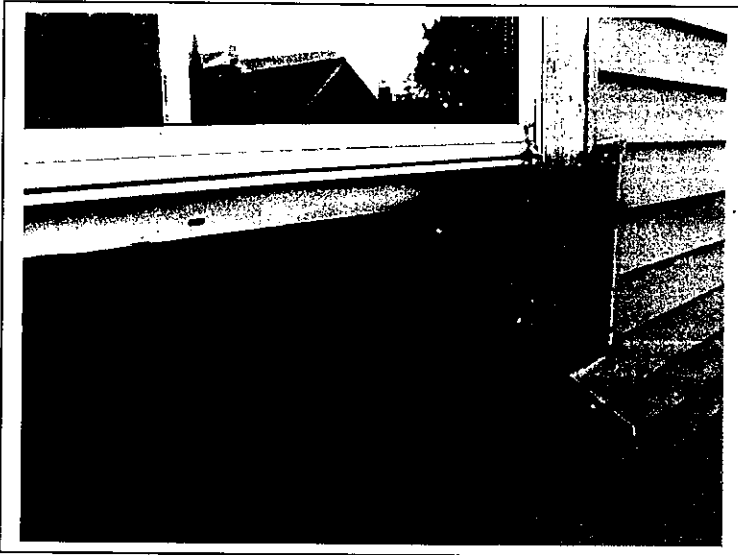
| Reason location selected | To confirm typical detailing and lapping of sheathing paper at windows |

Notice the reverse lap of the sheathing paper at the window sill. This appears to be a typical condition at all windows, however there is no resultant damage observed. Batt insulation was installed between the window frame and the rough opening at the sill. We assume that this is installed to provide resistance to air leakage.

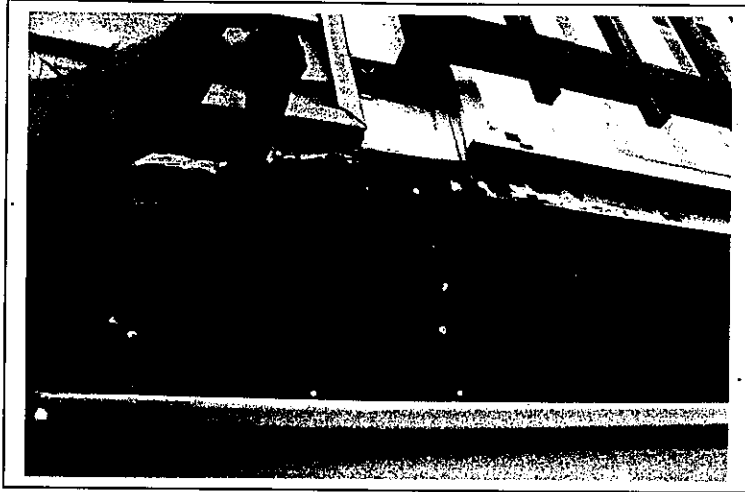
| Reason location selected | To assess as-built conditions |

Self-adhesive membrane was used at the door sill as shown (typical) lapping over a starter strip of wall sheathing paper. The field of sheathing paper below laps over top of the s.a. membrane and the starter strip, creating a back-lap. There was no evidence of damage or significant moisture penetration onto the sheathing membrane. It was noted that the release paper was left on the back side of the s.a. membrane

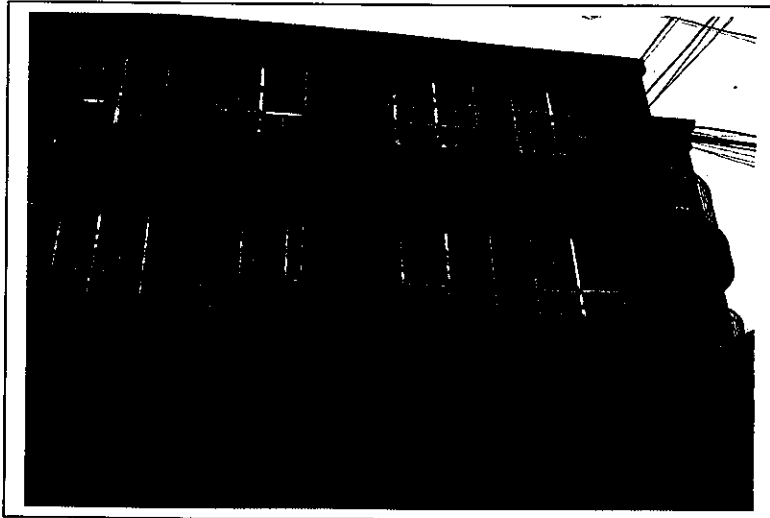
| Building Element | General view of window penetrations in vinyl siding |

**Description:** Note that wood trim surrounds the windows set in vinyl siding. There is no overhang above.

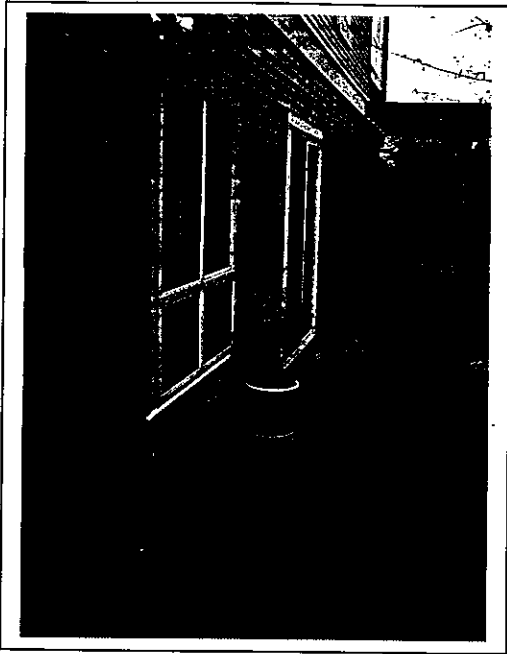
| Building Element | Window and patio door set in vinyl siding |

**Description:** The wall cladding extends down to grade level. Concrete slopes to patio drains. Test opening #\_ revealed this wall to be solid concrete, as the wood frame appears to terminate above.

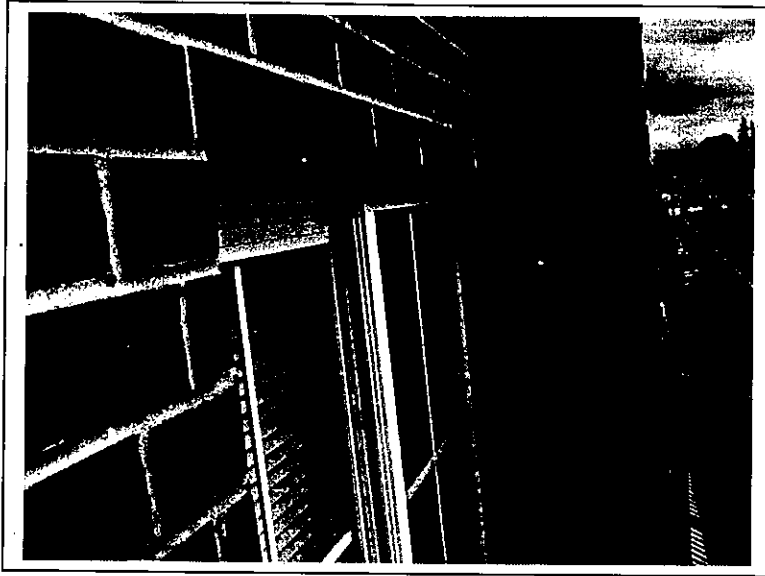
| Building Element | Typical window installed in brick clad opening |

**Description:** A shelf angle is used to support the brick over the opening and weep holes are provided for drainage. A head flashing is installed at the window head under the shelf angle.

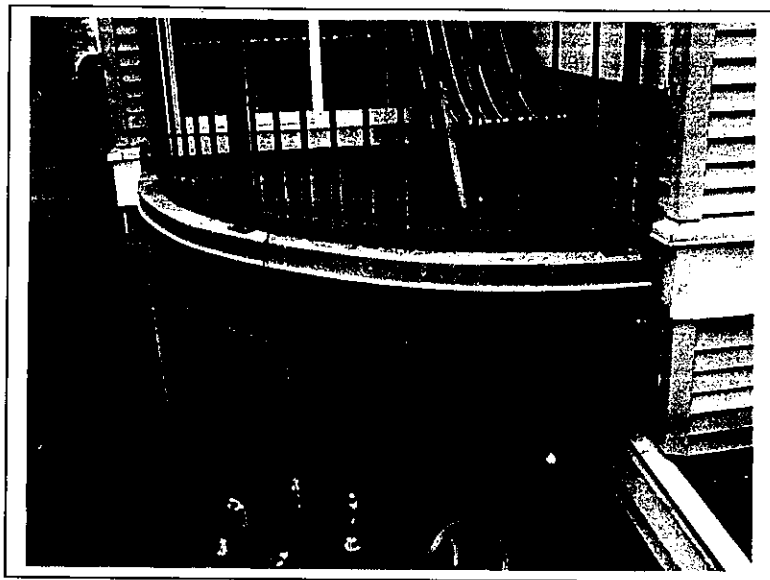
| <b>Building Element</b> | Curved balcony configuration |

**Description:** Typical curved balcony. Note railing attachment and vinyl membrane lapping over balcony edge.

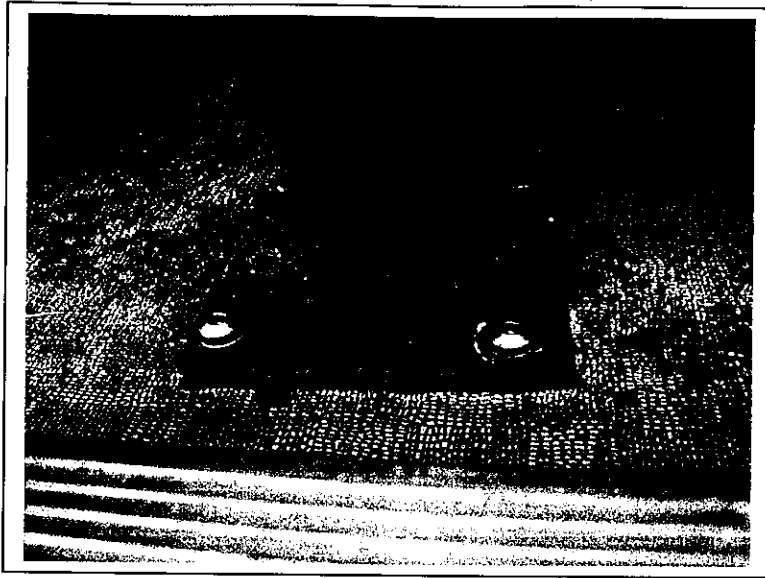
| Building Element | Typical railing post connection through vinyl membrane |

**Description:** Algae growth was observed on this balcony, which is common on the north elevation of buildings. An accumulation was noted near the outside edge of the deck, due to poor slope. The railing post shown was installed through a neoprene pad to seal the screw penetrations.

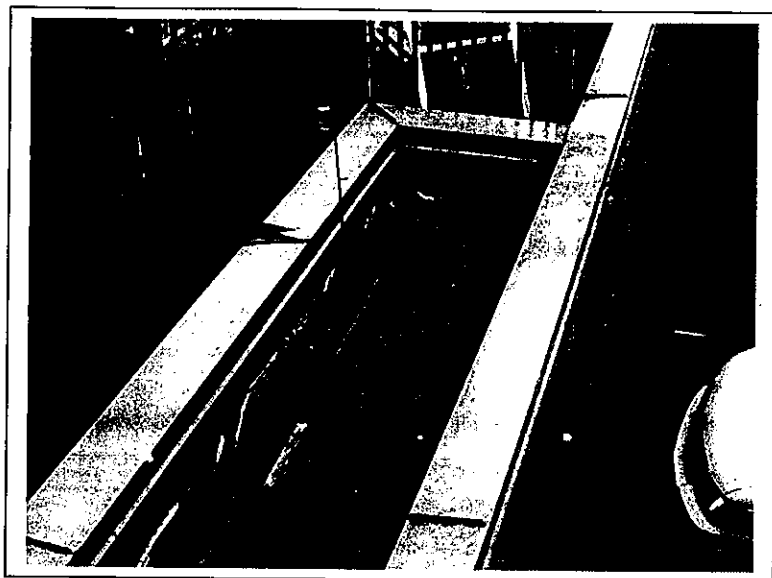
**Description:** View of the courtyard planter. Notice that the planter waterproof membrane is exposed. This type of membrane will deteriorate when exposed to UV light.

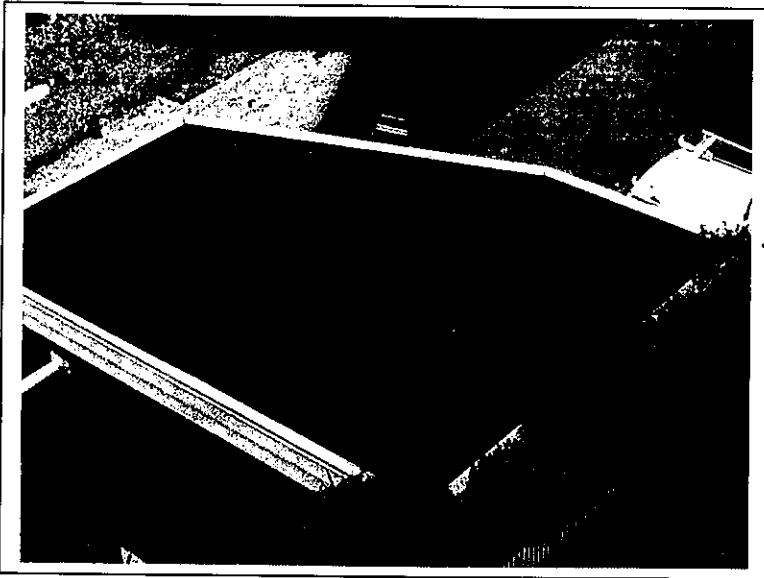
| <b>Building Element</b> | Flat roof |

**Description:** Ponding was observed on the flat roof area due to blockage of a drain. Regular maintenance is required to ensure clear drainage.

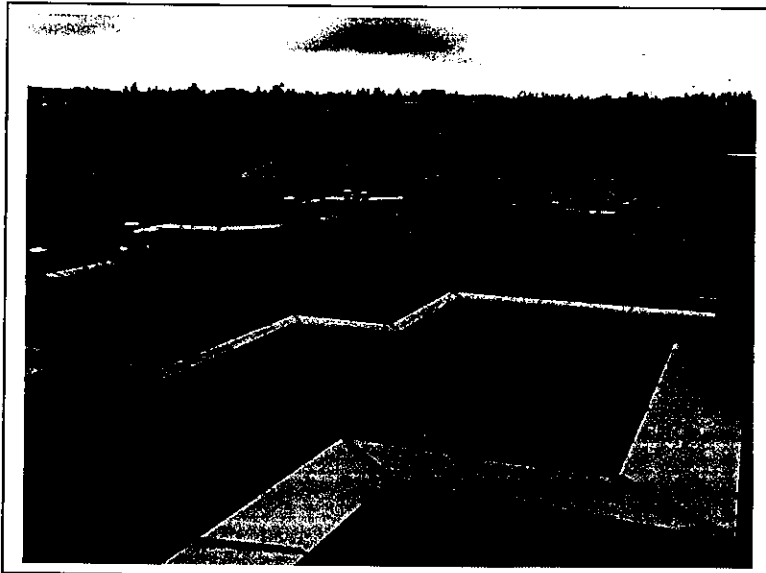
**Description:** Good slope was noted on the flat roof areas, drainage appeared to be generally good. Roof hood vents penetrate the parapet cap flashing at some locations (left side of photo).
