## PERFORMANCE ASSESSMENT REVIEW

<sup>3</sup>  
Delano Centre  
3024 West 4th Avenue, Vancouver, BC

**Project:** Delano Centre, 3023 West 4th Avenue, Vancouver

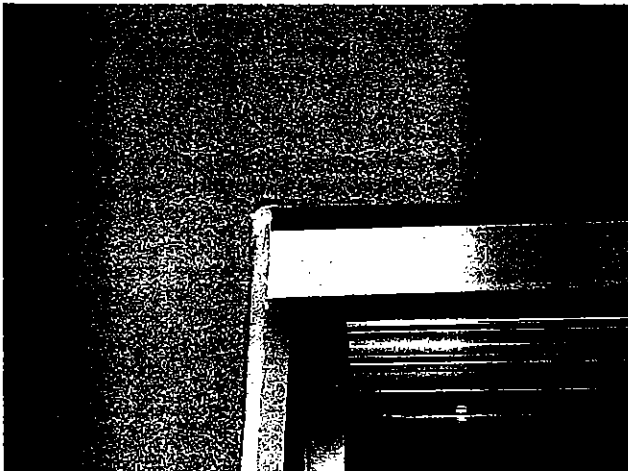
9. Fine radial stucco crack - Suite 406

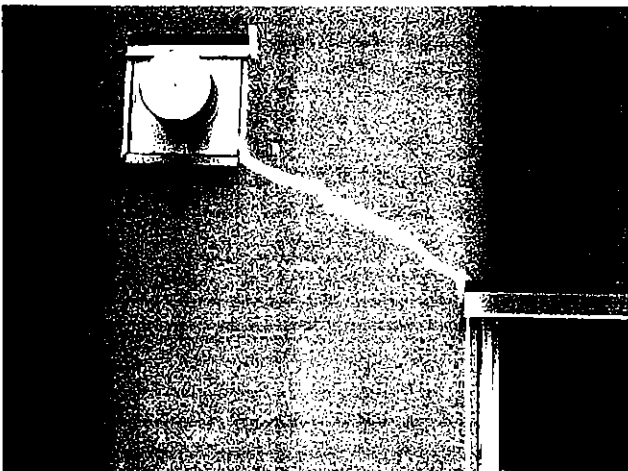
17. Sealant repair to stucco crack

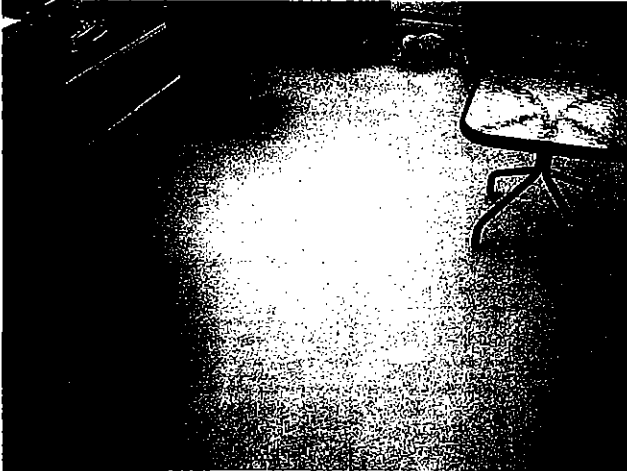
- 2.3 Balcony Membranes and Guardrails** - see photos 6, 8, 16, 25  
Balcony decks inspected showed little signs of ponding - see photo 25. Membranes are sealed at the lower frame of patio doors. Guardrails have been side mounted using stainless fasteners and neoprene gaskets. Silicone sealant at fasteners was observed to be in place.

25. Deck membrane - Suite 401

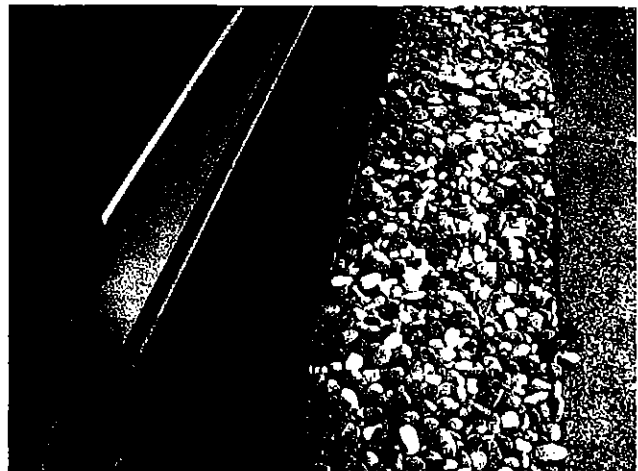
- 2.5 Base-of-wall detail** - See photo 30  
Recessed drainage channels are provided at the base-of-wall and landscaping and paving is held away from the building envelope with wood curbs. The base-of wall appears well protected and free of water ingress.

30. Base-of-wall detail

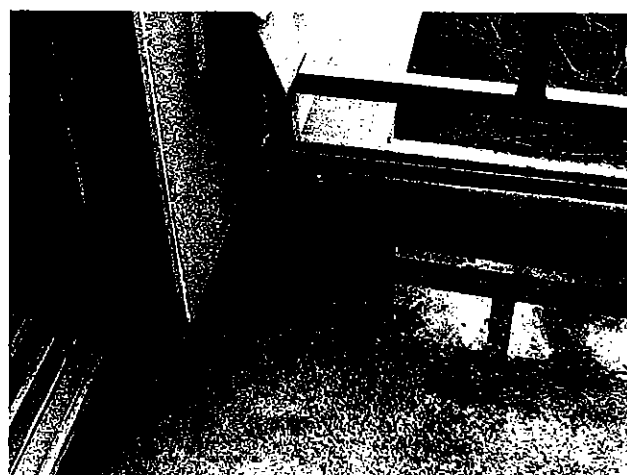
Kim Gibbs reported that approximately one year ago, after severe prolonged rainfall, water leaked in through the ceiling of Apartment 306 from above. I inspected the balcony of Apartment 405 above where ponding occurs at the east end of the balcony deck. The drain is at a higher level at the west end of the deck. It was reported that at the time of the leak the drain was blocked or restricted and that water ponded to the extent that it entered the wall assembly and the ceiling of Apartment 306.

2. Ponding against wall at Apartment 405

This is an isolated incident but highlights the importance of maintaining free-flowing drains at the balconies.

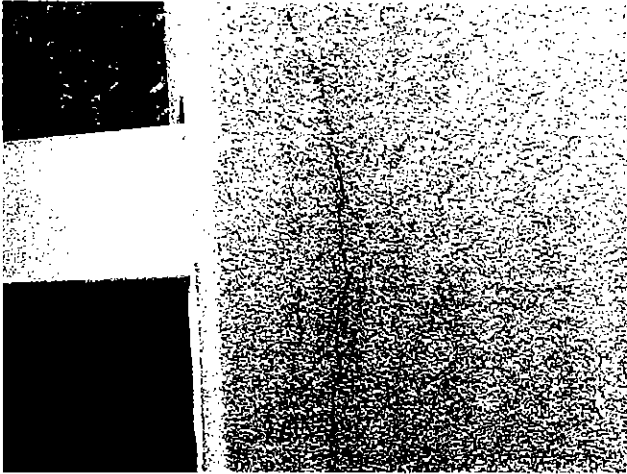
Repairs have been made to previously reported cracks in stucco cladding. Further cracks were observed from the roof on the upper walls on the south side of the building. These hairline cracks are not of immediate concern. The wall assemblies are well protected with the rainscreen cavity.

10. Cracks in stucco

However, in time, rain, organic matter and ice will further degrade the stucco. At some point repairs should be made to these cracks. I observed no cracks on the north or west elevations

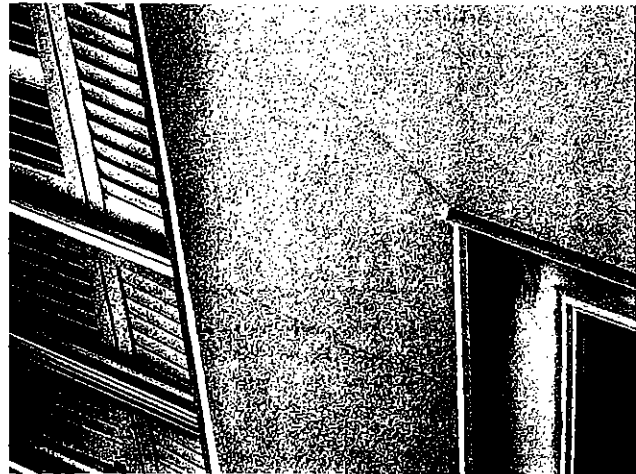
12. Cracks in stucco at balcony door frame

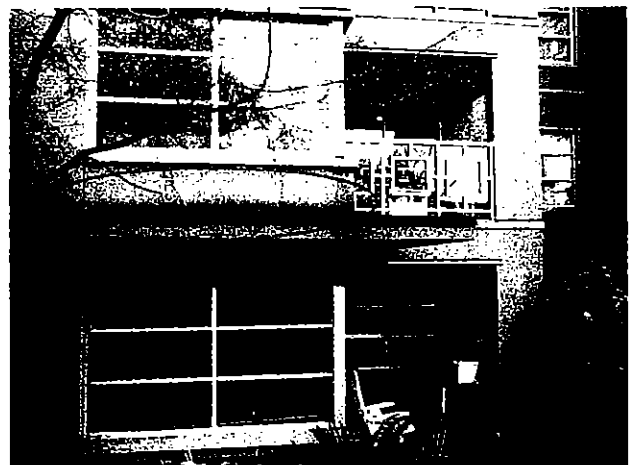
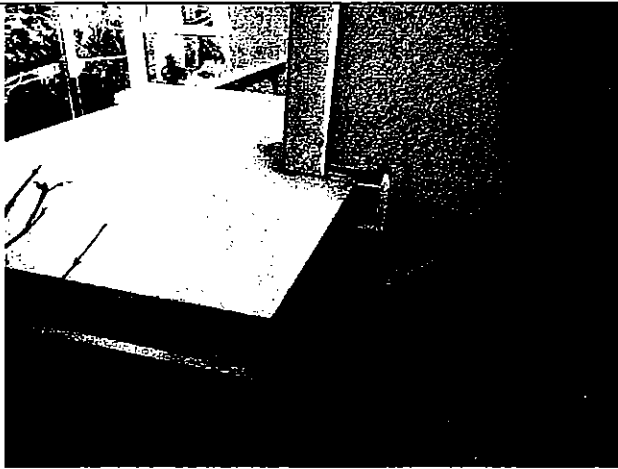
- Cracks were visible in the stucco in various locations on the building (**photos 2, 3, 4 and 5**).
- Some build up of dirt and algae were noted on some areas of the siding and flashings (**photos 6 and 7**). It is recommended that the siding and flashings be washed annually.

- Some flashings require washing to minimise staining on the stucco (**photo 7**).
- See roofs (section 9) for roof flashings.

- a. Review all wall areas and repair cracks in stucco to prevent the possibility of water ingress. (We note this was listed on the Third Annual MOP report as a Contractor Deficiency item.)
- b. Have the building carefully washed annually. Follow the guidelines in the manual for regular maintenance

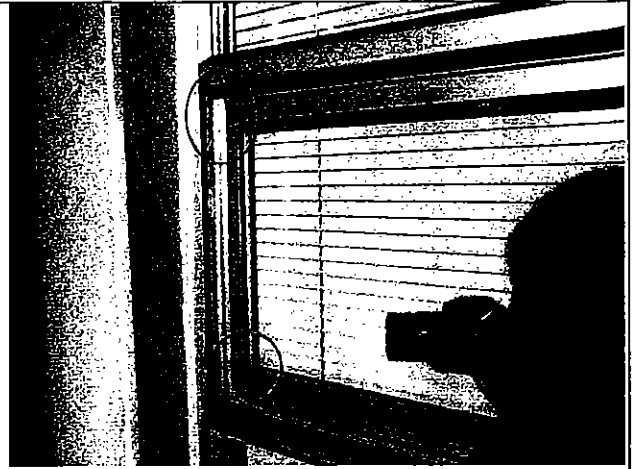
8.

- Windows appeared to be functional, but showed evidence of wear and tear, consistent with their age and the fact that they had been removed and replaced during the remediation (**photo 8**). Open mitre joints were noted on the opening windows (which will allow moisture into the frame and reduce the effective service life of the double glazed units). Distortion on window beads was also noted.
- The glass in a window on the west side of the main entry was cracked (**photo 9**).
- Condensation between panes of skylights indicating seal failure (**photo 10**, more an aesthetic issue than a risk of water ingress).

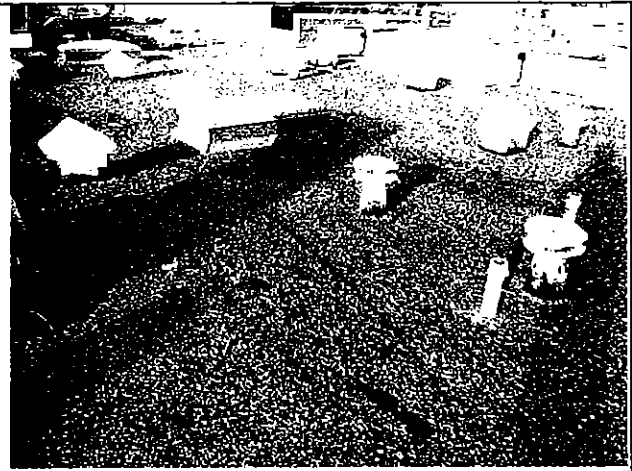
14.

- Small areas of tar were exposed and should be covered by gravel to protect them from damage by UV light (**photo 14**).
- Heavy moss growth in various, more sheltered areas (**photo 15**).
- A tarpaulin had been fixed over a parapet and some ductwork (**photo 16**).
- Some flashings had not been replaced at the time the walls were refinished (**photo 17**) - some rusting and physical damage was visible.
- Pooling water was noted on the surface of the lower skirt roofs (**photo 21**).
- From a distance, it was noted that the surface of a lower skirt roof on the north side (**photo 18**) was deteriorating.
- The edge of one of the lower skirt roofs on the south side was delaminating (**photo 19**).

| a. Add/ redistribute gravel to cover and protect the 'tar' waterproofing from UV light damage. |
