**BPG Inspection, LLC**

Client(s): Sorge  
Inspection Date: 9/30/2026  
Inspector: Mark Kirkland ,

## SECTION I. KEY FINDINGS

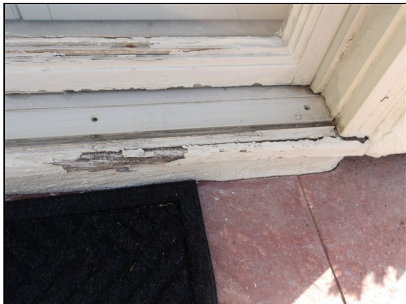
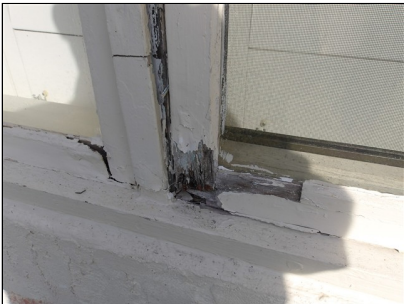
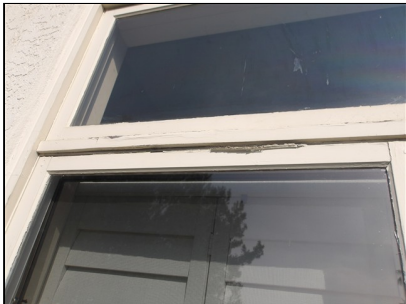
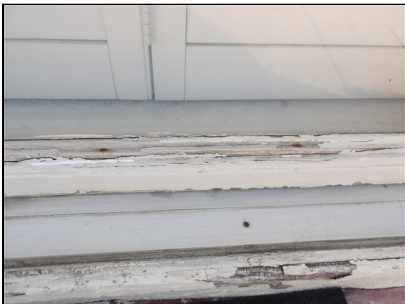
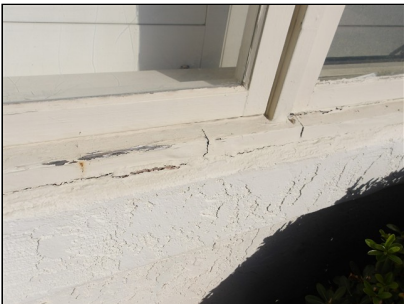
2. Some of the exterior trim is damaged in several areas. Especially around the doors and windows.
- A qualified technician should examine all exterior trim for damage or deterioration and repair or replace material as necessary. Refer to the termite inspection report for repairs of all wood.

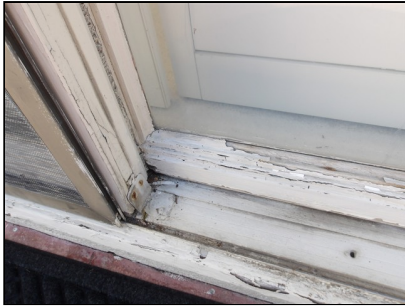
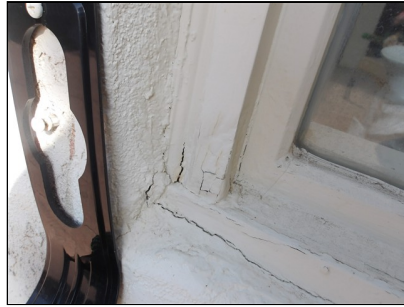
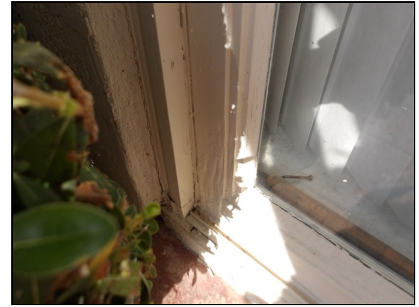
3. Both of the rear sliding glass doors have signs of wood damage. All damaged wood should be evaluated by a termite inspector. A qualified technician should make any needed repairs or modifications.

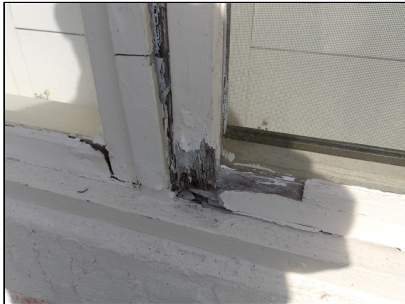
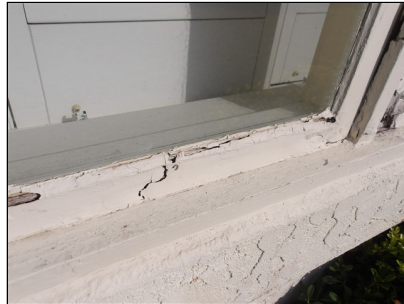
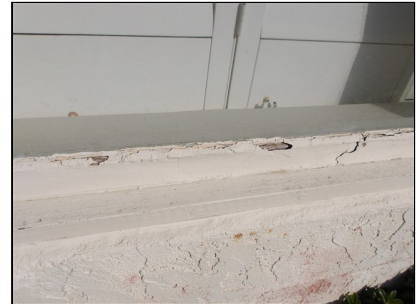
- ❌ 4. Four or more windows at the rear of the home are noticeably damaged. All wood damage should be evaluated by a termite inspector.
- Have a qualified technician check all windows and make repairs as needed.

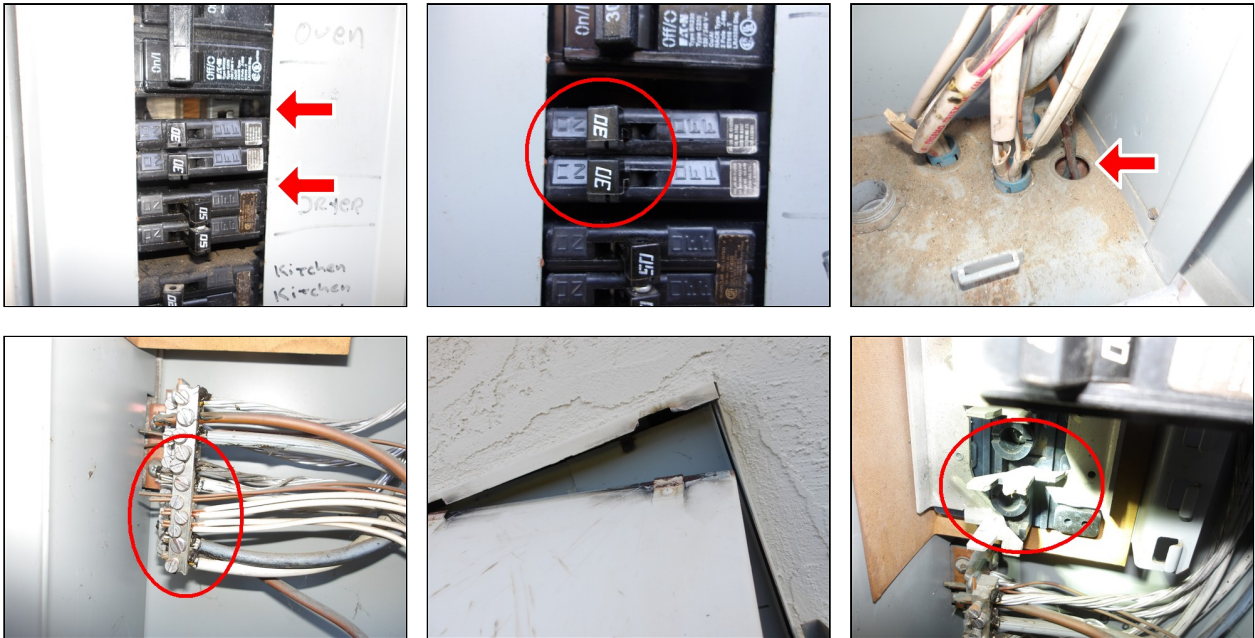
6. The problem(s) discovered in the main distribution panel such as double lugged neutral wiring, gaps in dead cover, missing labels, damaged cover hinges, common neutrals, missing 240 breaker tie at 30 amp breakers, missing wire bushing, chip at breaker clamp on buss, and any other problems that an electrician may discover while performing repairs need correcting. We recommend a licensed electrician inspect further and correct as needed.

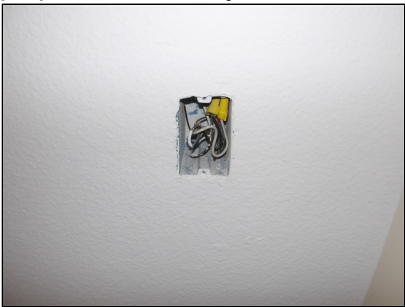
8. There is an open junction box in the master bedroom. Lack of covers on junction boxes is a shock or fire hazard. - A qualified technician should install a proper cover on all junction boxes.

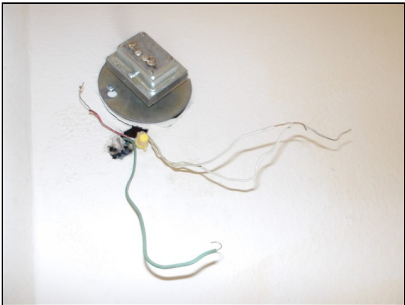
9. Exposed wiring is visible at the hallway closet. We recommend a qualified technician make any repairs needed.

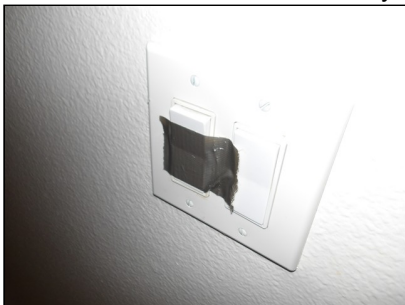
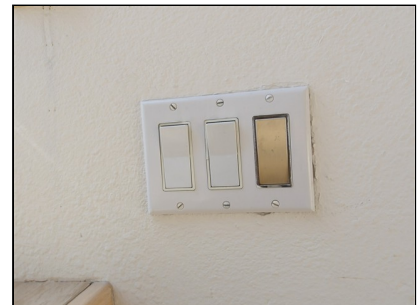
- ❌ 12. Several switches are loose at multiple locations in the home. One was even taped down so it wouldn't come on. A qualified electrician should make any needed repairs.

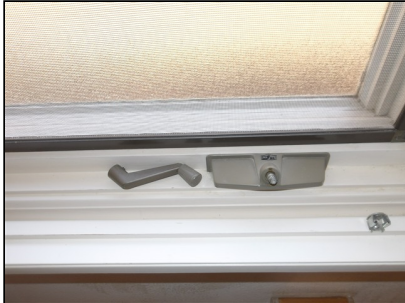
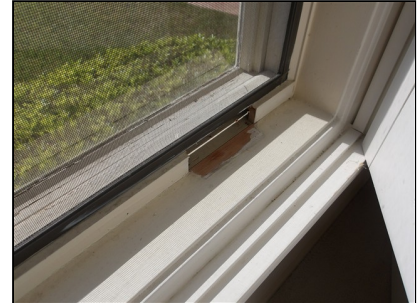
- ✘ 15. Several windows do not operate smoothly, are difficult to latch or are in need of adjustment. Several windows are missing hardware or stuck and not operational. All poorly or non-operating windows and their associated hardware should be cleaned, lubricated, and adjusted for smoother operation. Where needed, essential hardware, such as operator cranks, sash balances and latches should be replaced with compatible components.

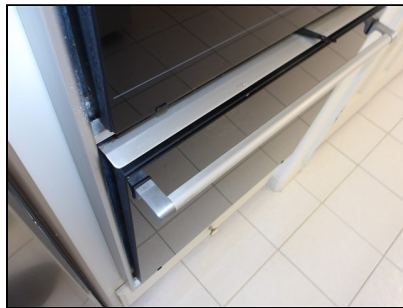
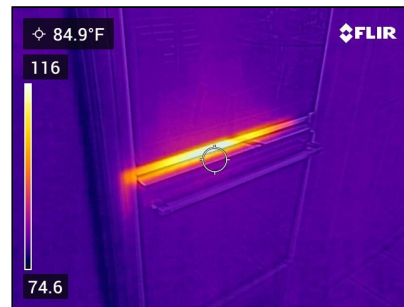
- ❌ 19. The lower oven door does not fully close. There is a gap when the oven door is closed. A qualified technician should repair as needed.

heat leaks

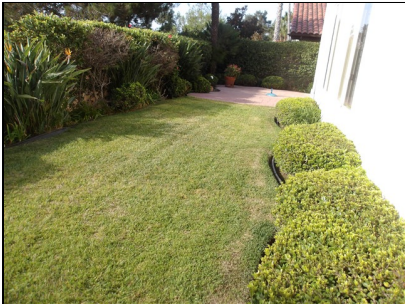
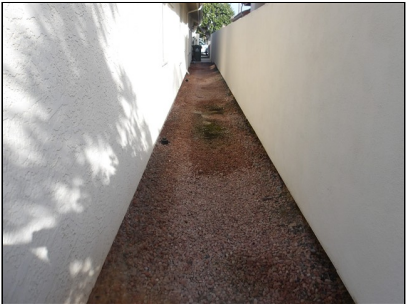
27. The yard grading on the left side and rear of the home has a very low slope grade or drains toward the home. Water may tend to pool along this side of the house. A below grade drainage system, regrading the area, or installing swales may help to drain this area quickly. Monitor the area during heavy rains.
- Have a qualified contractor or landscaper evaluate the area and perform repairs as needed.

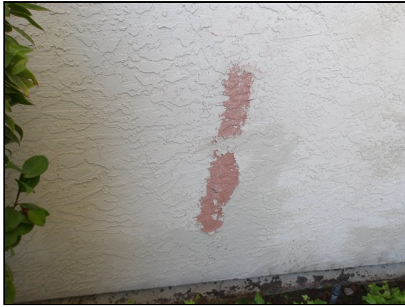
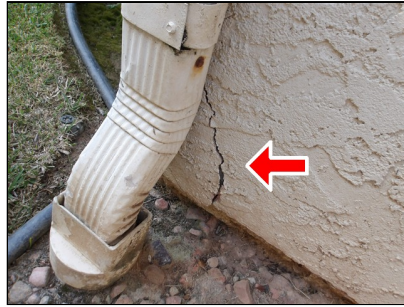
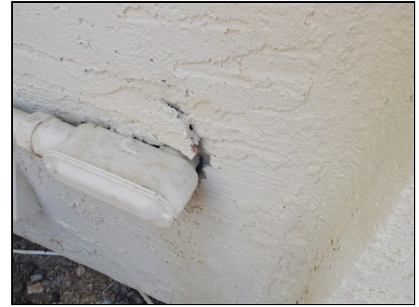
28. Sections of the stucco at the exterior of the building is cracked, deteriorated or damaged. We did not list or identify every location in this report.
- A qualified plastering technician should evaluate the stucco and make repairs or modifications as necessary.

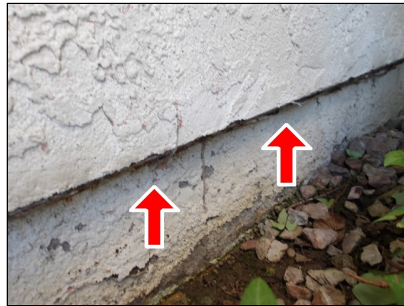
29. The weep screed at the base of the stucco-finished exterior walls is corroded in spots and/or damaged.  
- A qualified technician should replace any damaged weep screed, as needed.

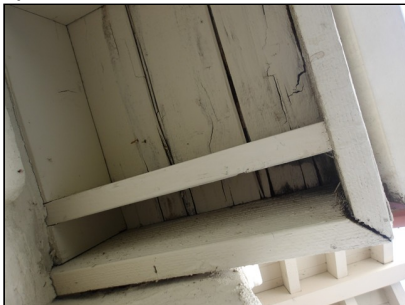
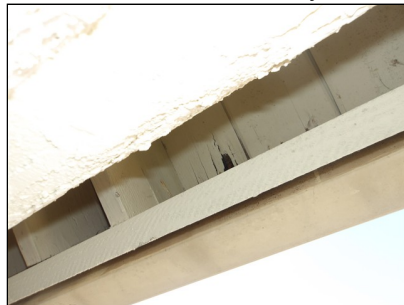
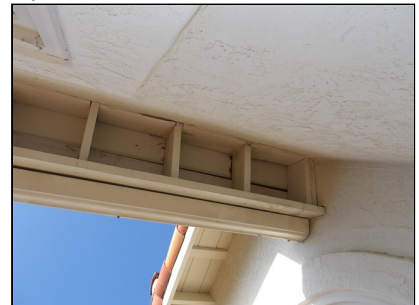
31. There are stains and/or damage indicating roof leakage at the eaves at several areas.  
- A qualified roofer should further evaluate the area and make any needed repairs or modifications.

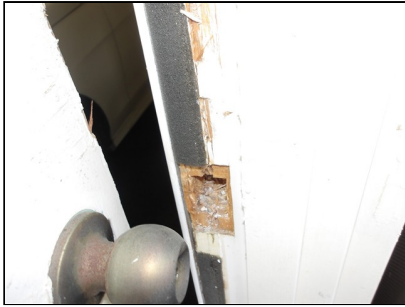
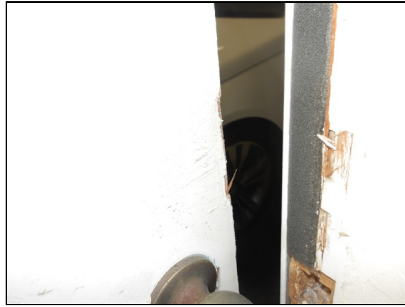
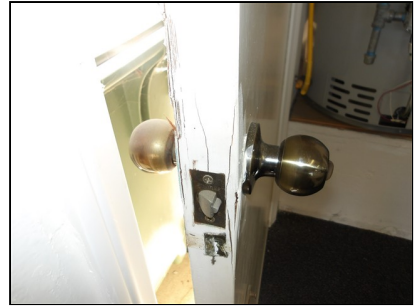
32. The door weatherstripping is installed improperly or missing at several locations. Improperly installed weatherstripping can allow, or even encourage water or air to enter the home.  
- All missing or improper weatherstripping should be modified to reduce the potential for water penetration. It is also possible that the door may also need to be adjusted, a qualified technician should perform repairs as needed.
33. The door at the side entry garage is damaged, rubs the ground, is hard to open and requires repairs. A qualified technician should make any needed repairs or modifications.

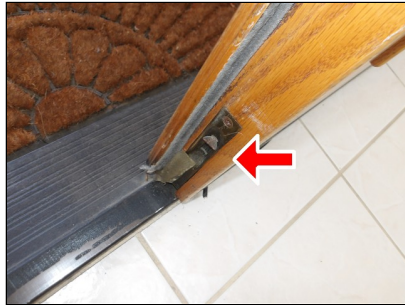
- 34. The sliding door screen at three or more areas is damaged and/or deteriorated. A qualified technician should make any repairs or modifications as needed.
- 35. The bottom door latch for the door at the front entry is damaged and not able to operate. A qualified technician should make any needed repairs or modifications.

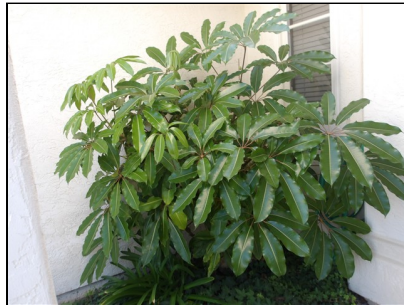
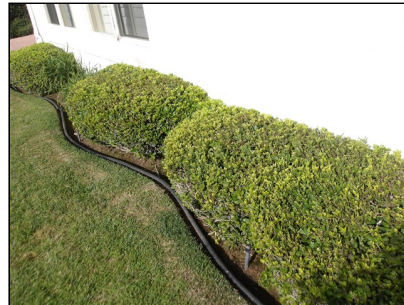
- 37. Vegetation on the property should be maintained to prevent overgrowth and encroachment onto and possible damage to the structure.

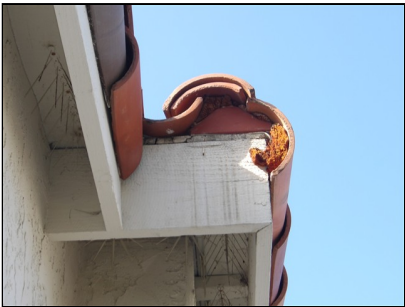
- 43. We observed none standard repairs to the front roof near the fascia board. It looks like foam was installed. A qualified technician should perform appropriate repairs.

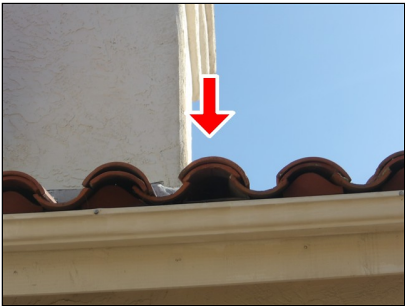
44. The tile roofing is missing the bird stops at the eaves in several areas. This can allow rodents and other pests access to the under roof tile areas. A qualified roofing contractor should make any needed repairs.

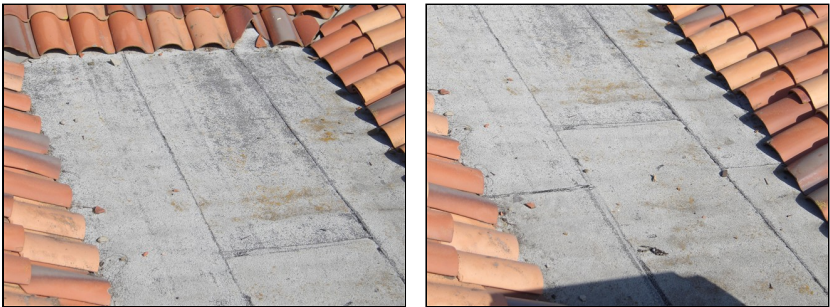
45. Portions of the roll roofing surface granulation have washed away and minor surface cracks have developed at the middle flat section of roof. Loss of granules is a primary indicator of advancing age. The roof should be evaluated prior to the close of escrow.

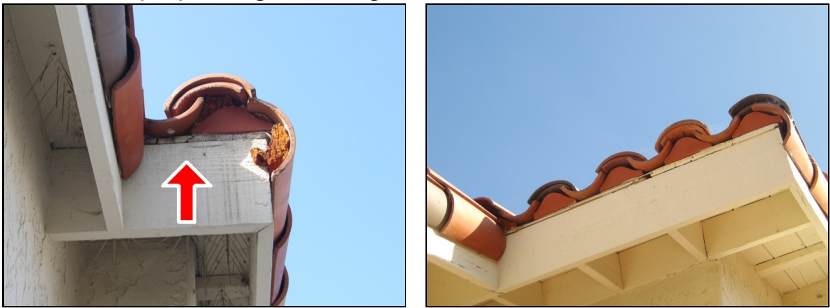
46. The roof has no edge flashing. Water can curl back under the shingles and potentially damage the wood at the eaves.  
- A qualified roofer should install proper edge flashings.

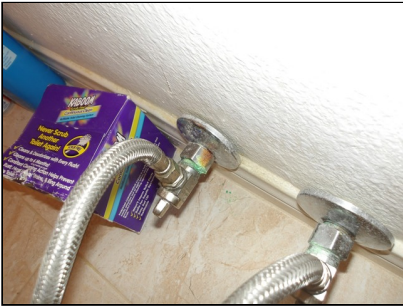
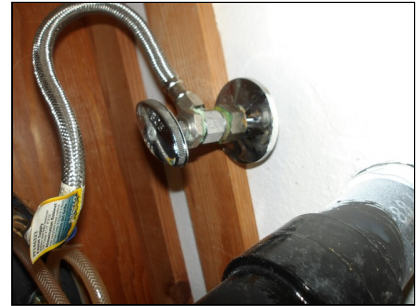
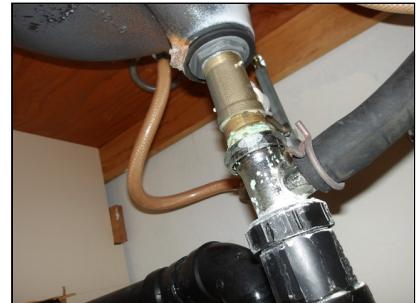
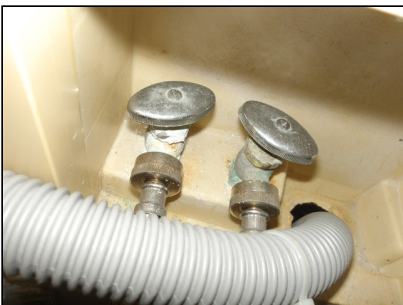
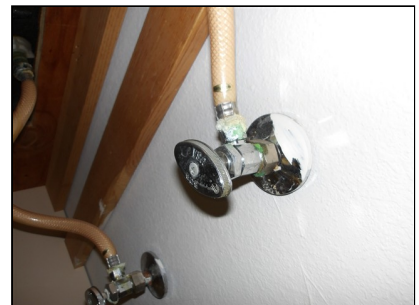
53. There is surface corrosion in the visible supply and/or waste piping at several valves, fixture and drains in the home. We observed no signs of active leaks at the time of the inspection but leaks can develop anytime without warning. All valves and fixtures should be evaluated during your final walk through and before close of escrow to verify that no new leaks have developed.
- This piping should be evaluated for leaks on a regular basis and repaired by a qualified technician when necessary.

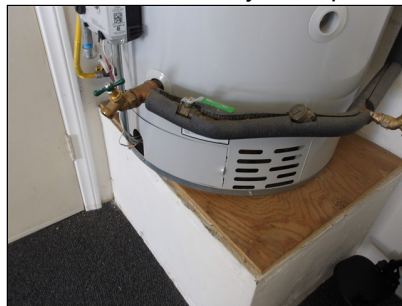
56. There is no exterior routed catch pan and drain installed at the water heater. A pan with an exterior routed drain is required by some jurisdictions when the appliance is located inside the foundation foot print of the structure or if the water heater leaks, the water will flood the floor or surrounding structure and cause water damage to the home. Consider installing a properly routed drain pan and pipe as a recommended preventive upgrade (this often requires the water heater to be drained, removed, reinstalled and may be expensive).

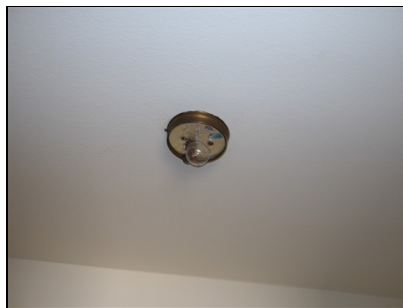
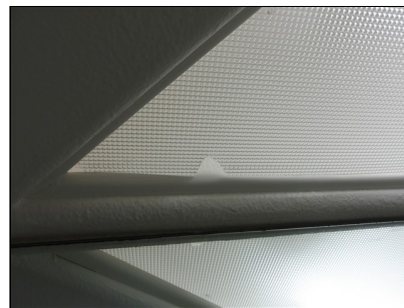
59. Several light fixtures are missing globes or have damaged lens covers. A qualified technician should make any needed repairs.

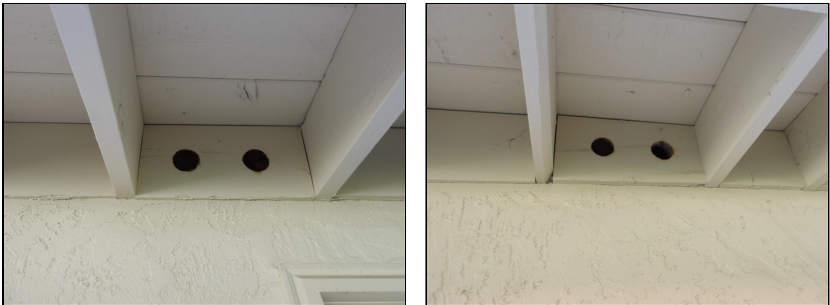
62. Four or more soffit vents are blocked at the right side. A qualified technician should repair or replace as needed.

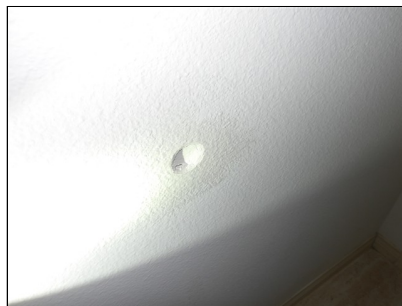
master bed closet

67. There is a small hole in the drywall behind the door handle. A qualified technician could make repairs or modifications as necessary.

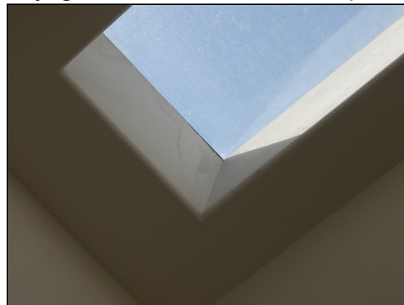
71. There is evidence of previous leaks from the skylight at the entryway. Ask the owner about any history of leaks, and/or monitor for active leakage. If the skylight leaks, it should be repaired or replaced.

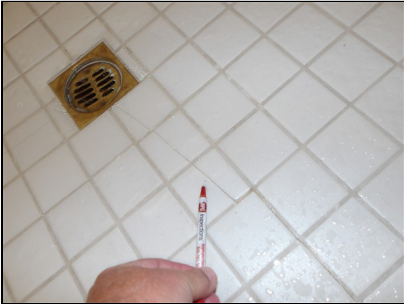
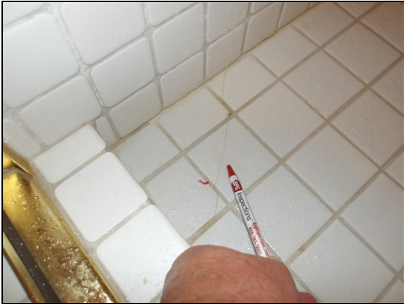
81. The tile floor is cracked in the master bathroom and middle bedroom bathroom. A qualified technician should repair or replace the damaged tiles.

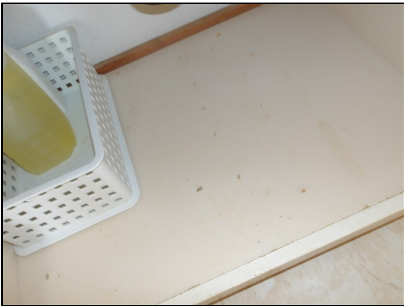
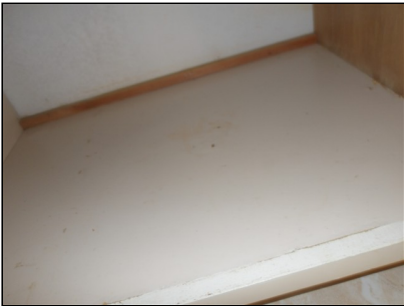
82. The cabinet shelf under the sinks is stained at the bathrooms. The area was dry at the time of the inspection and a technician should repair as needed.
