# **GREENWOOD FEASIBILITY STUDY**

*Preservation of Existing Smelter Heritage Structures*

**June 2017**

**DJ&T Engineering Ltd.**

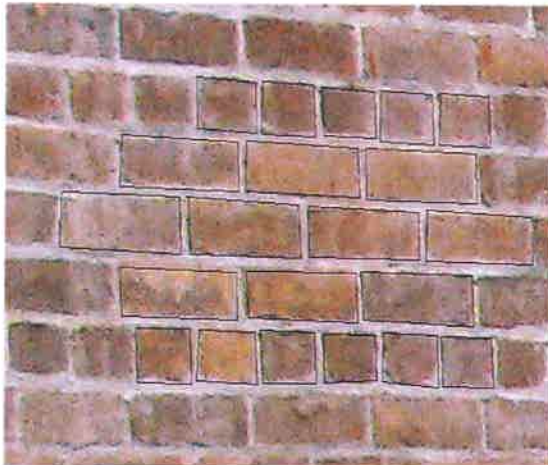
**Figure 1 - The brick pattern on the stack wall and the corner building wall is predominantly a 3-layer running bond with stretcher blocks, bounded by single courses of header bricks.**

Measured wall thicknesses vary from 13" (building walls) to 48" or more (base of masonry stack wall). The exact number of leafs/wythes in the stack wall could not have been determined without using destructive methods. We have made a reasonable assumption that the central part of the stack wall is comprised of multiple staggered wythes, which would provide a good bearing surface capable of carrying the weight of the structure.

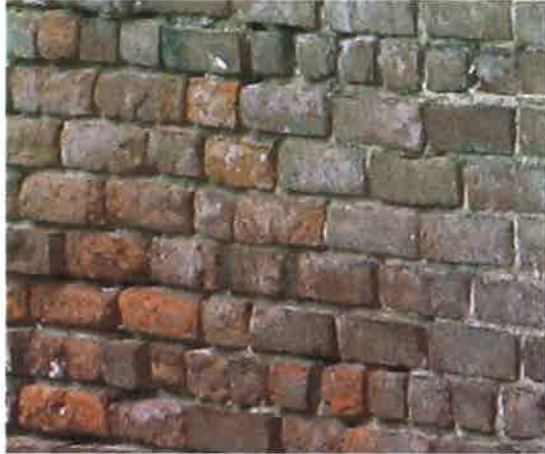
**Figure 2 - The only other pattern found on site was for the portion of the partially collapsed flume structure just south of the stack. It shows a common masonry layout with five running bond courses of stretcher blocks laid between single courses of headers**

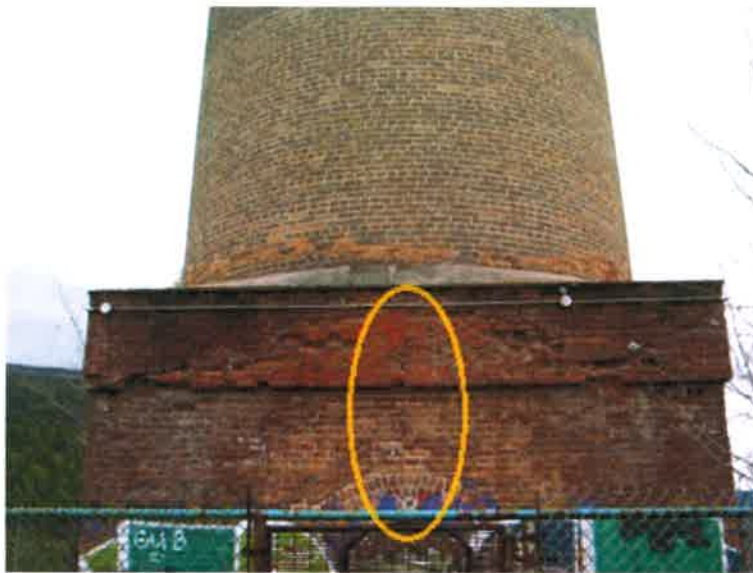
On the north side of the square stack base there is a 48" wide opening with the deep arch top. There exists a long vertical crack in the arch itself, as well as the masonry wall above it, extending to the interface with the pseudo-cylindrical stack wall. Since the masonry arch was designed to carry compressive forces only, the vertical crack indicates that the massive stack base may have experienced a horizontal movement, most likely at the foundation level (Figure 3 and Figure 4).

**Figure 3 - Vertical Crack in Stack Base**

- Drilling and installation of post-tensioned bars/cables to stabilize the cracked portion of the wall on the north side of the structure. Prior to installation of the PT tendons, the foundation should be exposed and investigated to confirm viability of this option. If the investigation shows that foundation experienced differential movement/settlement on this side of the wall, the retrofit scheme should consider mitigation of the foundation deficiencies at the same time;

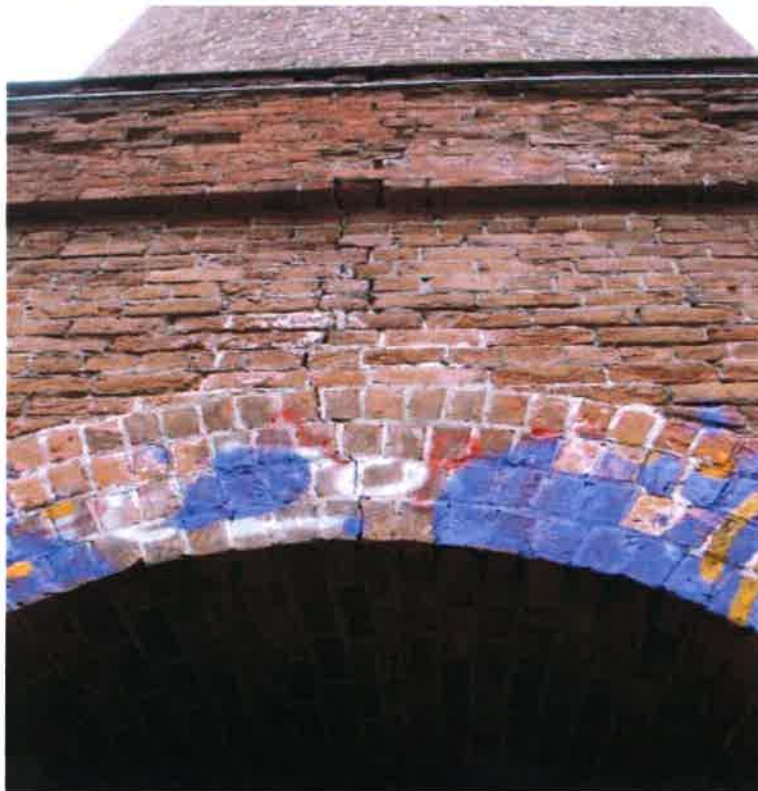
**Figure 4 - Close-up of the Vertical Crack**

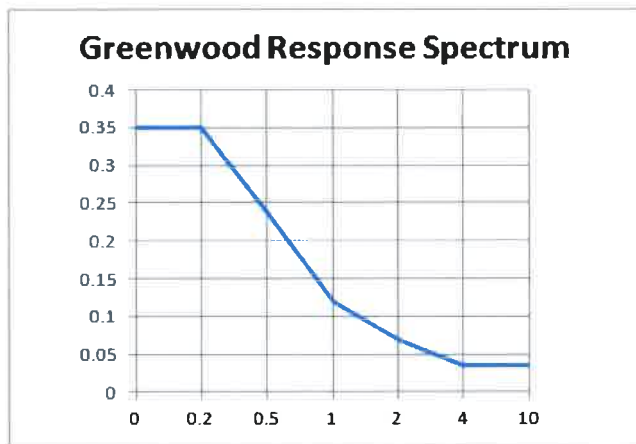
Figure 5 - Response Spectrum for Greenwood

The graph of the response spectrum was created and used in further seismic analysis with the ductility modifiers of  $R_d = R_0 = 1.0$  as specified in the Code for seismic force resisting system comprised of unreinforced masonry structures (Figure 5).

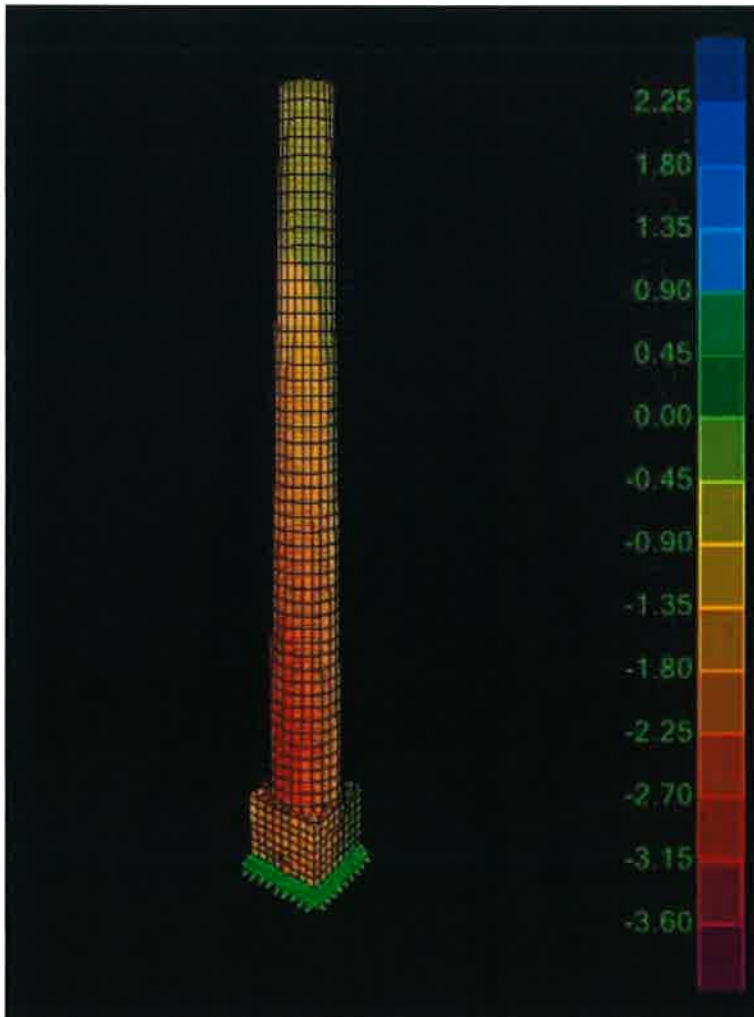
Figure 6 - Stress Results

The results of the FEM analysis were in line with the initial expectations based on visual observations: vertical tensile stresses under full seismic load would exceed the compressive stress due to gravity load, thus prompting the need for structural strengthening. The analysis shows that the stack as built would be capable of carrying only 20% of the seismic base shear as per current Code.

We also recommend consideration of additional retrofits, including adding tensile enhancement of the masonry tube wall by installing vertical reinforcing elements in the lower two thirds of the stack structure. One feasible solution could be the installation of carbon fibre reinforced polymer (CFRP) rods instilled into epoxy resin in vertical grooves premade in the wall.

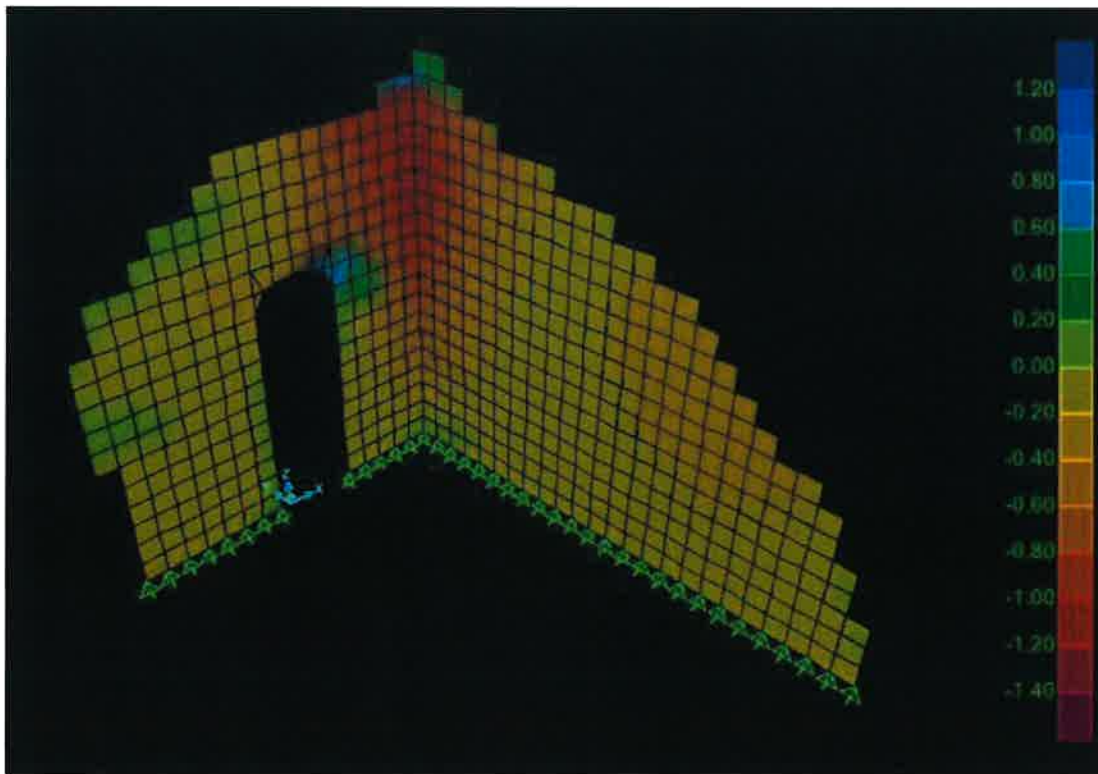
The maximum compressive stress due to horizontal bending of the wall structure under wind load is 1.23 MPa. (Figure 7).

**Figure 7 - Compressive Stress in Corner Wall due to Wind**

This governing demand exceeds the average shear capacity of the existing mortar joints of 0.3 MPa, and thus we recommend that the corner wall be structurally supported to mitigate against potential collapse.

The Corner wall structure shows significant deterioration of the masonry mortar. The average demand/capacity ratio is higher than 3.0 for the structure, indicating an imminent

- The top four courses of both walls should be carefully removed and reinstated using cement based masonry mortar. Since the base fixity of the walls is unknown and presumed nonexistent, the vertical seismic ties/dowels should be installed at every 48 inches center-to-center to enhance wall stability;
- At least one timber support structure should be installed for each wall to provide additional lateral support for the existing wall structure. One possible rehabilitation option is shown on Figure 8. Another possible solution could be structural steel strong back structures (vertical steel posts fixed at the ground level and connected to the walls at prescribed internals).

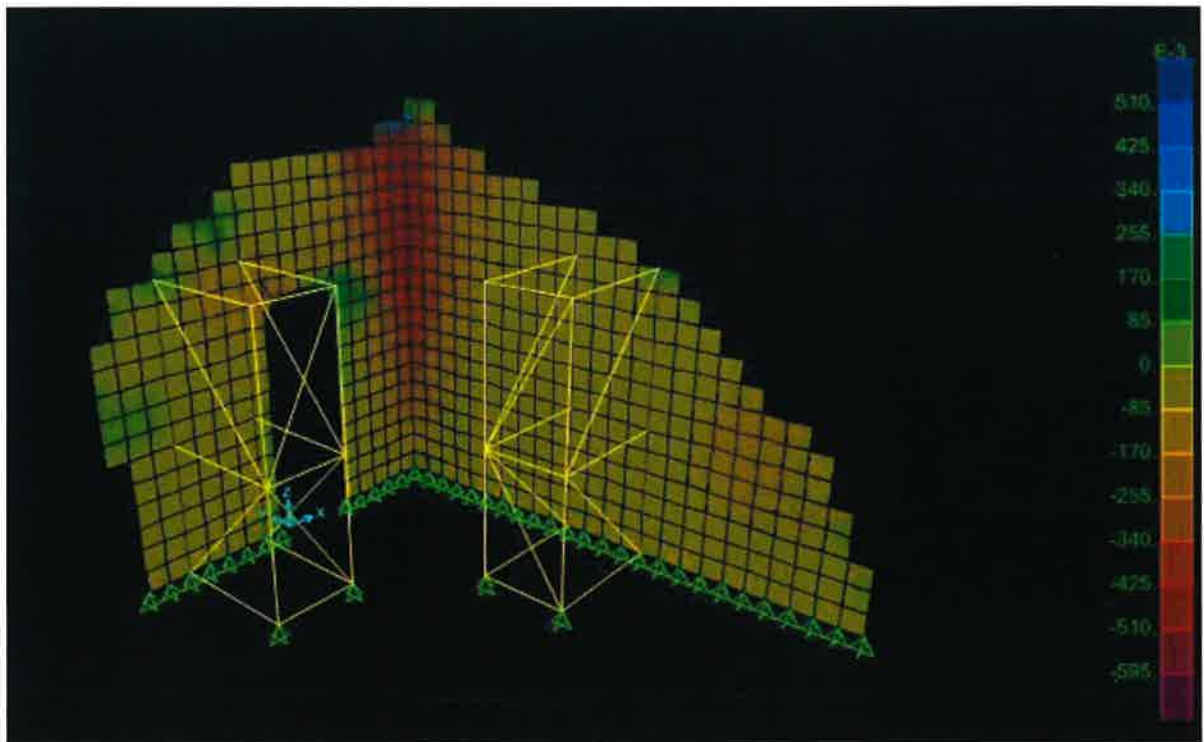
**Figure 8 - Possible Rehabilitation Option with Timber Supports**
