# SERVICE NO. 1304 BULLETIN

## PIPER CONSIDERS COMPLIANCE MANDATORY

Date: August 23, 2017

**MAIN WING SPAR INSPECTION**

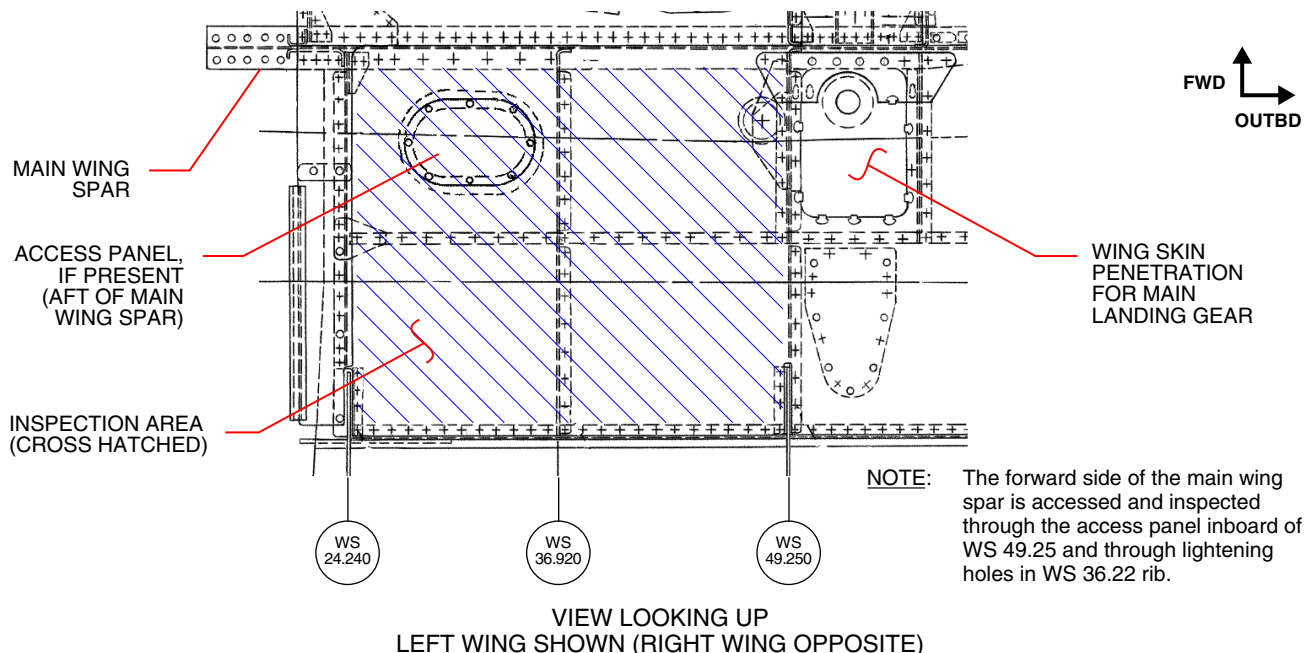
**Figure 1**  
Access Panel Location

1. RC – Examine the lower wing skin in the area shown in Figure 1 for the presence of an access panel, which is in the area aft of the main wing spar and inboard of the main landing gear. This access panel, if present, will be oval shaped, roughly eight (8) inches long and 5.50 inches wide.
  - If an access panel already exists in the area identified in Figure 1, proceed to Step 2.
  - If no access panel exists in the area identified in Figure 1, order and install Inspection Access Hole Kit, Piper Part Number (P/N) 765-106V. Each kit provides parts to install one access panel on the lower surface of both the left and right wings, at a location that provides direct visual access to the inspection area. Proceed to Step 2.

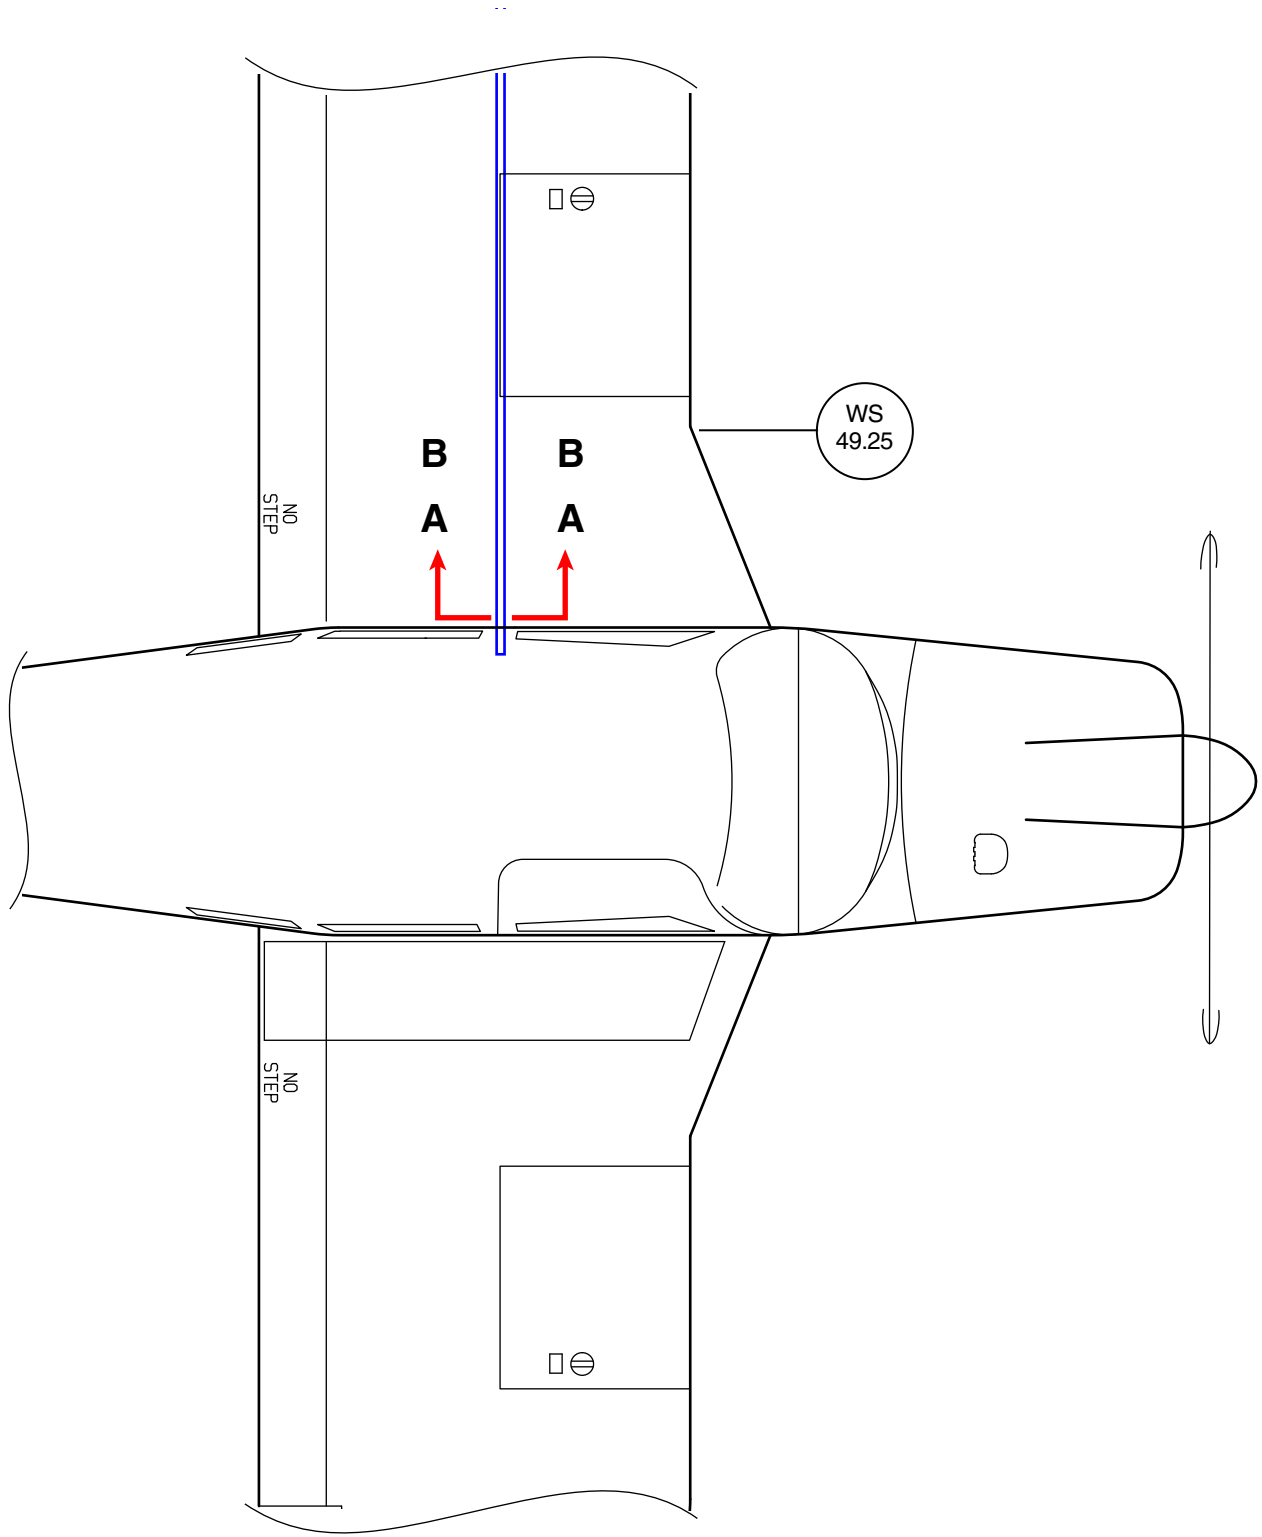
**Figure 2, Sheet 1 of 2**  
Wing Spar Configurations

Carefully inspect spar components for evidence of corrosion. The initial stages of corrosion are often masked by paint coatings and hidden under faying surfaces such as riveted lap joints. Since corrosion products occupy more volume than the original metal, carefully inspect these areas for irregularities such as blisters, flakes, chips, lumps, bulging skins and missing rivets.

- If no corrosion is present, proceed to Part III.
  - If corrosion is detected, remove per FAA Advisory Circular AC 43.13-1B, Chapter 6. Proceed to Step 5.

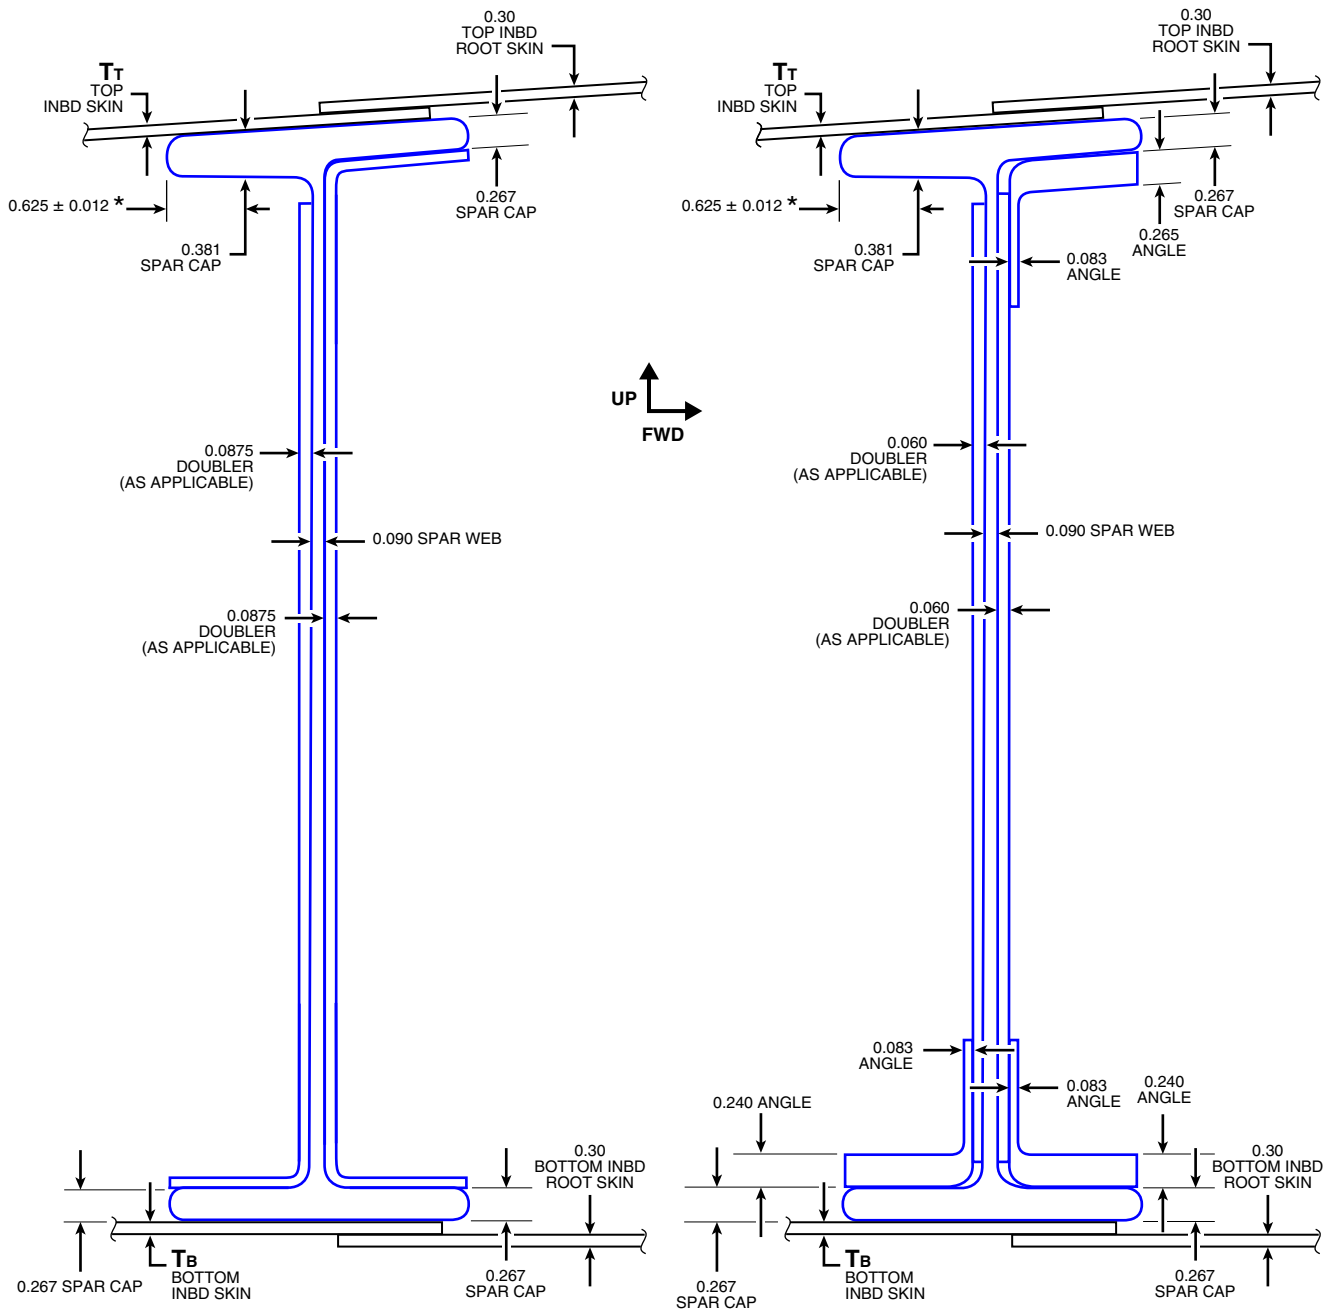
**Figure 2, Sheet 2 of 2**  
Wing Spar Configurations

**NOTE:** The minimum allowable dimensions are shown in View A-A and B-B, except as denoted by \*.

\* The dimension 0.625 +/- 0.012 is not a measure of material thickness. Rather, this dimension defines the location to measure for the minimum allowable thickness of 0.381 in the spar cap.

5. RC – After removal of the corrosion, verify that all affected areas meet or exceed the minimum thicknesses stated within this service bulletin. At locations where direct measurement is not possible, thickness measurements shall be accomplished using a nondestructive inspection method such as ultrasound, eddy current, or equivalent, provided that such method achieves a measurement accuracy of +/- 0.005 inches or better.

- If the part thickness at all locations meets or exceeds the minimum thicknesses stated within this service bulletin, proceed as follows: Apply primer to the areas where paint was removed using MIL-PRF-85582D Type I Class C2 primer, or any primer conforming to MIL-P-23377 and apply per manufacturer's instructions. Alternately, any of the primers listed in Table 3 may be used. Proceed to Part III.

- If corrosion is detected, and removal of corrosion in the affected areas results in a part thickness at any location that is less than the minimum values stated within this service bulletin, further assessment and/or structural repair is required. Proceed to Part II.
