Piper Aircraft, Inc.
2926 Piper Drive
Vero Beach, FL, U.S.A. 32960

SERVICE NO. 1161B BULLETIN

Date: February 21, 2020

**RIB ASSEMBLY INSPECTION AND MODIFICATION –
AFT WING, WS 49.25**

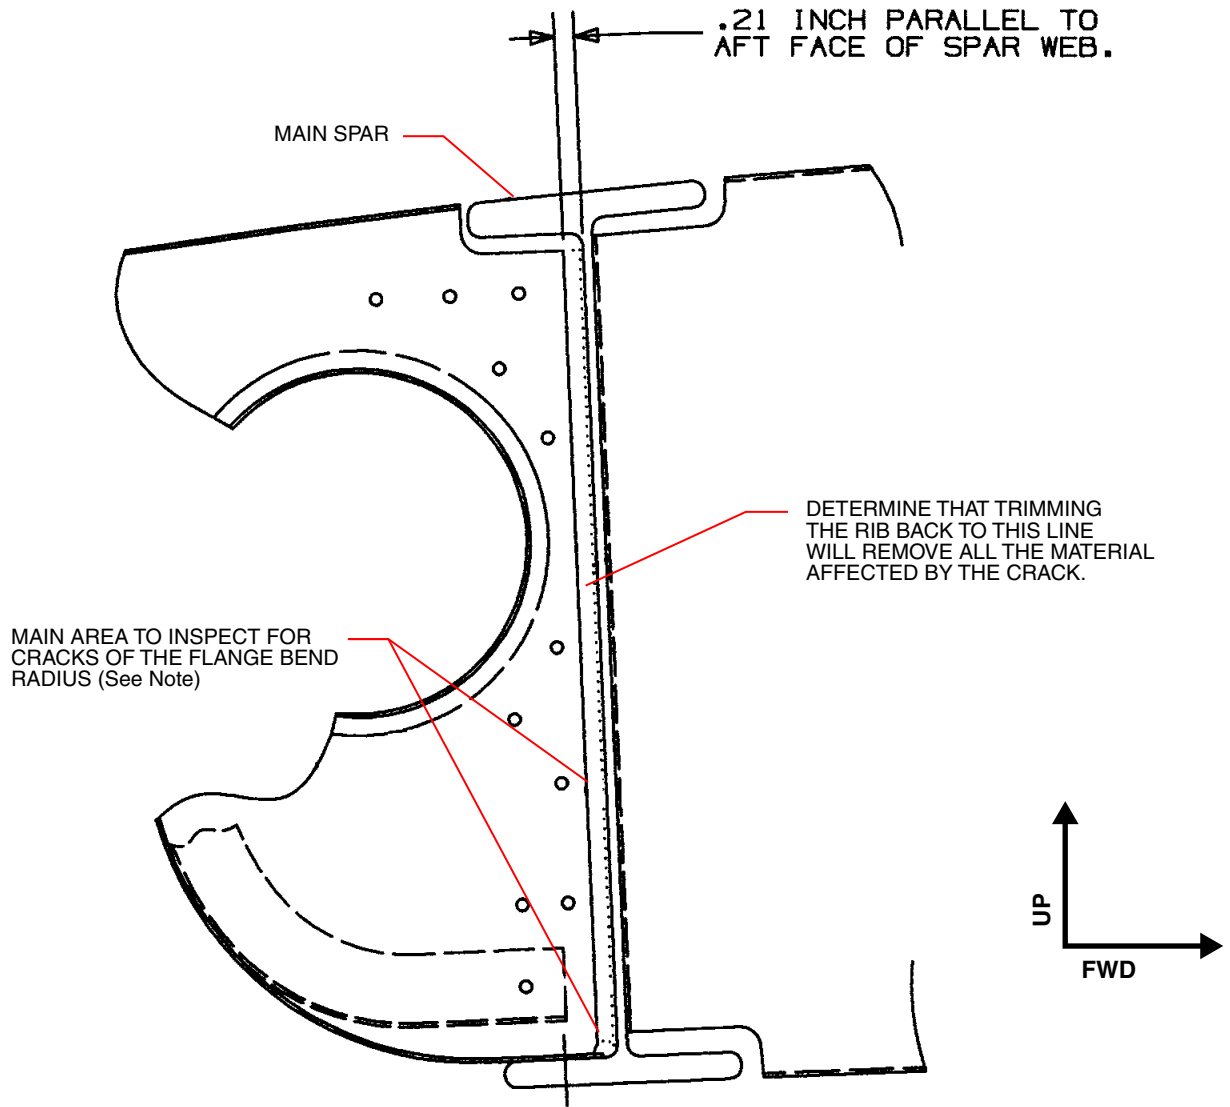
Figure 1
Determine if trimming will remove all material affected by cracks or damage

It has been determined that, under certain conditions, the rib assembly on the aft side of the main wing spar at wing station (WS) 49.25 may develop a crack, located vertically along the bend radius of the flange common to the main wing spar and the side brace attach fitting.

A crack in the wing rib assembly as described, if not repaired, could compromise the ability of the rib to support the spar web and carry torsional shear loads, thereby reducing the shear buckling capability of the spar web and torsional strength of the wing.

3. Inspect the rib assembly (LH wing and RH wing) for evidence of cracks in the bend radius of the flange common to the main spar web (as shown in Figure 1), using dye penetrant inspection techniques.

- If a **crack is detected**, identify the path of propagation. Determine if trimming will remove all the material affected by the crack, as illustrated in Figure 1.

LOOKING OUTBOARD AT LEFT WING
(RIGHT WING OPPOSITE)

- If so, then install the appropriate kit (see Material Required section of this service bulletin). Kit installation will eliminate the recurring inspection requirements mandated by this service bulletin.

- If not, then replacement of the rib assembly is mandated.
 - If a replacement Rib Assembly – Aft Wing – WS 49.25, P/N 78475-000 through 78475-009, is installed, this **does not relieve the recurring inspection requirements** of this service bulletin. However, the **recurring inspections are relieved** if the applicable kit P/N 767-397 or 767-398 is also installed, and if the kit instructions are marked drawing number 88373, revision J (or later).

- If a replacement Rib Assembly – Aft Wing – WS 49.25, P/N 78475-010 or higher, as defined in Table 1, is installed, this **relieves the recurring inspection requirements** of this service bulletin. (Installation of either kit P/N 767-397 or 767-398 is not required, in this case.)
