# SERVICE NO. 1350 BULLETIN

Date: December 17, 2020

**NOSE LANDING GEAR STEERING HORN AND ARM  
ASSEMBLIES INSPECTION**

PA-46-350P M350  
PA-46-500TP M500  
PA-46-600TP M600

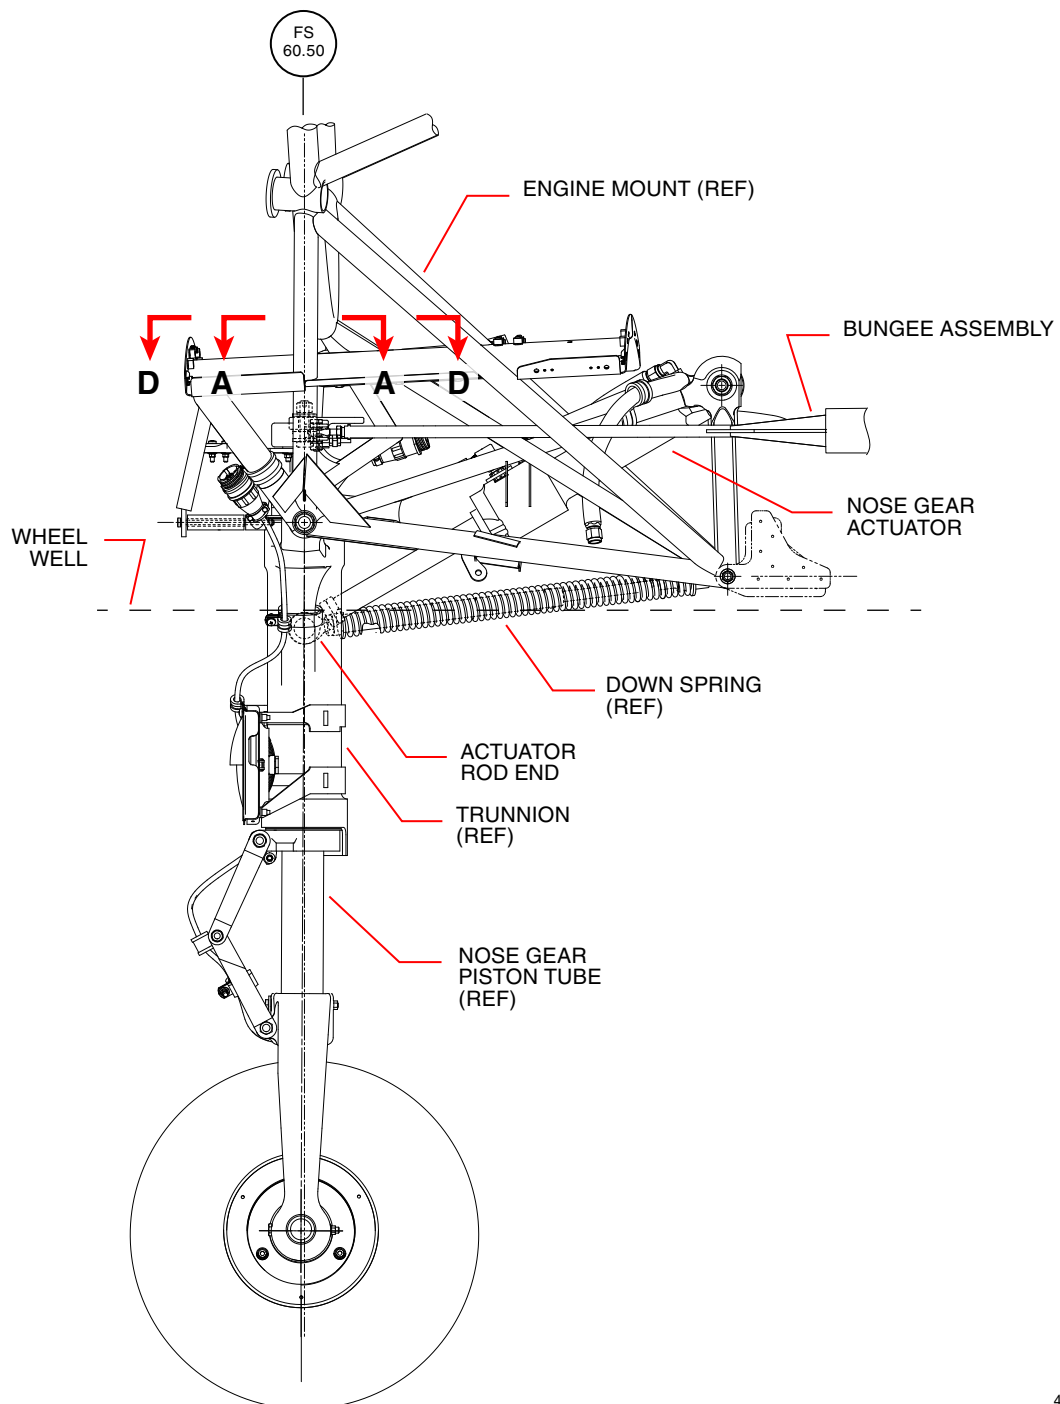
**Figure 1 – Sheet 1 of 5**  
Nose Wheel Steering Assemblies – Typical

The steering pads, which are components welded onto the nose wheel steering horn assembly, may be protruding beyond the steering horn rollers on the affected airplanes. This may result in the steering pads making improper contact with the nose wheel steering arm assembly. Left uncorrected, this condition may cause damage to the steering arm assembly.

1. Gain access to the location of the Nose Wheel Steering Horn Assembly, Piper part number (P/N) 85154-012, and Nose Wheel Steering Arm Assembly, Piper P/N 83626-004. These assemblies are installed above the gear trunnion assembly, just inside the nose landing gear wheel well. Refer to Figure 1.
2. Remove the steering horn from the aircraft. See View A–A and Detail B.

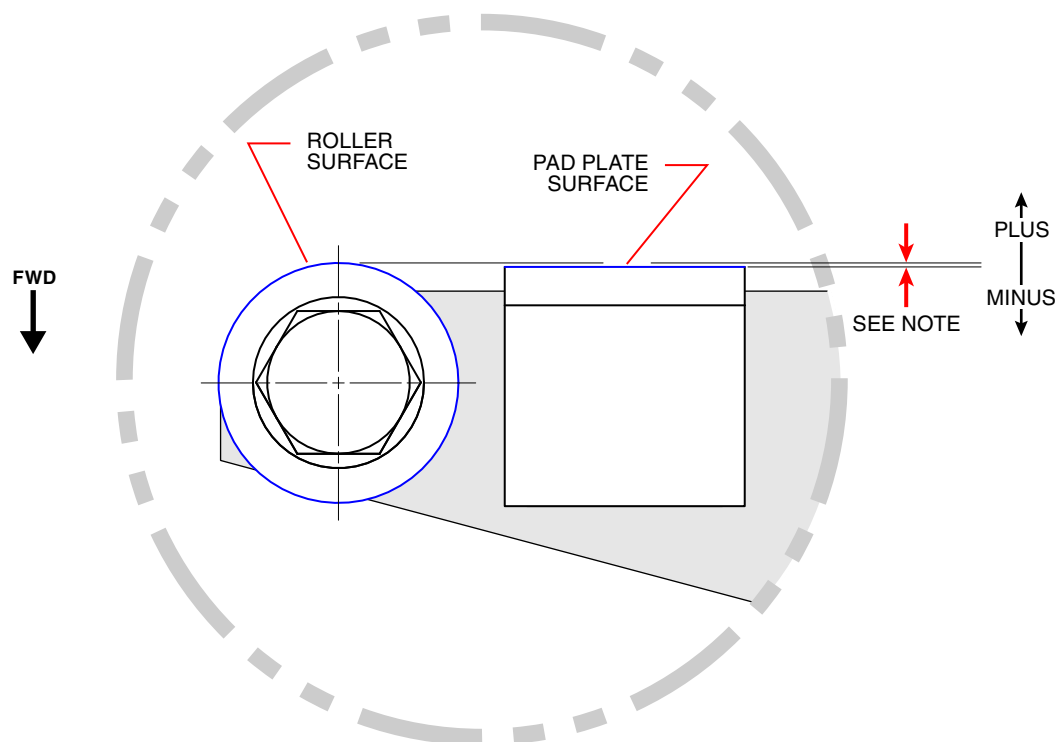
### DETAIL C

**NOTE:** The surface of both rollers must be positioned between plus 0.020 in. maximum and minus 0.001 in. maximum distance from the surface of both steering pad plates. The acceptable distance is applicable to both sides at the same time.

CORRECT ROLLER AND PAD POSITIONING  
(TYPICAL OF BOTH ENDS OF HORN AND ALL HORN ASSEMBLIES)

- If there is no visually apparent damage, then proceed to Step 4.
  4. Check if the steering pads and rollers are positioned correctly on the steering horn as shown in Detail C. Place the steering horn onto a flat surface, with the rollers facing the surface. Use a feeler gauge, or a shop aid of appropriate thickness, to determine if the parts are positioned as depicted in Detail C.

- If the steering pads and rollers are not positioned as Detail C shows, then the parts must be replaced, which will be accomplished in an upcoming step. Proceed to Step 5.
  - If the steering pads and rollers are positioned as Detail C shows, then it may not be necessary to replace the steering horn assembly and rollers. Proceed to Step 5.
5. Inspect the Arm Assembly, P/N 83626-004, for any signs of damage, especially in the areas where the steering pads make contact.

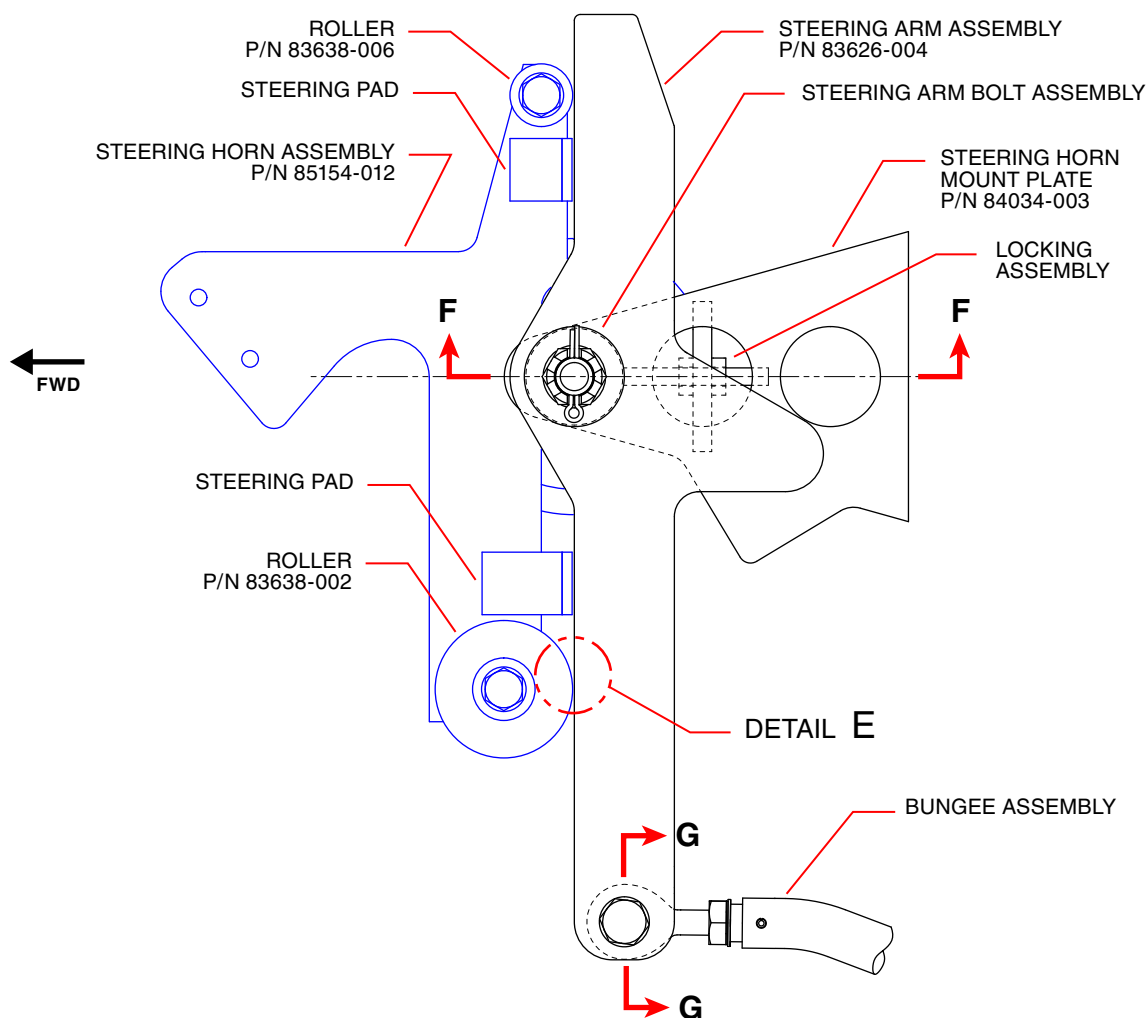
**VIEW D-D**

FACTORY INSTALLED STEERING HORN ASSEMBLY (P/N 85154-012)  
AND STEERING ARM ASSEMBLY (P/N 83626-004)  
LOOKING DOWN

- Cotter Pin, P/N 424-059 (MS24665-283) (for the M600 only)
  - 2) Remove the existing arm assembly:
    - a) Disconnect the forward end of the steering bungee from the left hand side of the steering arm, shown in View D–D. Retain the hardware for reinstallation (see View G–G), except for the cotter pin, which is to be discarded; replace any hardware, depending on condition.

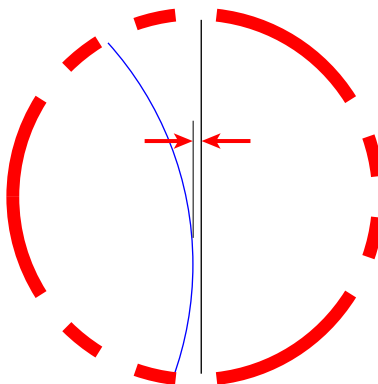
**DETAIL E**

**NOTE:** The clearance between the steering arm and both of the rollers must be 0.010 – 0.030 inch.

CLEARANCE BETWEEN STEERING ARM AND ROLLERS

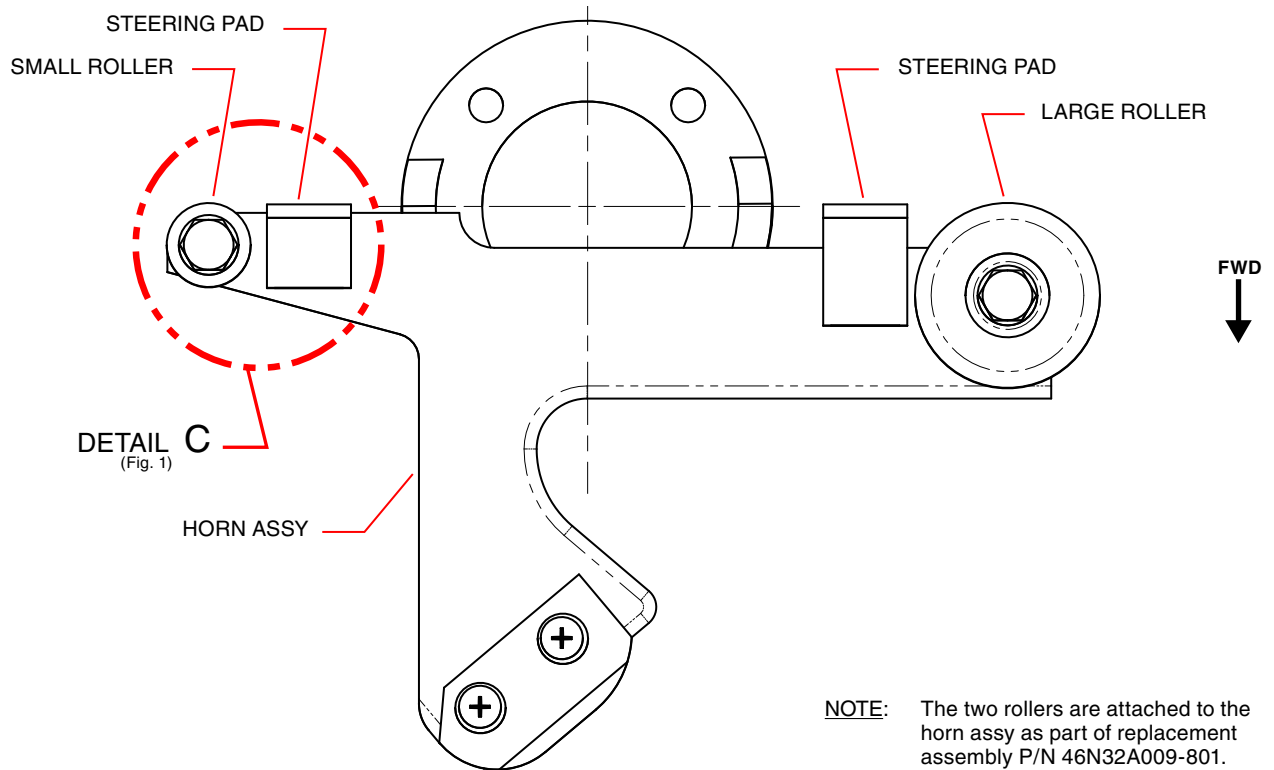
**Figure 2**

Replacement Steering Horn and Roller Assembly

- 1) Order one (1) Nose Wheel Steering Horn and Roller Assembly, P/N 46N32A009-801, which is shown in Figure 2. This new, improved assembly replaces, as one assembly, the existing steering horn assembly (which includes the steering pads) and steering horn rollers.
