# SERVICE NO. 540B BULLETIN

Date: February 9, 2021

**INSPECTION AND REINFORCEMENT OF  
STABILATOR TIP TUBE AND WEIGHT ASSEMBLY**

PA-23-250 (Six-Place) Aztec "F"

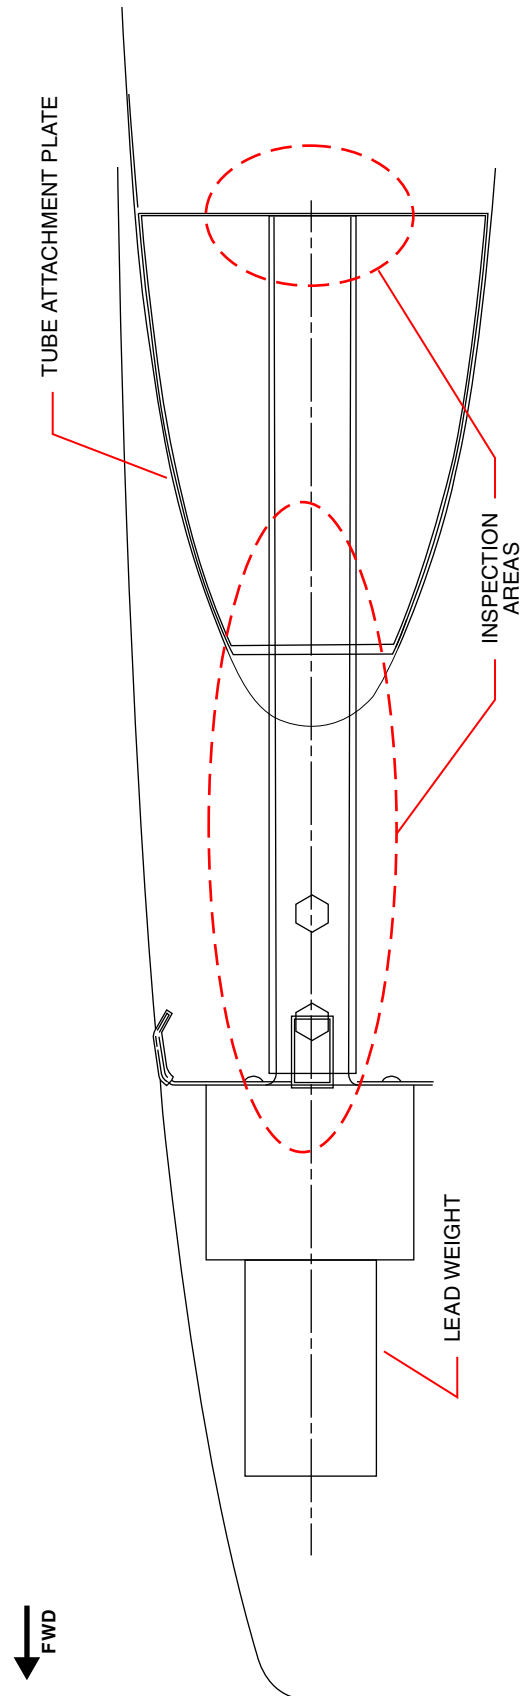
**Figure 2**  
Side View of Tube and Weight Assembly

4. RC – For S/Ns 27-7954036 through 27-7954121; and for S/Ns 27-7654001 through 27-7954035 if Stabilator Balance Weight Replacement Kit, P/N 763-987, is installed: examine the inspection areas identified in Figure 2. Perform the inspection using a 10X magnifier, a mirror, and a suitable light source or other equipment capable of providing equal or better resolution.
  - **If cracks are found**, then repair is necessary prior to next flight. Contact Piper Customer Service for assistance at (+1) 772-299-2141 or CustomerService@piper.com. Piper’s normal business hours are Monday through Friday, 7:30 a.m. to 4:30 p.m. (Eastern).
  - **If no cracks are found**, then proceed to Part III.
