# SERVICE NO. 1354 BULLETIN

**FUSELAGE STATION 247 BULKHEAD  
INSPECTION**

PA-44-180 Seminole

PA-44-180T Turbo Seminole

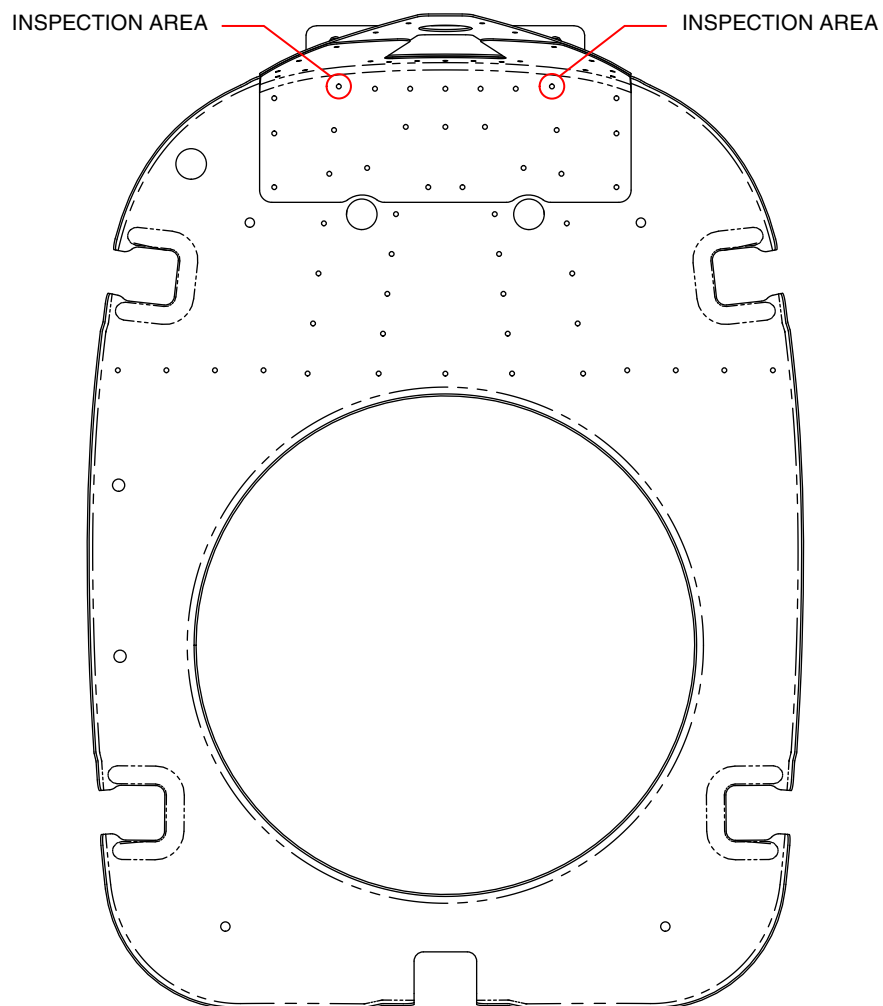
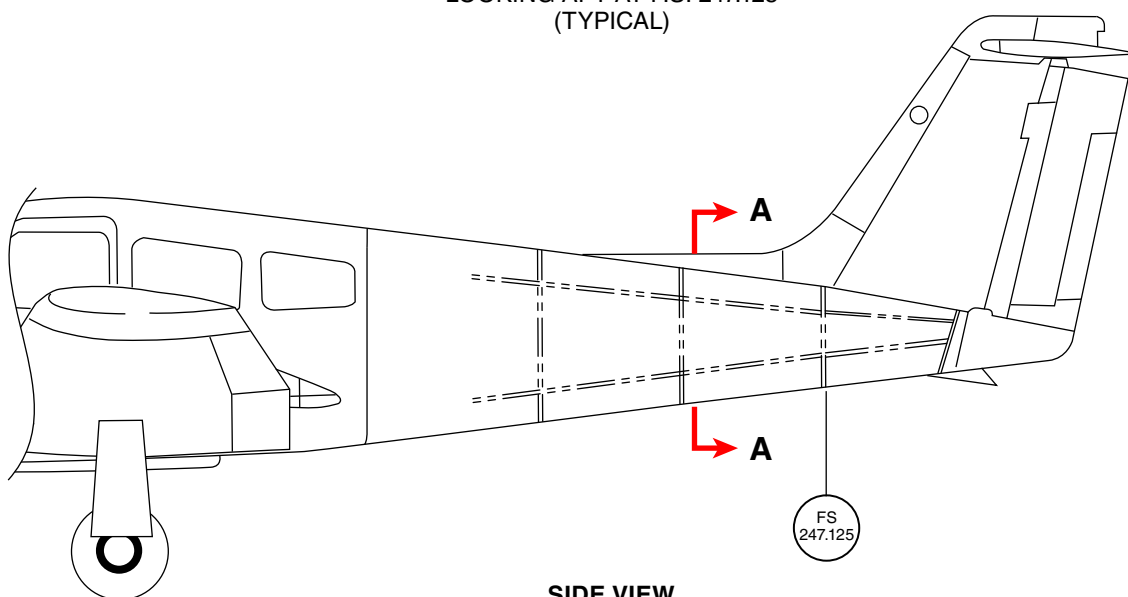
**Figure 1**  
PA-44-180/T Seminole Aft Fuselage Frame Inspection

Cracks may develop in the bulkhead assembly Piper P/N 86462-002, located at fuselage station (FS) 247, on the affected aircraft.

1. Gain visual access to the forward face of the FS 247 bulkhead, as shown in Figure 1. Carefully examine the area identified as the “inspection area,” with emphasis on the two rivet locations specifically identified. Inspect for cracks near rivet heads. Additionally, inspect the formed radius of the bulkhead directly above these rivets for cracks.
  - If **no cracks** are found, proceed to Step 2.
  - If **cracks are found**, then comply with Part II prior to next flight.
2. Make a logbook entry documenting compliance with Part I of this service bulletin.

1. Order and install Kit – Frame Assy Replacement – Aft Fuselage, Piper P/N 88686-701.
2. Make a logbook entry documenting compliance with Part II this service bulletin.
