# SERVICE NO. 1413 BULLETIN

Date: April 9, 2024

**AFT WING SPAR ATTACH FITTING INSPECTION**

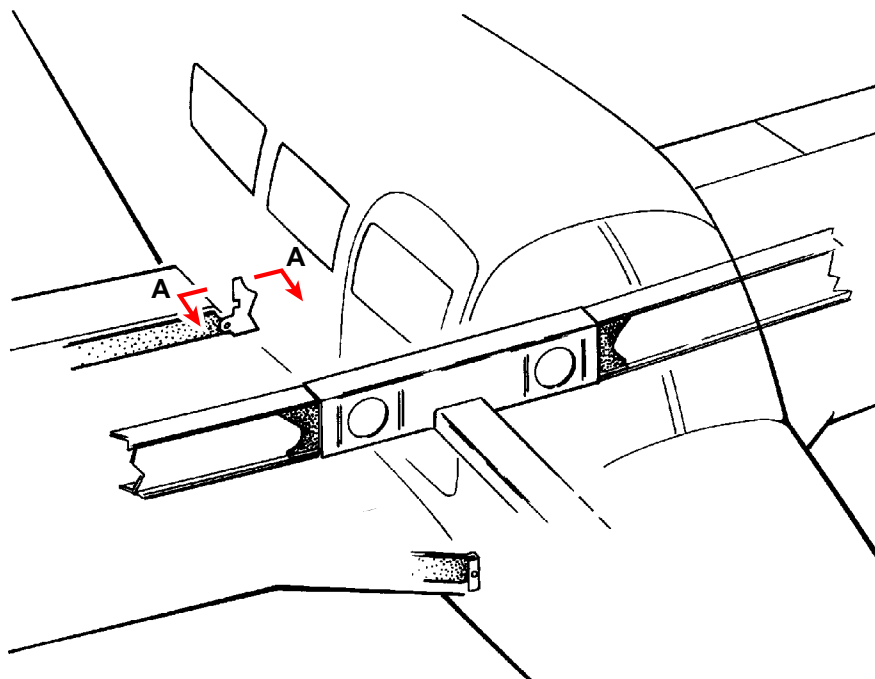
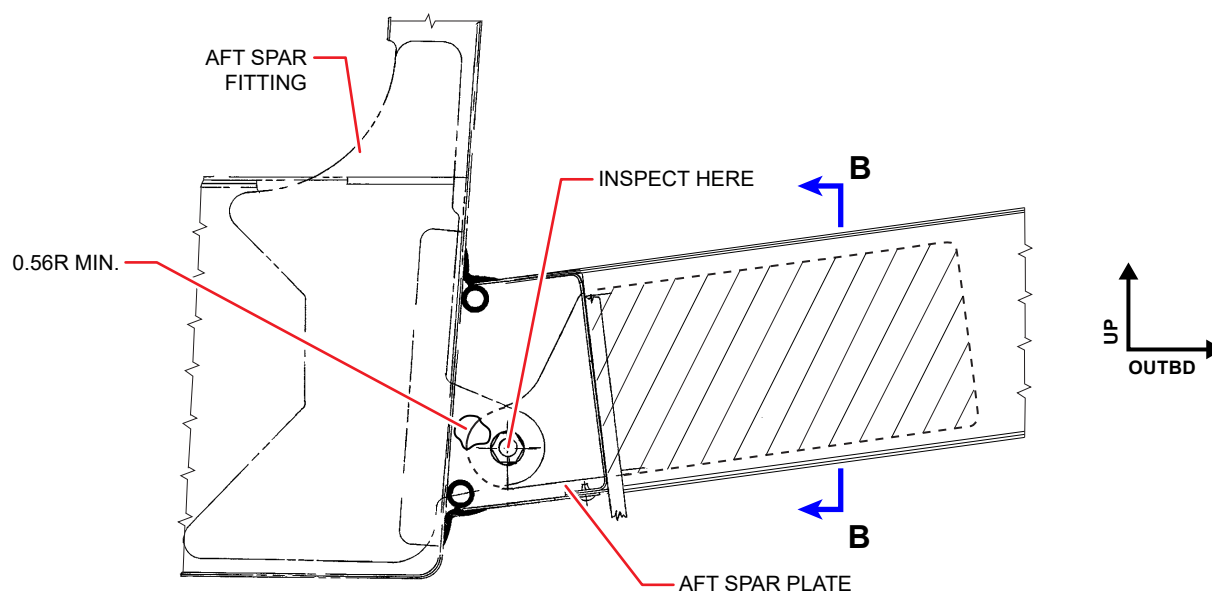
**Figure 1** (Sheet 1 of 2)  
Aft Attach Fitting Installation (Typical)

On some of the affected aircraft, the bolt hole(s) common to the aft spar fitting and the aft spar plate may be mis-drilled. An airplane in this condition does not conform to type design and does not possess its required type design strength.

1. Place airplane on jacks. Refer to 7-10-00 of the applicable AMM for instructions.
2. RC – Locate the aft spar attachment on the wing as identified in Figure 1 and remove the fastener hardware (bolt, washers, and nut) securing the aft spar attachment. Replace the nut; retain bolt and washers that are in serviceable condition.
3. Inspect the holes in the Aft Spar Plate (installed on the wing) and the Aft Spar Fitting (installed on the fuselage), as shown in View A-A and Section B-B of Figure 1. Verify that holes in the aft spar plate and aft spar attachment are circular and do not exceed 0.3765 inch diameter.

**VIEW A-A**  
LOOKING FWD AT AFT SPAR ATTACHMENT  
RIGHT WING SHOWN (LEFT WING OPPOSITE)

For aircraft models PA-28-181 Archer III, PA-28-181 Piper Pilot, and PA-28R-201 Arrow III only, determine if a 0.437–0.438 inch diameter line-reamed hole perpendicular to both the Aft Spar Plate and the Aft Spar Fitting will clean out any oversize or out-of-round condition, and achieve a minimum 0.56 inch radius edge distance for both parts, as shown in View A-A of Figure 1.

- If the above conditions can be satisfied, order and install Kit – Wing Aft Spar/Fuselage Attach Fitting, Piper P/N 88365-002. This kit provides parts and instructions for repairing an oversize hole condition in the wing aft spar/fuselage attach fittings, for specific aircraft models. Upon completion, proceed to step 5.
- If the hole size conditions cannot be satisfied, proceed to Step c.

5. RC – Upon completion of the corrective measures described in step 4, perform a reaming operation as needed to achieve a 0.3745–0.3765 diameter hole with the Aft Spar Plate and the Aft Spar Fitting, while maintaining a minimum 0.56 inch radius edge distance for both parts, as shown in View A-A of Figure 1.

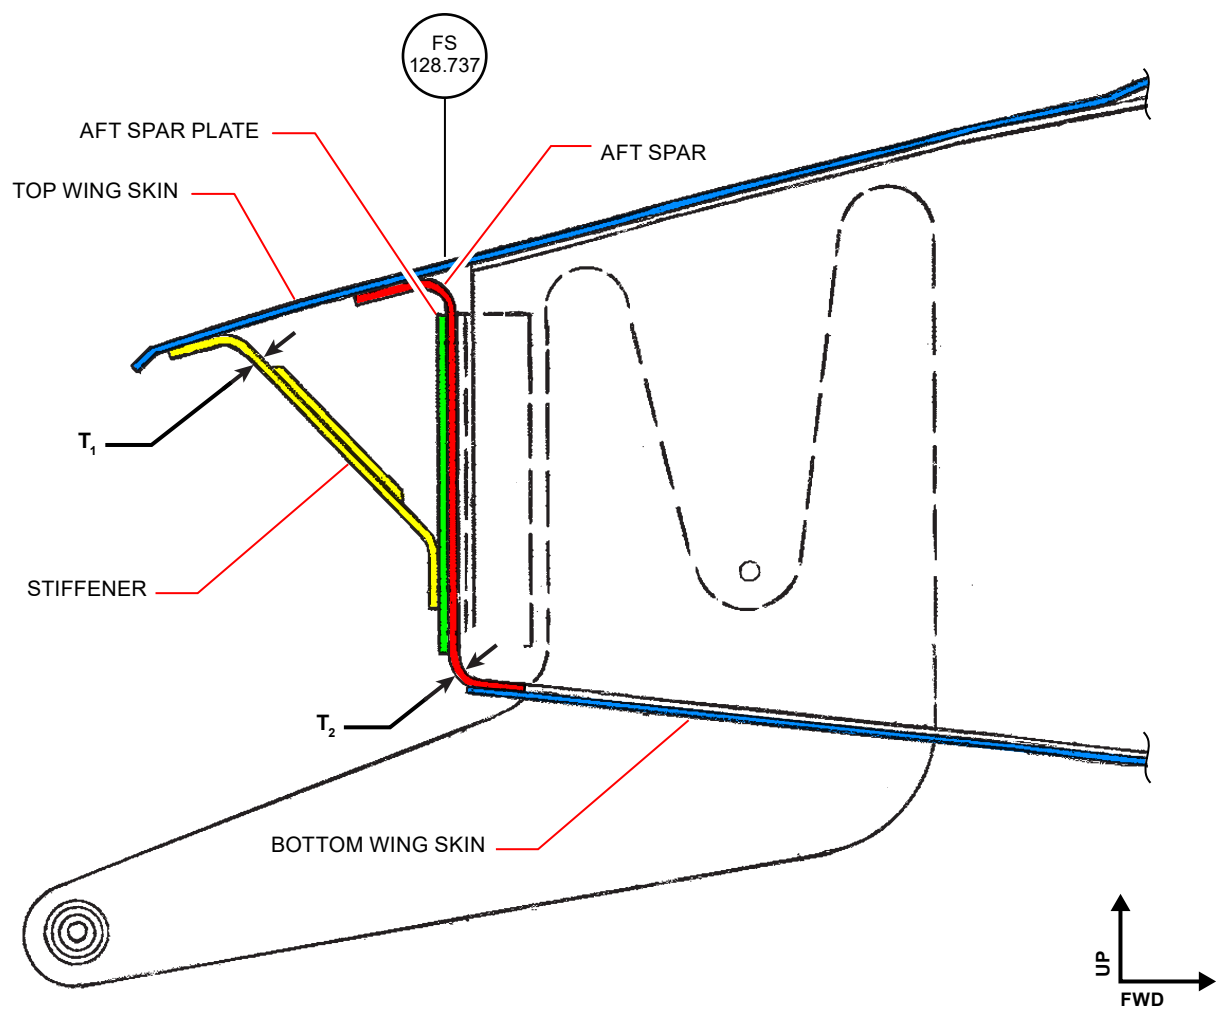
**Figure 1** (Sheet 2 of 2)  
Aft Attach Fitting Installation (Typical)

The Aft Spar Plate is made from steel. The adjacent components such as the Aft Spar and Stiffener, as shown in Section B-B of Figure 1, are made from aluminum. If the area is exposed to a corrosive environment over an extended period of time these components are susceptible to galvanic (i.e. “dissimilar metal”) corrosion.

Carefully inspect forward and aft wing spar surfaces that are in contact with the Aft Spar Plate for evidence of corrosion. Refer to Figure 1, Section B-B. The initial stages of corrosion are often masked by paint coatings, and hidden under faying surfaces, such as riveted lap joints. Since the products of corrosion occupy more volume than the parent metal, carefully inspect these areas for irregularities such as blisters, flakes, chips, lumps, bulging skins and missing rivets.

**SECTION B-B**  
LOOKING INBOARD  
RIGHT WING SHOWN (LEFT WING OPPOSITE)

1) Remove corrosion per FAA Advisory Circular AC 43.13-1B, Chapter 6.

After removal of the corrosion, verify that all affected areas meet or exceed the minimum thicknesses stated within this service bulletin. See Section B-B and Chart 3. At locations where direct measurement is not possible, thickness measurements shall be accomplished using a nondestructive inspection method such as ultrasound, eddy current, or equivalent, provided that such method achieves a measurement accuracy of  $\pm 0.005$  inches or better.

- 2) Order and install Kit – Corrosion – Aft Spar Rework, Piper part number (P/N) 87584-000. This kit provides parts and instructions to replace (via a splicing operation) the Aft Spar Plate, as well as the inboard 10.80 inches of the aft wing spar on both left and right wings.
- 3) Review step b. and/or step c. for applicability. Otherwise, proceed to step 5.
