Very Peculiar 1981 FRN Fold-Over Error

Peter Huntoon

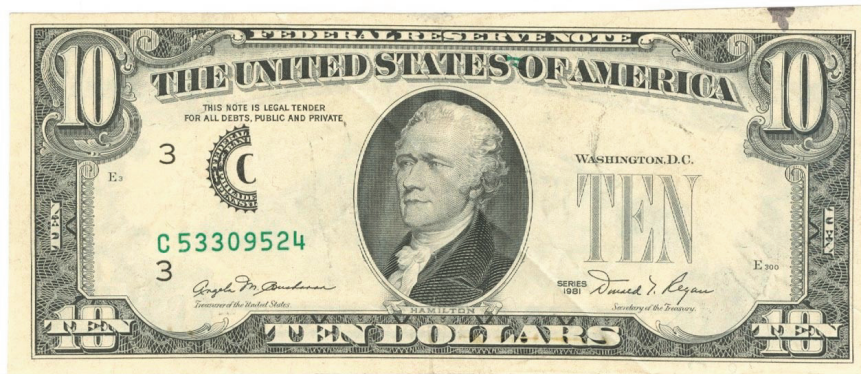
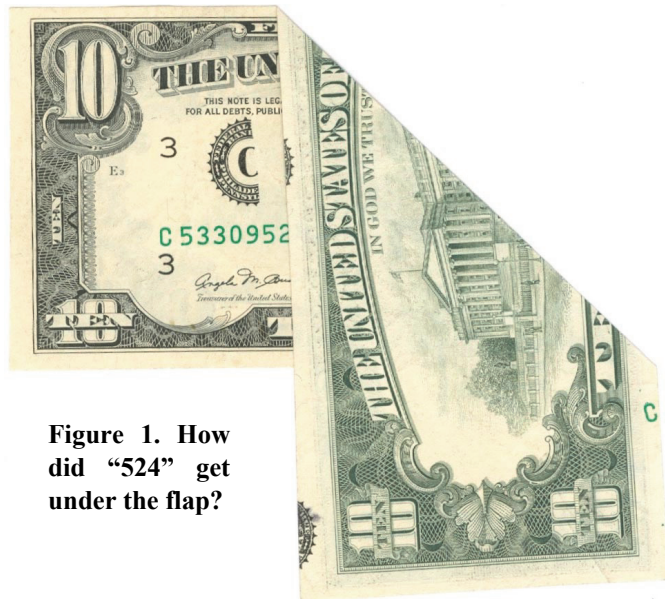
Figure 1. How did “524” get under the flap?

Bob Liddell, who seriously collects misprints, obtained this Series of 1981 FRN \$10 that exhibits a most unusual fold-over. It was overprinted on a COPE (currency overprinting equipment machine). The error involves the note from the upper right corner of the sheet. The flap was unfolded before the top selvage was cut from the sheet and the notes separated.

The peculiar thing that attracted Bob to the misprint is that 524 from the left serial number is printed where the top selvage blocked the district seal so should have blocked that part of the serial number as well. The question is: How was this possible; specifically, how did the 524 get under the selvage? Notice also that the C-prefix from the right serial number that was intended for the note below was caught on the right edge of the fold-over, albeit crooked.

Difficult to see in the photos is an ill-formed fragment of a serial number printed between STATES and OF on the face of the note. The fragment looks like part of some number, but getting it there seems impossible. Somehow that part of the note glanced against a numbering head.

It is our opinion that the half sheet started to deform into some sort of soft rollover as it was passing by the green cylinder such that the left serial number printed in its entirety, but the suffix letter landed on the selvage that was later cut away from the developing flap. The printing heads and other elements on the cylinders are raised with plenty of space between them so there are innumerable opportunities for a sheet to wad or curl weirdly into those spaces when something goes wrong. See Figure 3.

The sheet continued on to the black cylinder where by now the flap had flattened with a resulting hard crease and its left edge had slid appreciably to the left thus covering the 524 in the left serial number at the moment that the black seals printed. By now the paper was not only folded over but internally stretched and deformed.

There are two indicators that the paper was deforming. The top margin of the note has a crooked cut demonstrating that after the flap was unfolded, the paper remained somewhat wadded up as the top margin of the sheet was cut away. Also, the line delineating the left edge of the selvage that blocked the seal on Bob's note is not straight as expected. Instead it is concave toward the left.

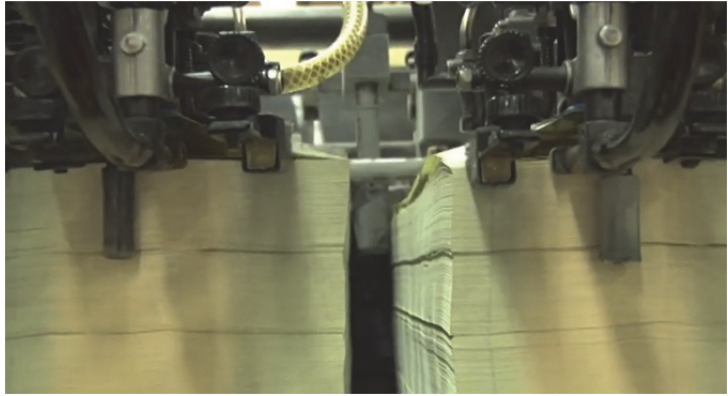
The feed stock for the COPE machines consists of two piles of 16-subject half sheets (Figure 2) that are simultaneously fed through the respective sides of the machine. When this note was processed, the two cylinders that applied the overprints were configured so that the first printed the green serial numbers and Treasury seals and the second printed the black district numbers and seals. Numbering was through the stack of notes in each plate position and the machine numbered from the high to low serial numbers in each print run so that the low numbers landed on the top in the output bins.

Figure 2. Two piles of half sheets being fed simultaneously into a COPE machine.

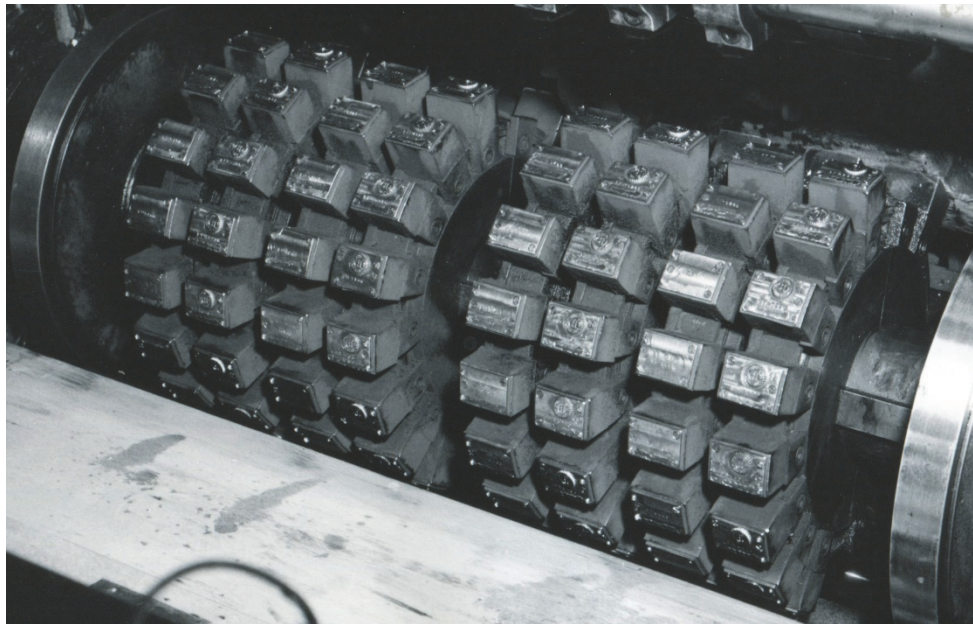
Figure 3. View of the cylinder that prints the black district letters and seals. Notice the separation in the middle because the cylinder prints both half sheets at once, which are separated from each other. It takes two posts to print the district information on each note.
