Project:	<b>8939 Cardiff Road, Chesterfield, Virginia</b>	Permit Number:	<b>N/A</b>
Client:	<b>Michael Lind</b>	Inspected by:	<b>Charles R. Field, P.E.</b>
Date:	<b>July 13, 2025</b>	Time:	<b>10:00 am</b>
Weather:	<b>Sunny</b>	Temperature Range:	<b>80's</b>

**General:** The structure is located at 8939 Cardiff Road, in the Bexley subdivision of Chesterfield County, Virginia, is a two story, detached, single family home. The house was built in 1987, using construction methods typical of the time. The 3,180 square foot home faces south on a 0.81-acre lot.

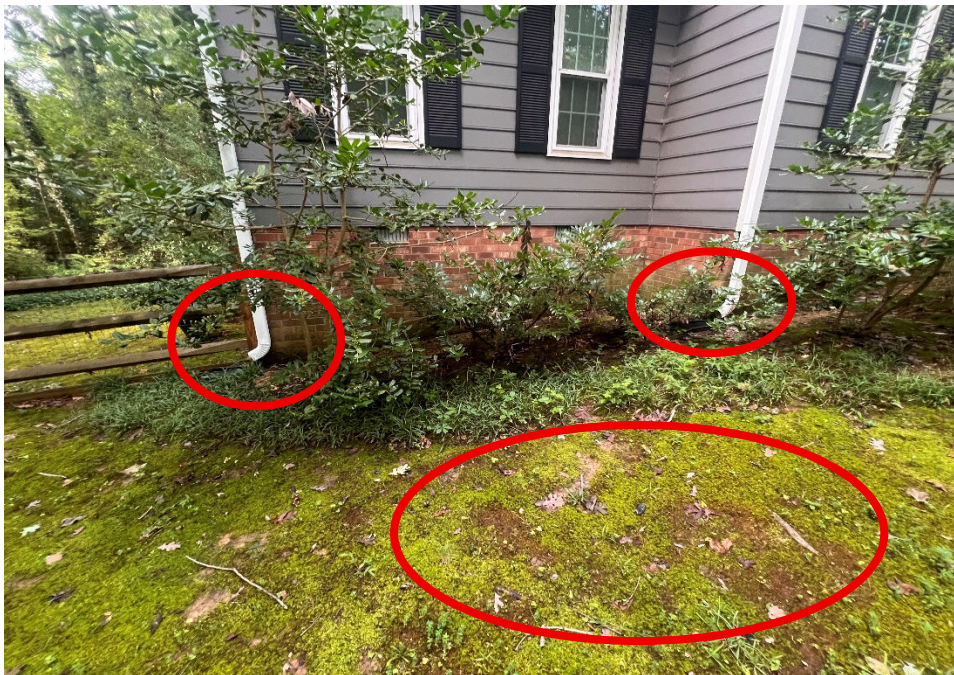
Exterior inspection of the home finds that the house has a working gutter system installed. Downspouts discharge at the base of the home's foundation. The homeowner states that gutters were only recently added to the home and that they were not permitted when the home was originally constructed.

Downspouts discharge at the base of the homes foundation. Wet conditions encourages moss to flourish around the home.

Install Schedule 40 PVC piping to route the discharge from the downspout adjacent to the garage to the backyard or, alternatively, direct it into the driveway apron channel. Do not use black plastic corrugated drainpipe. Do not use thin wall drainpipe. Do not use any perforated product. Use only Schedule 40 PVC plumbing pipe.

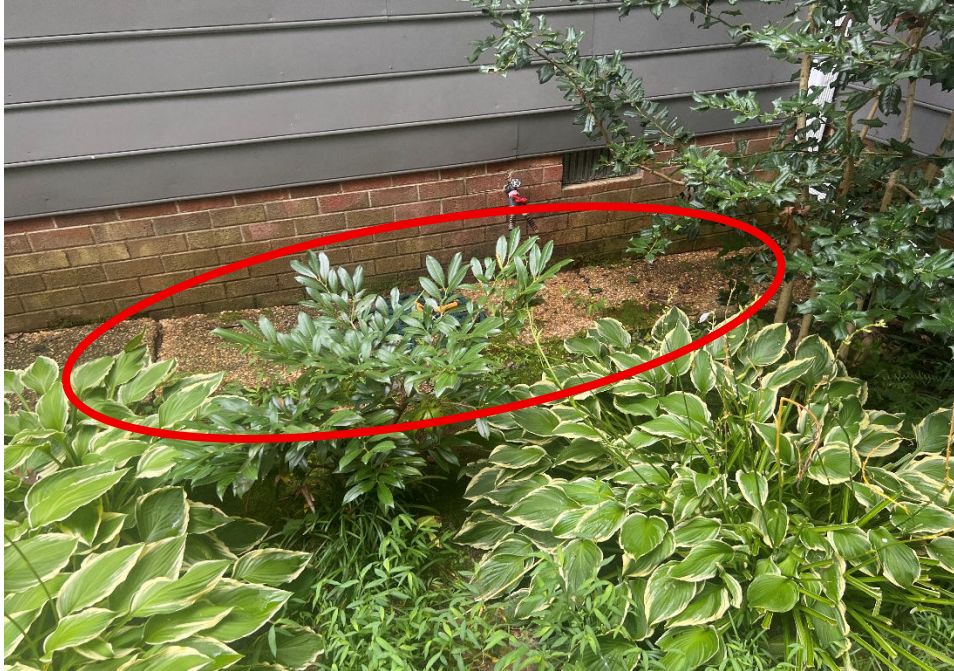
Before the gutters were installed, water fell from the roof and landed on a concrete apron. The aprons are still in place. They are uneven, tilted, and cracked in places.

The original concrete apron was designed to move water away from the foundation. It is now cracked and broken.

Remove the old garage concrete apron that is encouraging water to flow toward the foundation and repour to channel the runoff from the driveway to the backyard.

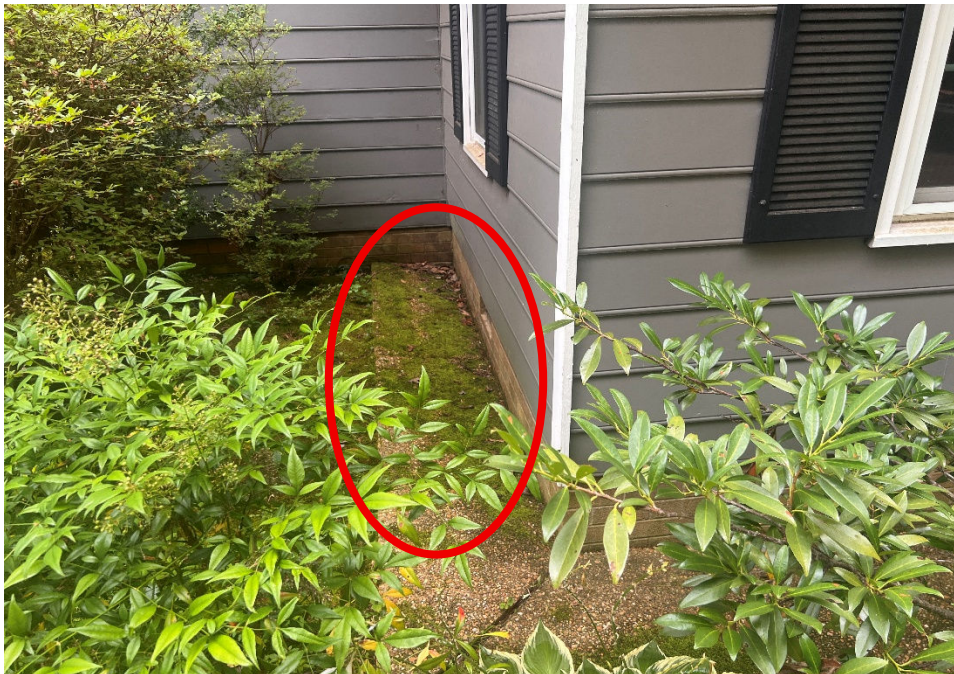
The large amount of moss confirms that water is constantly present.

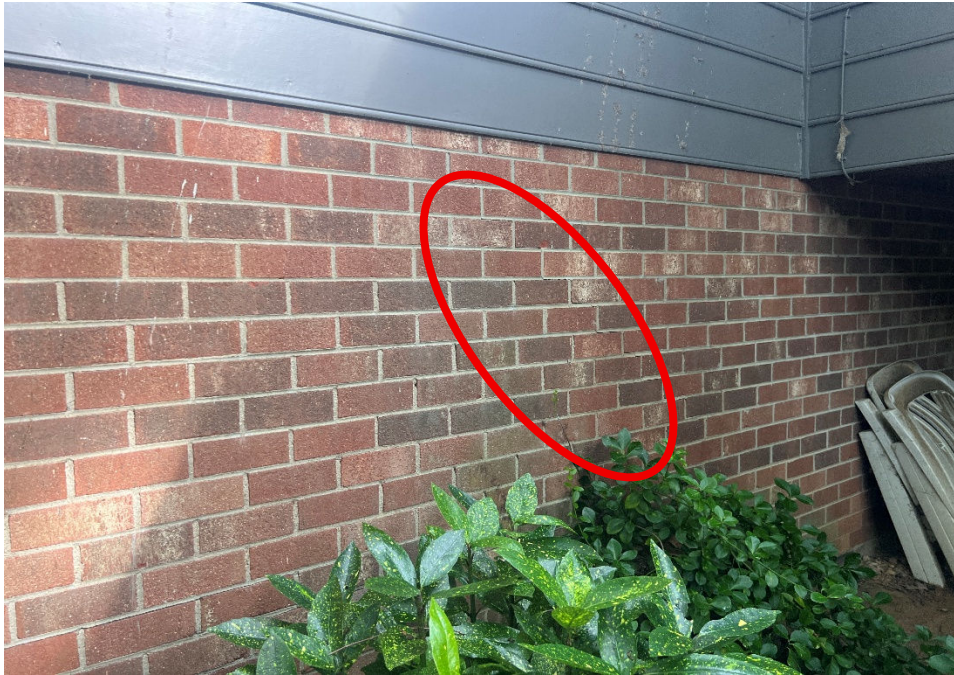
Cracks are seen on the exterior of the garage. Stairstep cracks in the brick sheathing are seen behind the garage.

The cracks in the interior and exterior of the garage formed from both settlement of the foundation and from the stresses exerted on the blocks when the slab began to sink.

Cracks in the brick sheathing behind the garage.

Once the drainage system is in place and the earth around the home has fully dried, (which could take a year or more) have a licensed masonry contractor repair any cracks in the homes foundation, or brick sheathed exterior.

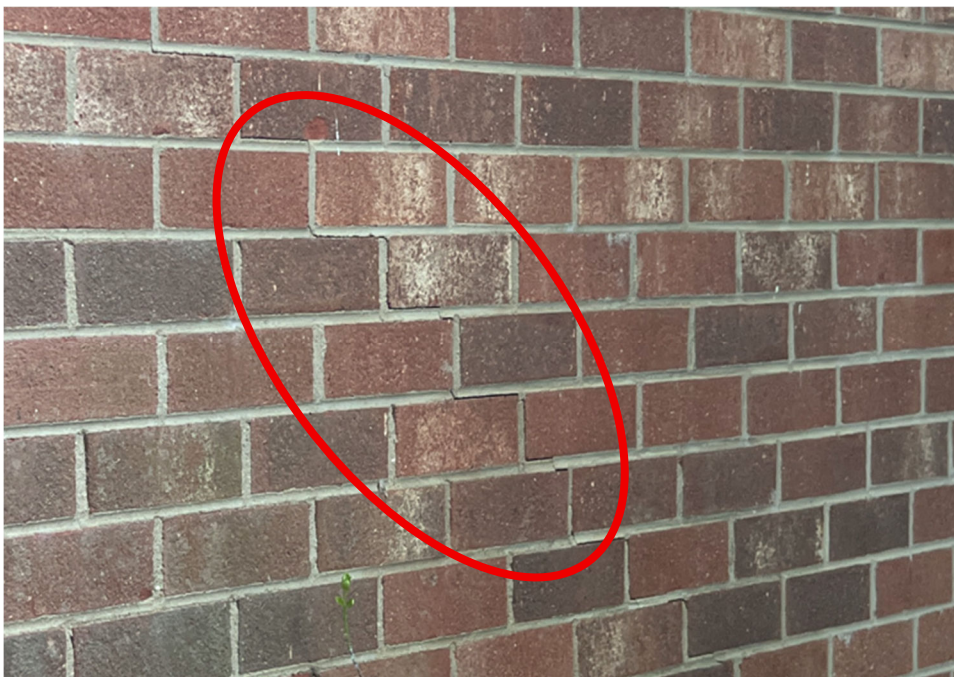
Stair step settlement cracks.

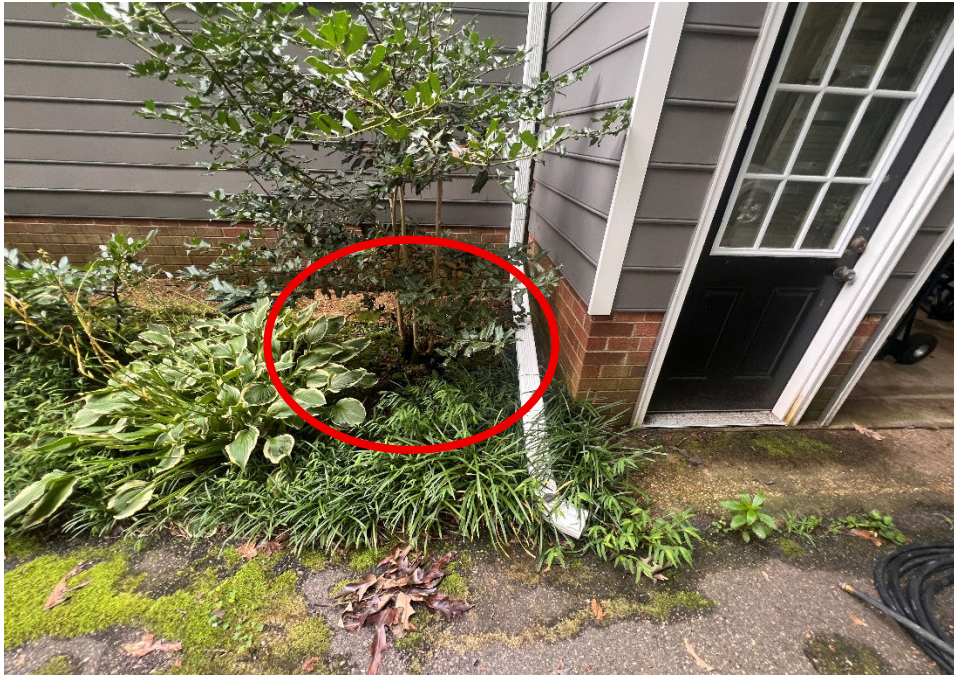
One downspout, on the right side of the home, near the garage has been piped out to the driveway with the use of a downspout extension.

Water ponded here for many years before gutters were added. This downspout has been piped away from the foundation, to the front of the garage.

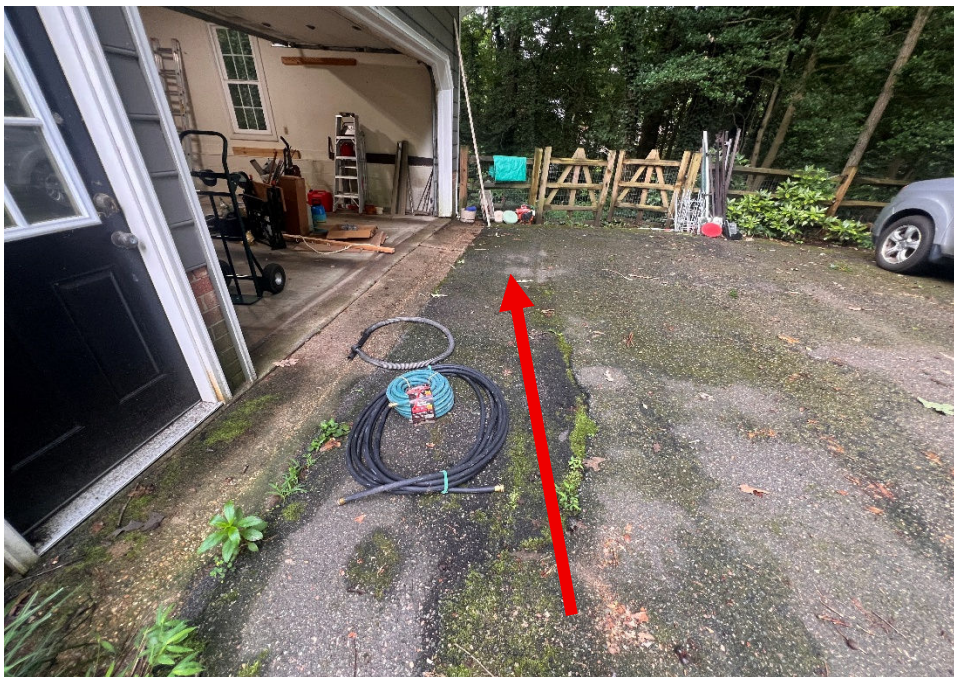
Compounding the problem is water that also arrives from the nearby asphalt driveway, which is sloped toward the rear yard. Visible water stains and moss growth on the asphalt show that water impacts the garage from the driveway.

Water flows down the asphalt driveway and arrives at the garage.

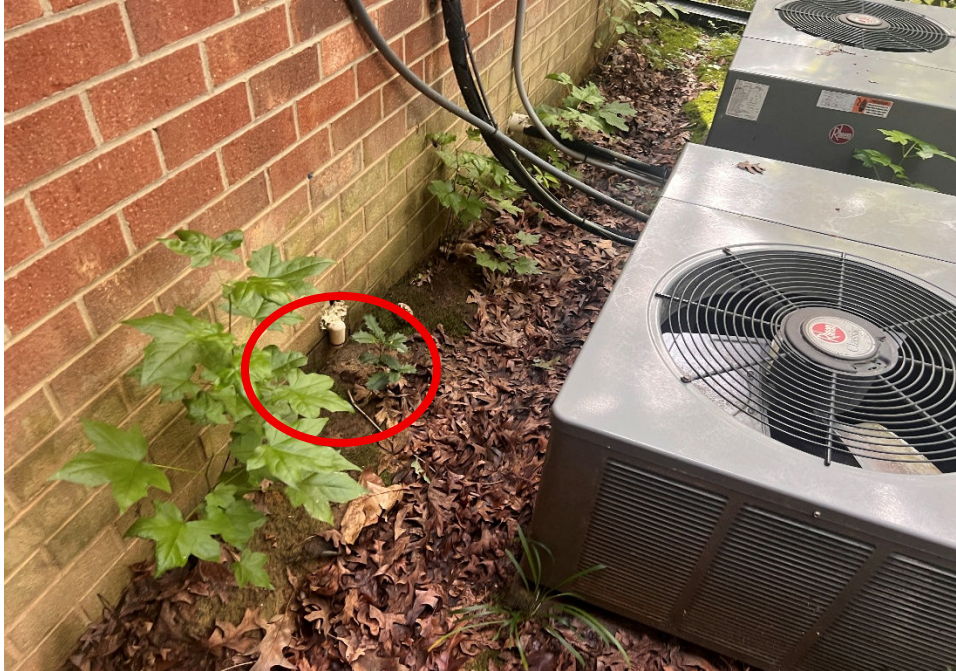
An HVAC condensate line is seen discharging at the base of the foundation in the rear of the home.

The HVAC condensate line that is seen discharging at the foundation is not helping the situation. An HVAC condensate line can discharge a surprising amount of water. During hot, humid days as much as

60 gallons of water can be generated per line. And this water comes out drip by drip, which is the perfect way to fully saturate the earth over time.

The HVAC condensate line is discharging too close to the homes foundation.

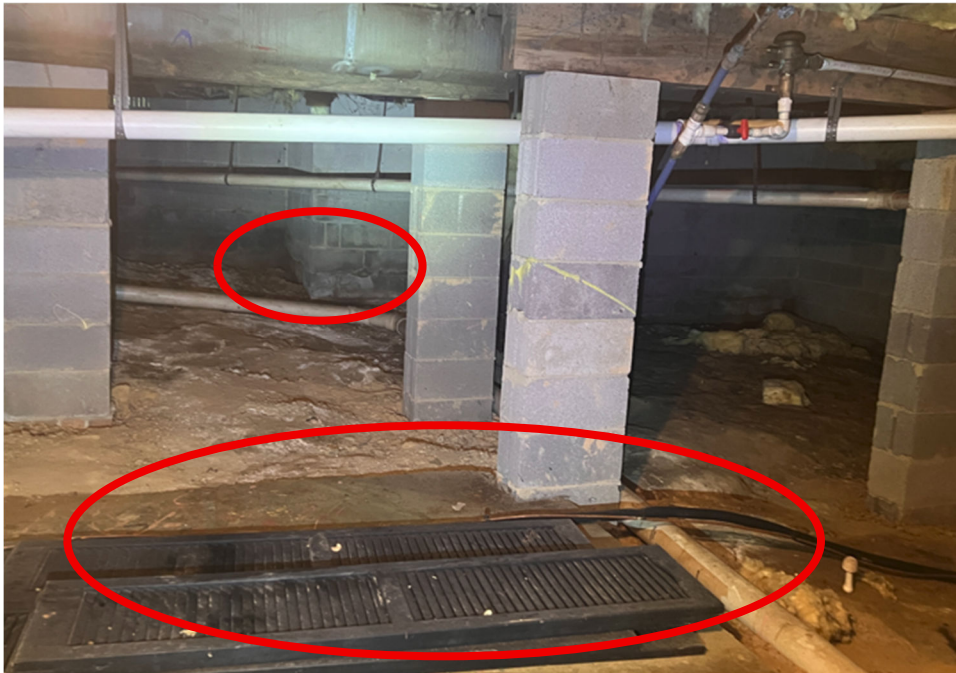
Inspection under the home in the crawl space found damp/wet conditions. Efflorescence stains are seen in places. No vapor barrier is present.

The efflorescence stains in the crawl space are proof that water has traveled under the home. Efflorescence is a crystalline deposit of salts that can form when water is present in or on brick, concrete, stone, or stucco. It has a white or greyish tint and consists of salt deposits left behind when water evaporates. The presence of efflorescence on masonry components is a sure sign that water is present.

Conditions under the home are damp and wet in places. Efflorescence stains are prevalent.

Consider installing a vapor barrier, or having the entire crawlspace encapsulated. Of the two, Obsidian recommends complete encapsulation.

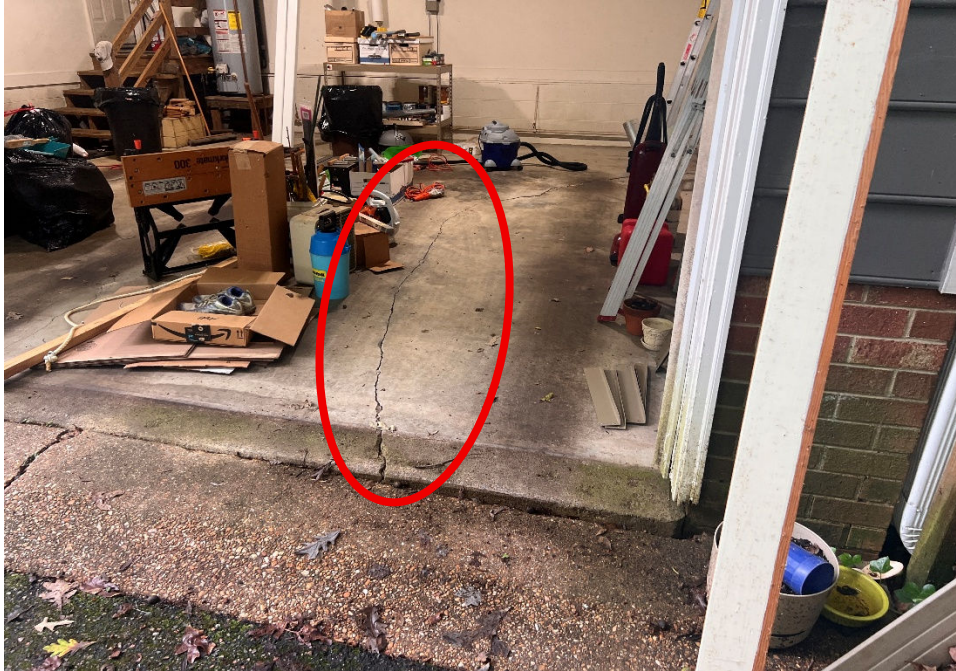
Inspection in the garage of the home finds that the concrete floor is cracked and broken in places. The cracks are mostly located in the rear of the concrete slab, from the halfway point to the rear wall. The slab on the rear wall has sank approximately 4". Horizontal and vertical cracks in the CMU blocks are seen inside the garage.

So, as all this water arrived at the garage, it simply had nowhere to go. The accumulated runoff flowed under the slab to the left rear corner of the garage. As the water traveled under the slab it slowly took the earth under the concrete with it, leaving voids. Eventually not enough soil remained to properly support the concrete slab. When the earth was no longer supporting the slab, it cracked and sunk. The foundation under the left rear corner of the garage sank as the supporting soil became saturated.

The garage slab has cracked in several places.

To correct the garage floor, have a contractor cut and remove the rear half of the garage slab. Regrade the area and add copious amounts of clean #57 stone. Compact the area in layers. Repour the concrete slab back to its original position.

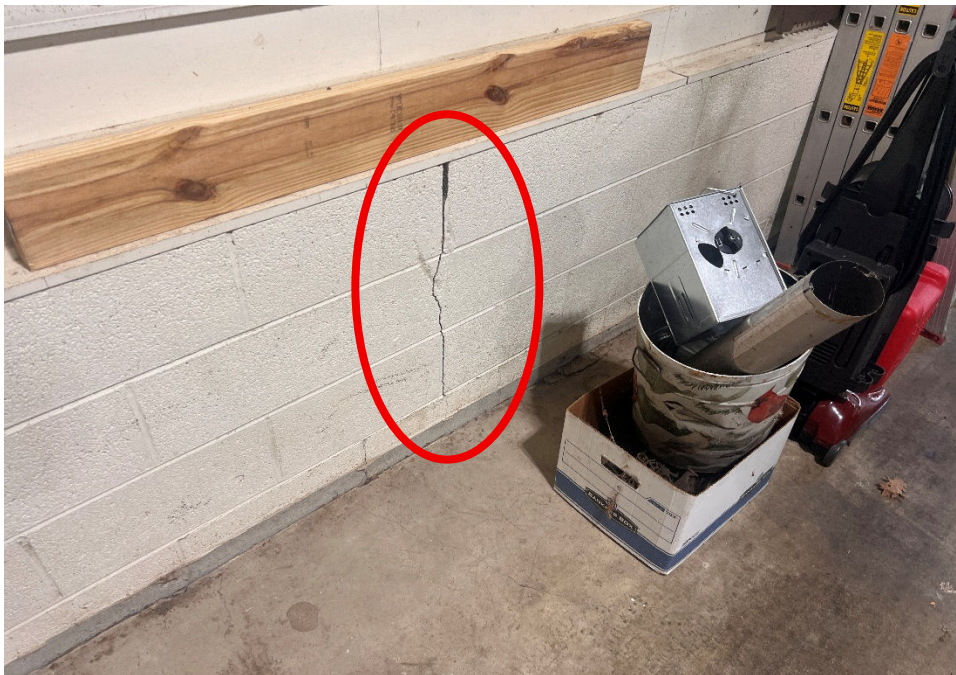
Cracks in the CMU wall in the garage.

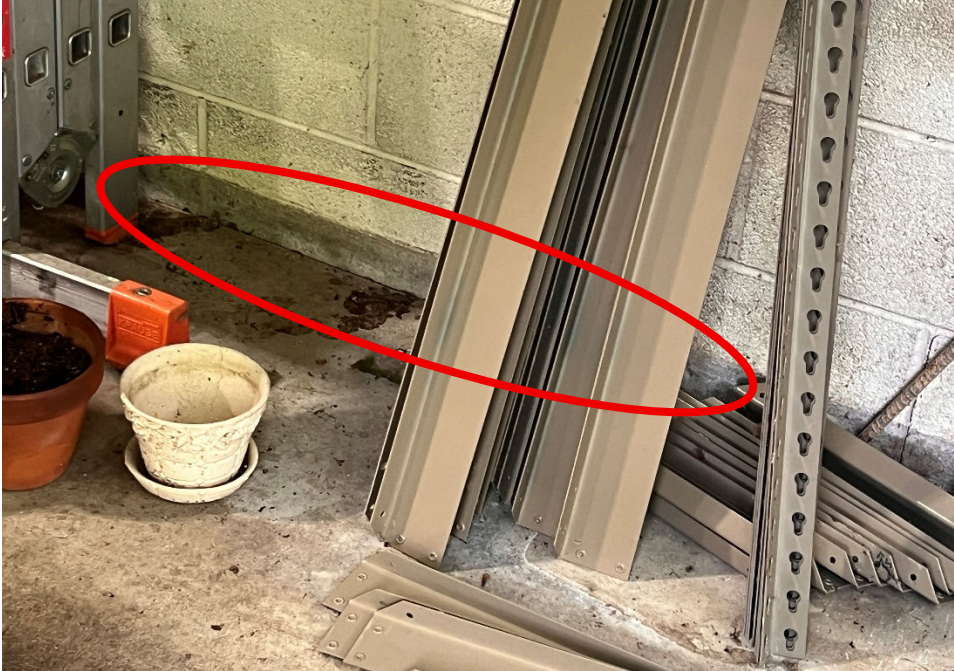
It's also possible that during the original construction of the garage the concrete slab was not properly installed. Quite often this area is back filled with soil excavated from other areas during construction. This soil should have been properly compacted. Stone should have been added, and the stone should have been compacted in layers as well. But it appears that this probably didn't happen, or if it did, it wasn't done to code requirements.

The concrete slab has sunk approximately 4 inches.

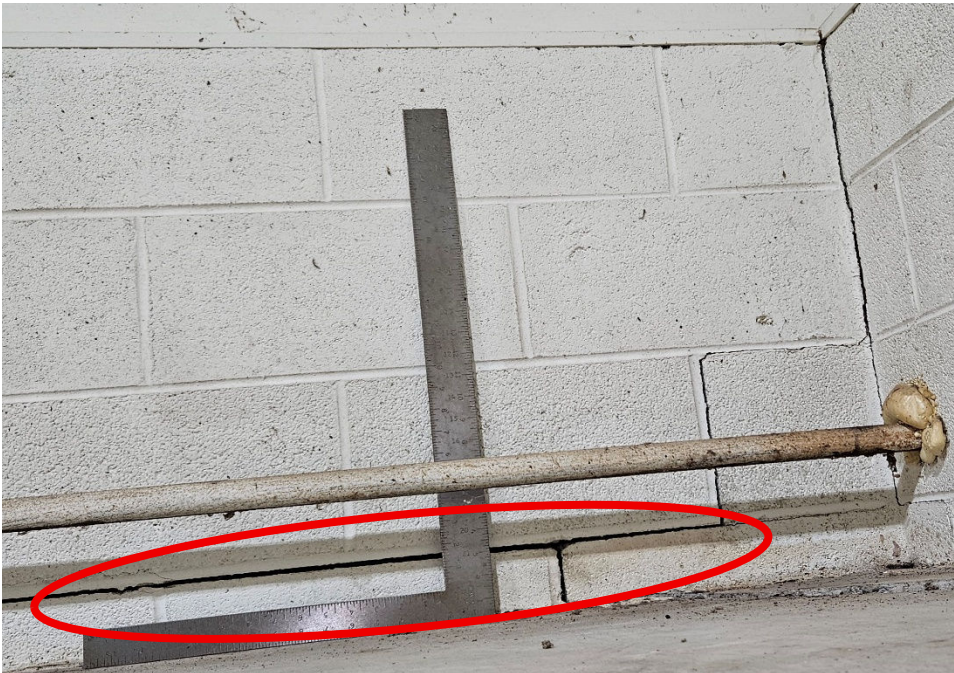
Horizontal and stair step cracks in the garage.
