**Cranor Inspection Services, LLC**

# Inspection Report

**8939 Cardiff Rd, Richmond, VA 23236**

Yr Blt:1987 Sq Ft: 3180

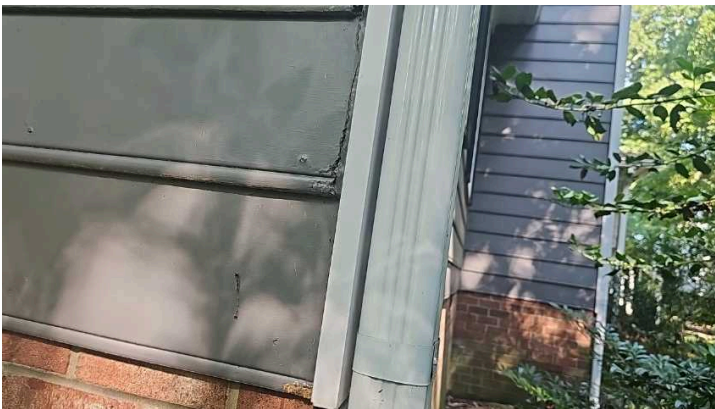
**1.2. Hardboard siding is swollen from water penetration and has moisture damage in scattered spots, the following areas were identified as the worst: left front corner, front right corner, near front porch, right along roof, right front inside corner, right front behind shrub, rear at garage window, left at window, left along roof. Recommend correcting.**

Left front corner - siding moisture damage

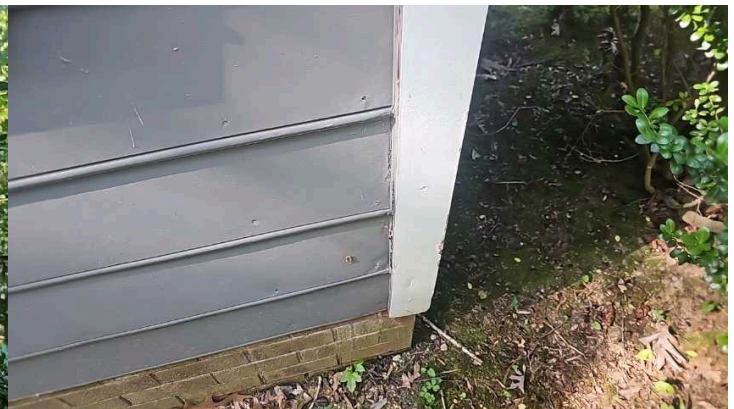
Front right corner - siding moisture damage

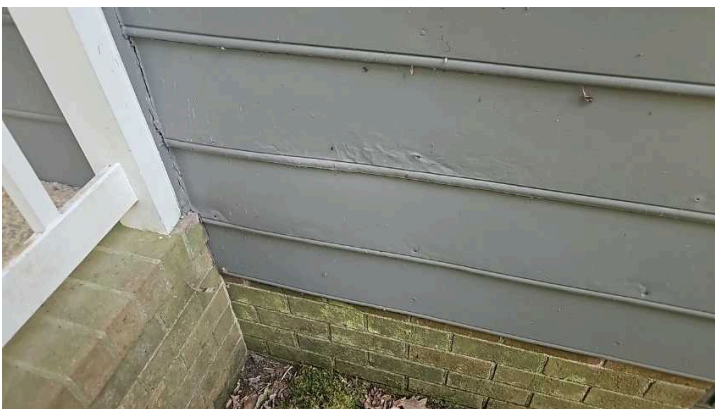
Front near porch- siding moisture damage

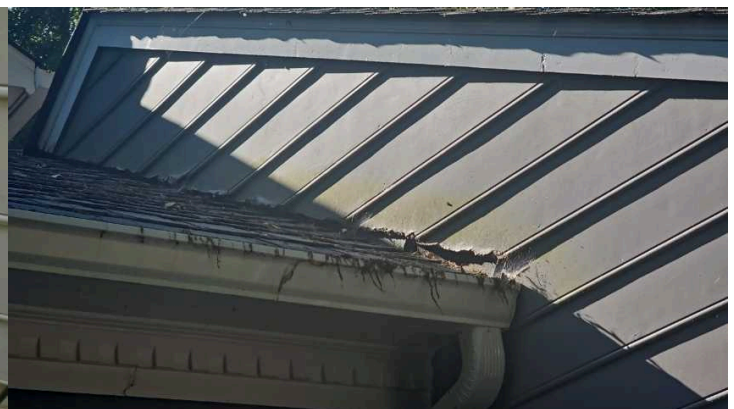
Right along roof - siding moisture damage

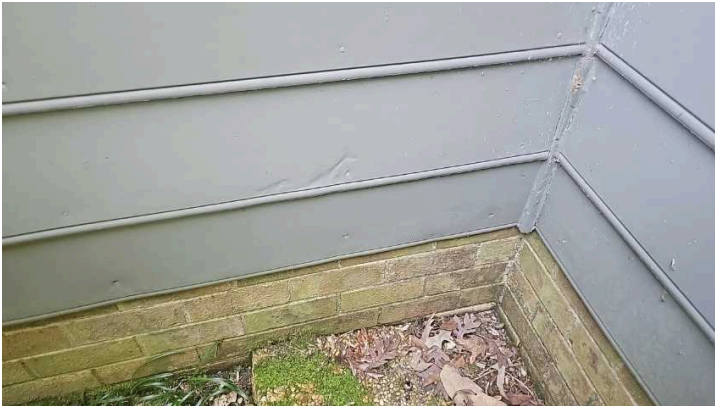
Right front inside corner- siding moisture damage

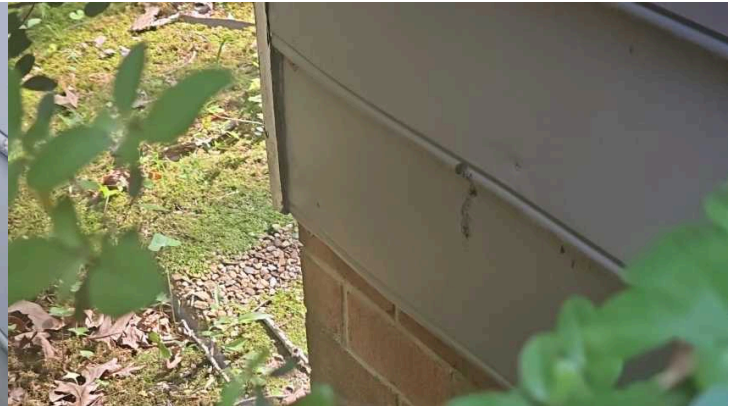
Right front behind overgrown shrub- siding moisture damage

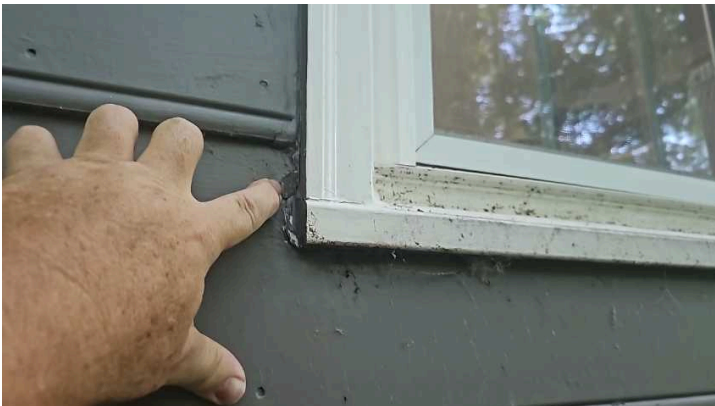
Rear right at garage window- siding moisture damage

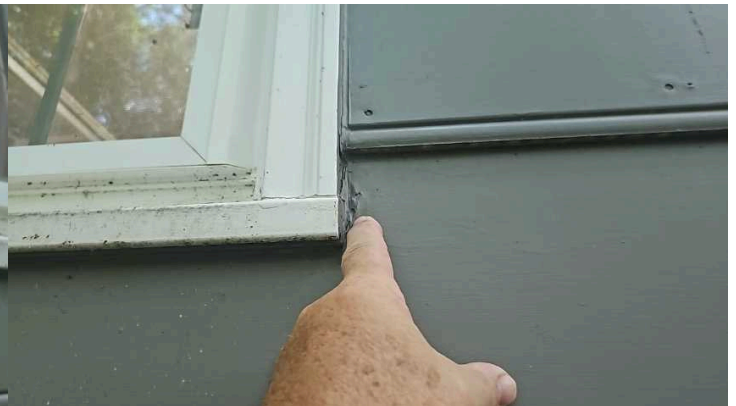
Rear right at garage window- siding moisture damage

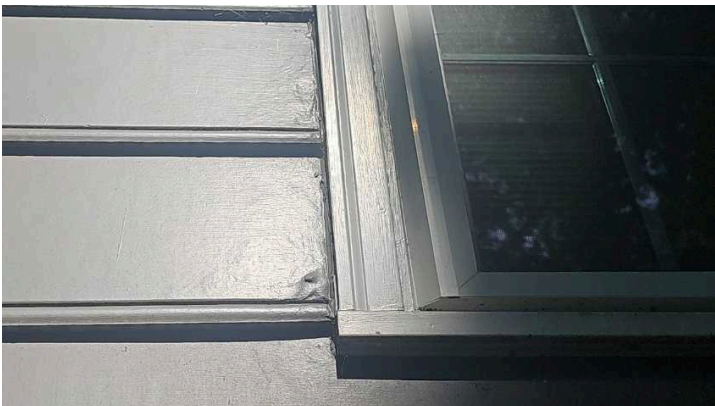
Left at window- siding moisture damage

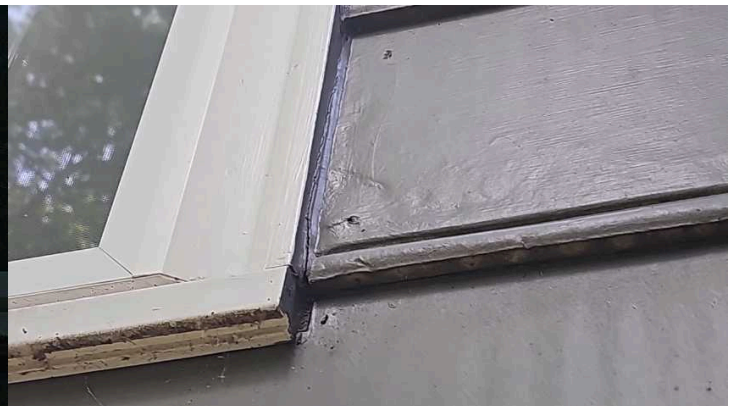
Left at window - siding moisture damage

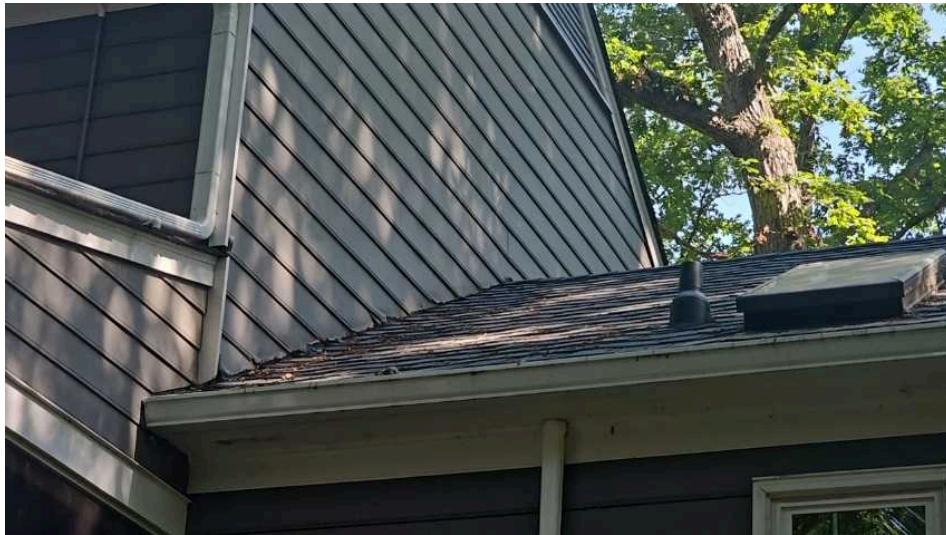
Left rear along roof- siding moisture damage

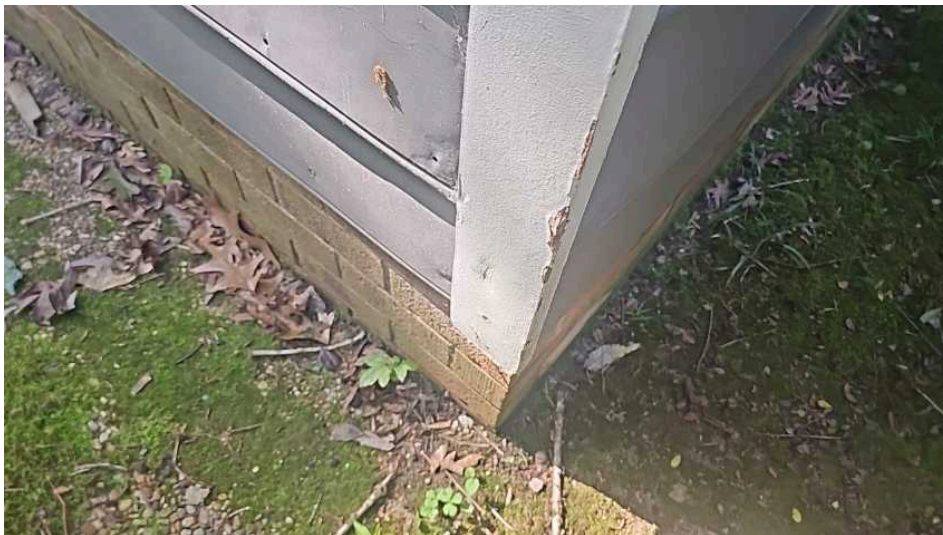
**2.2. Moisture damaged wood composite corner trim .on front right.**

Front right corner trim damaged

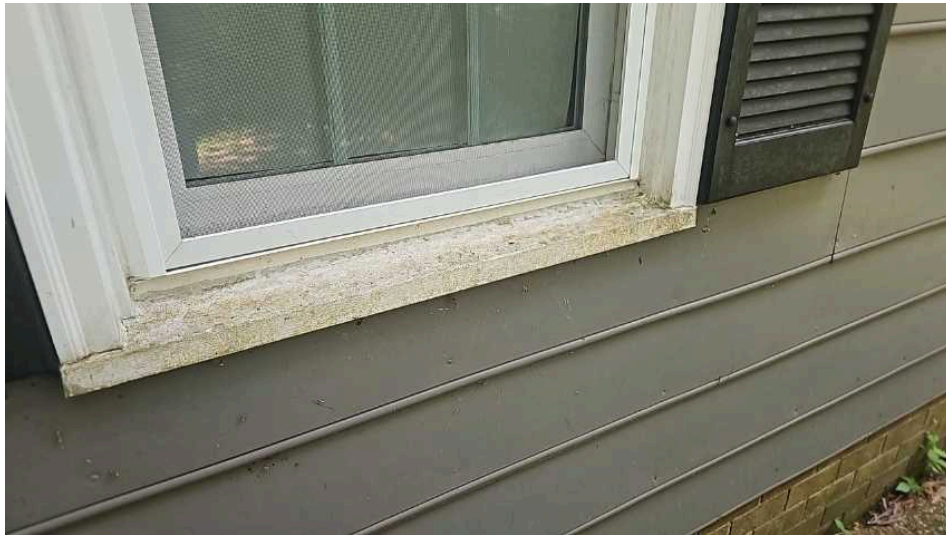
4.1. Recommend immediate maintenance on window trim.

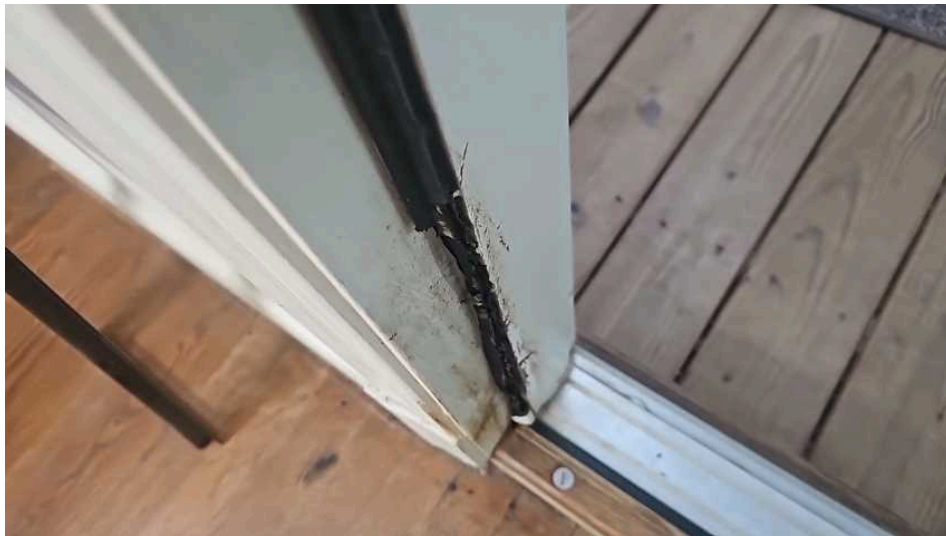
7.1. The weather stripping around the door is damaged and/or not functioning properly.

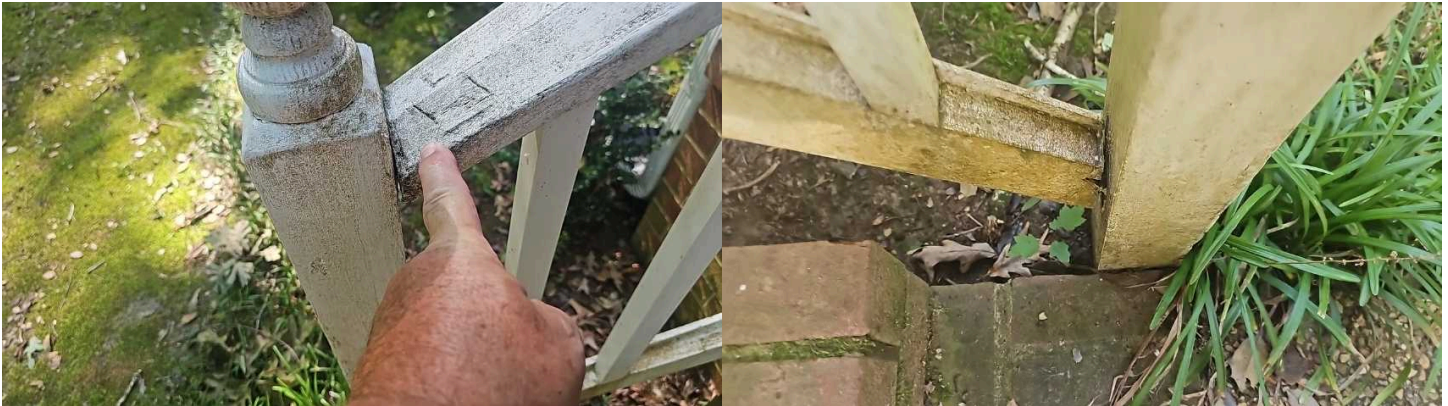
8.1. The railing on steps is separated from vertical post and loose. Railing needs repairs and maintenance.

Loose

Loose railing

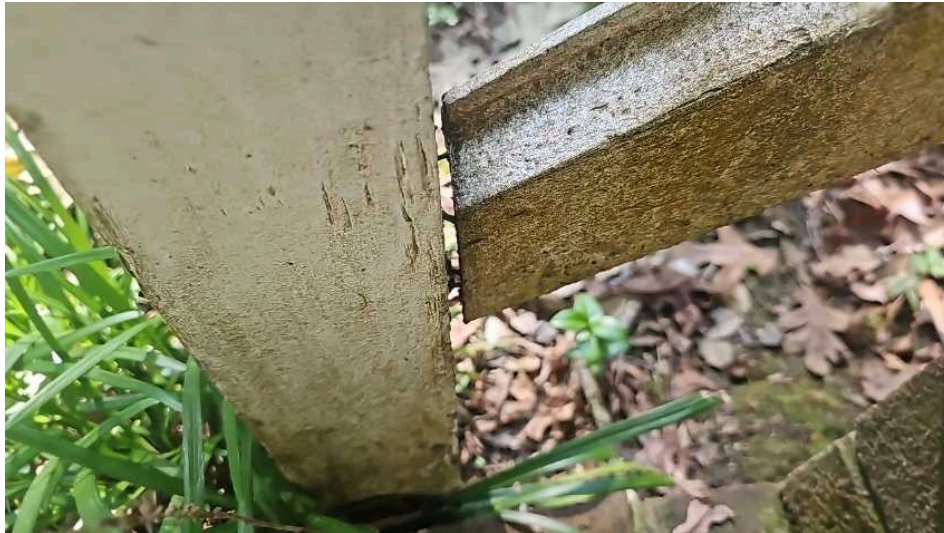
Separation in railing

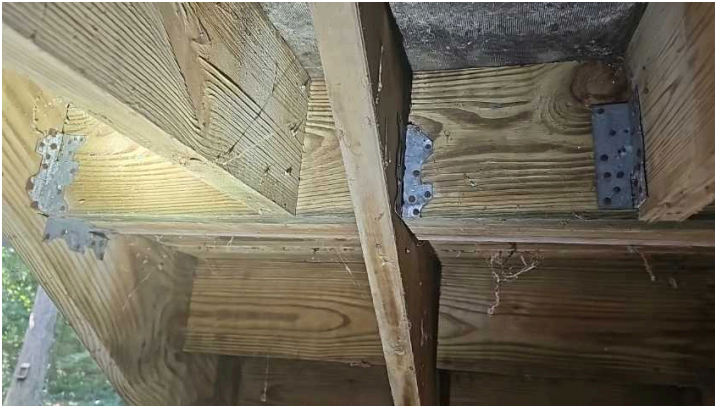
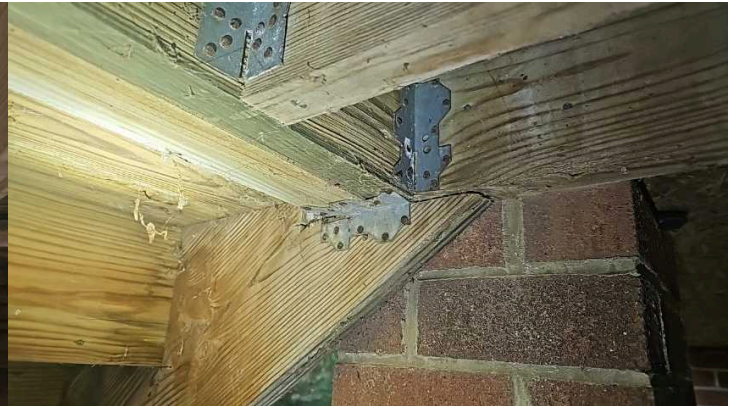
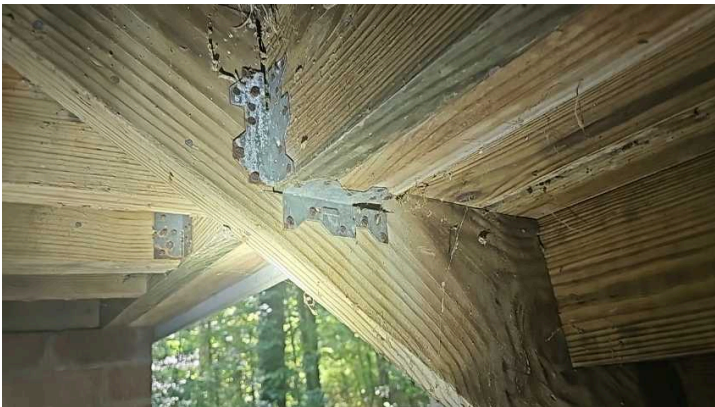
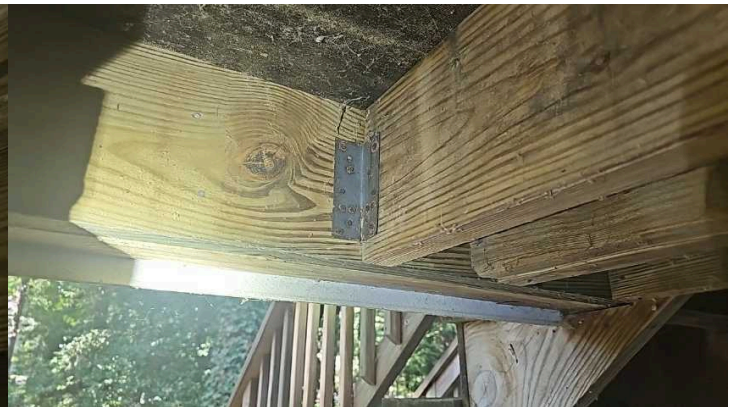
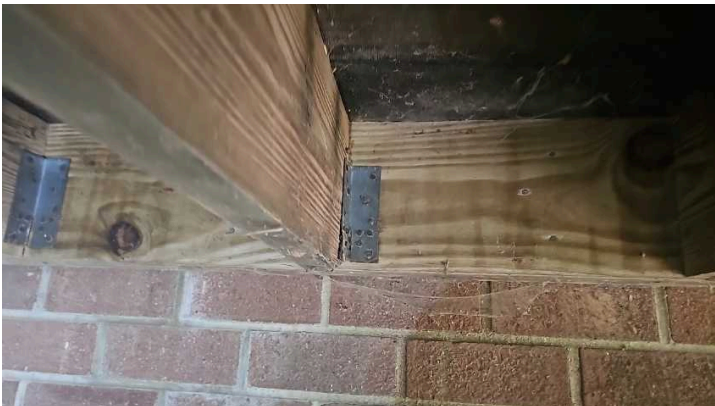
9.1. The porch steps and railing is weathered. The stair structure appears to have settled on one side causing it to be un level. The nails in the porch floor structure metal framing brackets are rusty. Framing brackets used are no longer considered acceptable however was commonly used when built. Recommend repairs and improvements.

Metal framing brackets has rusty nails

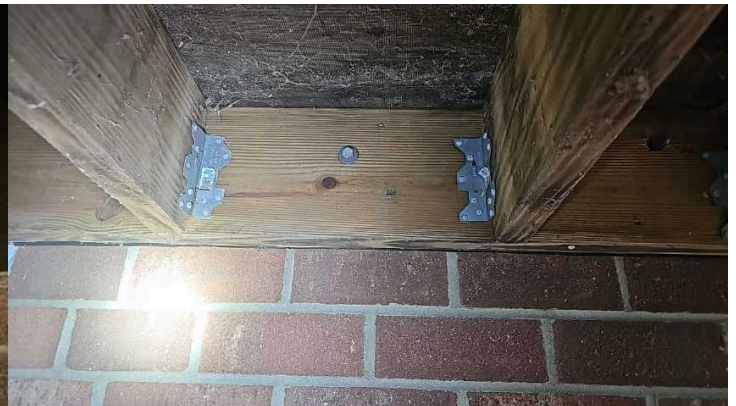
Some nails are not rusty

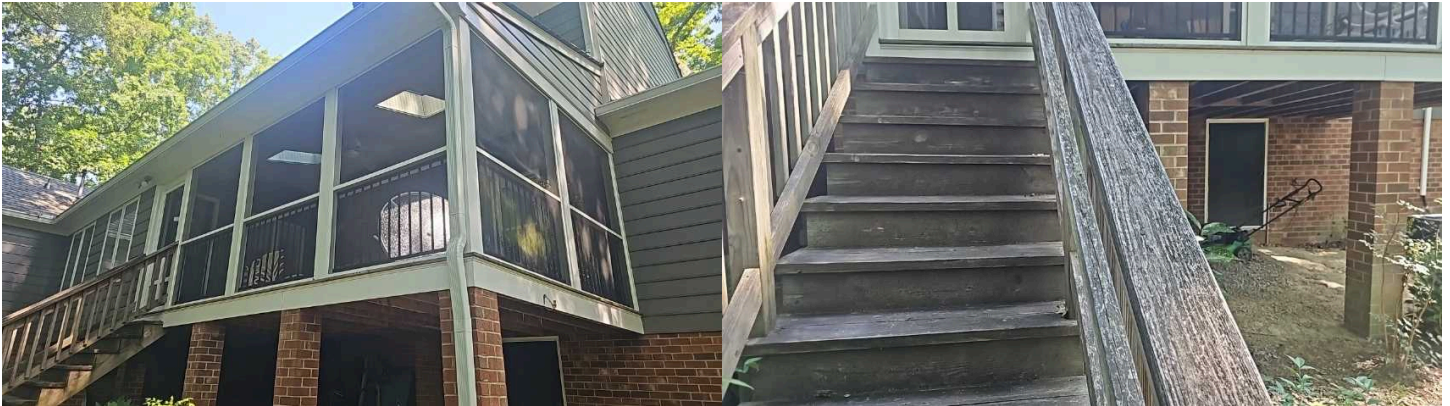
Weathered

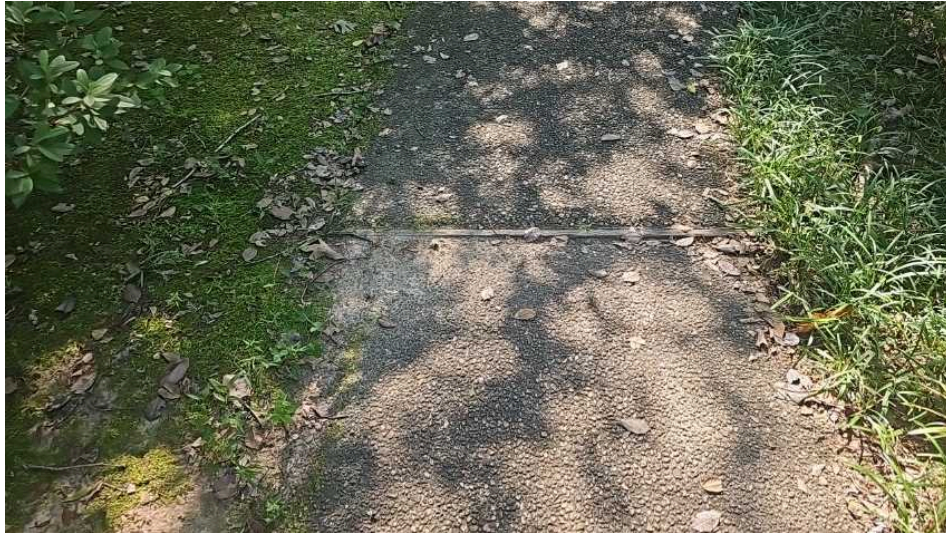
10.1. The concrete walk has settled in one area creating a variation in the elevations which is considered a trip hazard.

Trip hazard

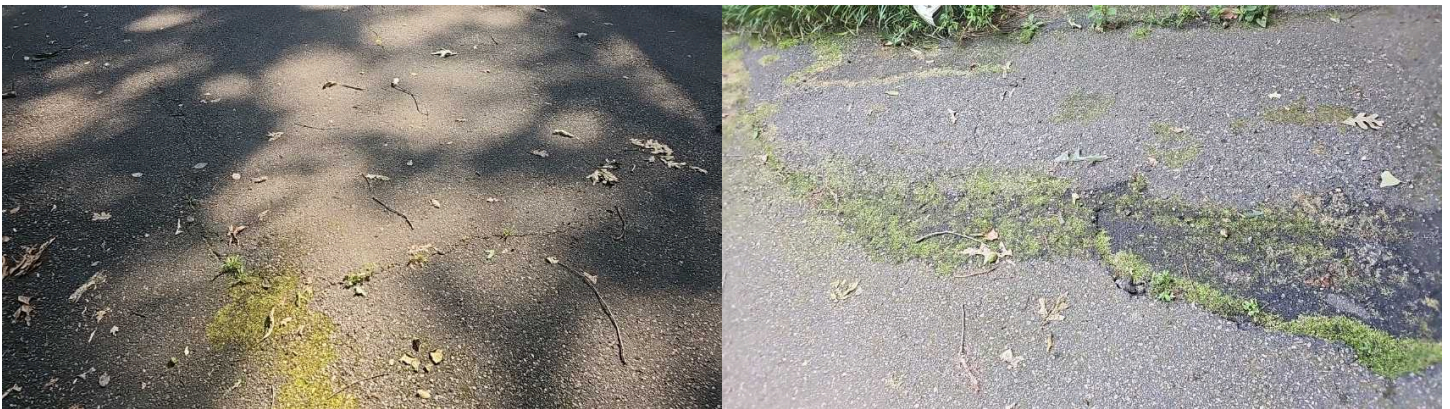
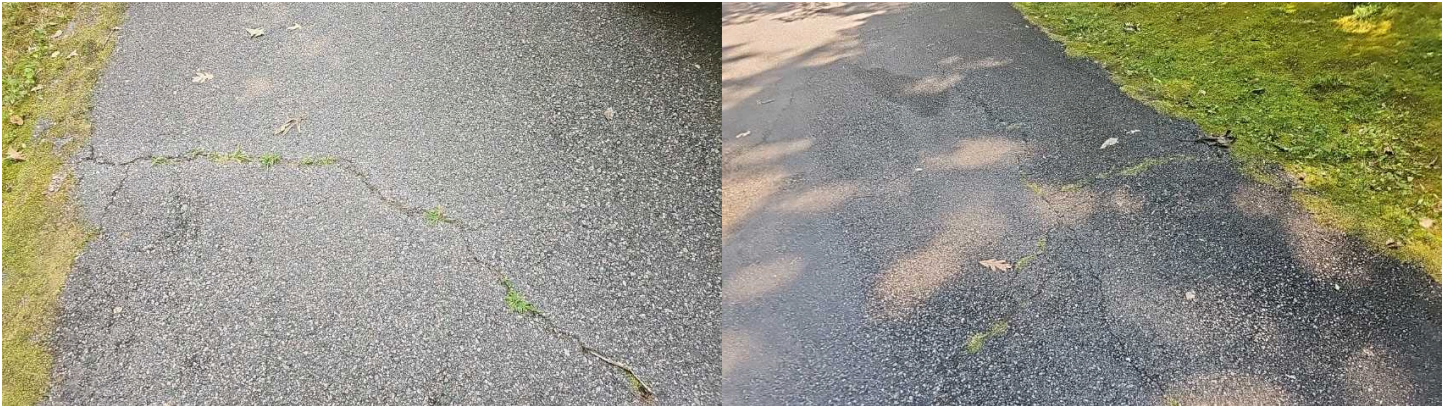
11.1. The driveway has cracks & deterioration that is typical of an older asphalt driveway.

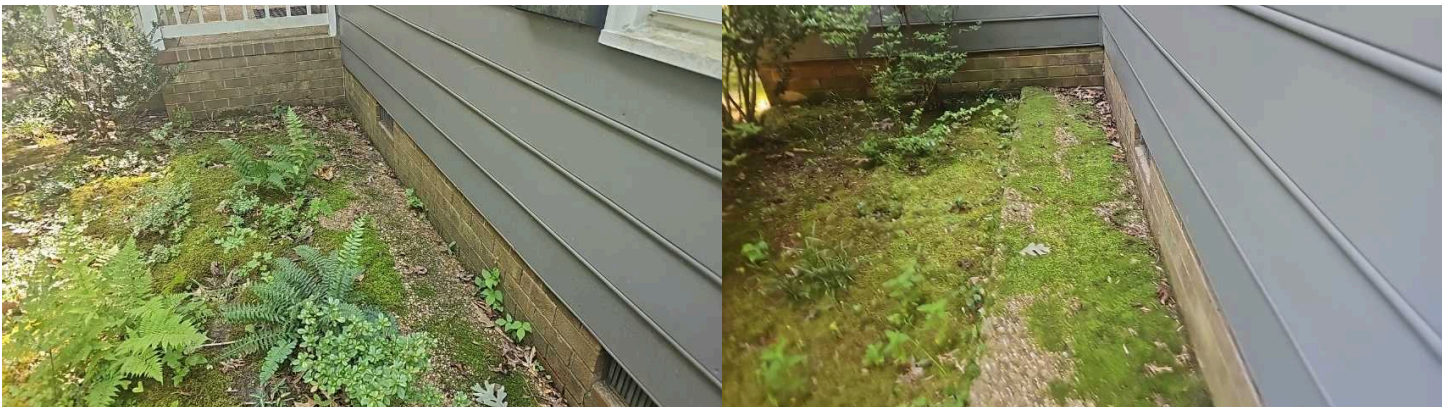
**12.1. The grade and drainage around the home is poor and the crawl space is wet. There is a concrete apron along the front that was originally designed to catch roof drainage (prior to gutter being installed). The concrete apron has settled and rotated in the wrong direction. As a result the foundation adjacent to the apron visible from crawl space is wet. The concrete apron is also covered with moss. There are numerous sunken holes along the front and a larger sunken spot on rear near the porch. Recommend filling in holes and sunken areas, and regrade so surface water drains away from the foundation. The grade should fall a minimum of 6-inches within the first 10-feet. Ideally the concrete apron should be removed but if fill dirt is trucked in, it is possible the concrete can be buried during the regrading.**

Concrete apron is rotated and sloped wrong direction

Concrete apron is rotated and sloped wrong direction / moss covered

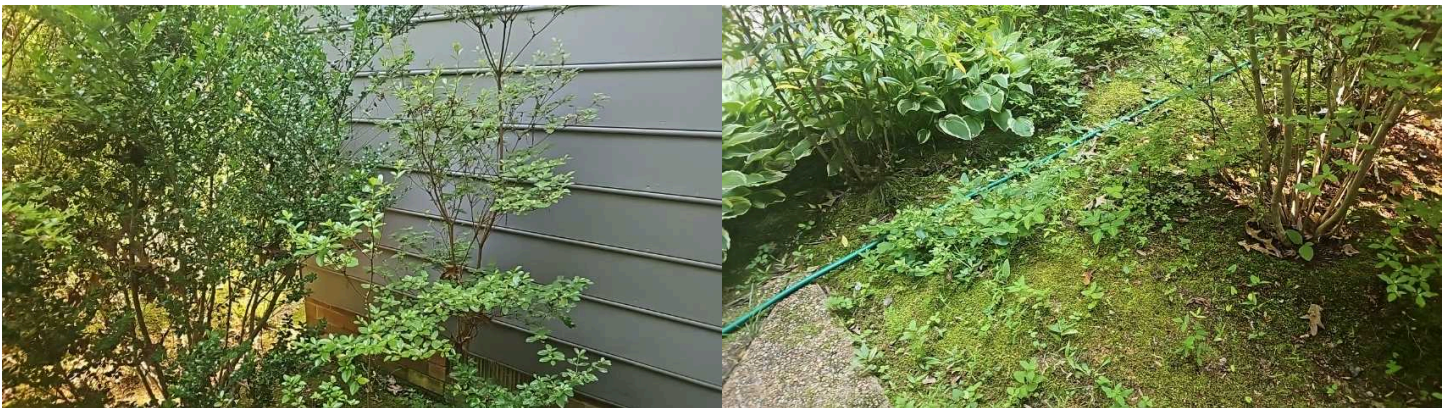
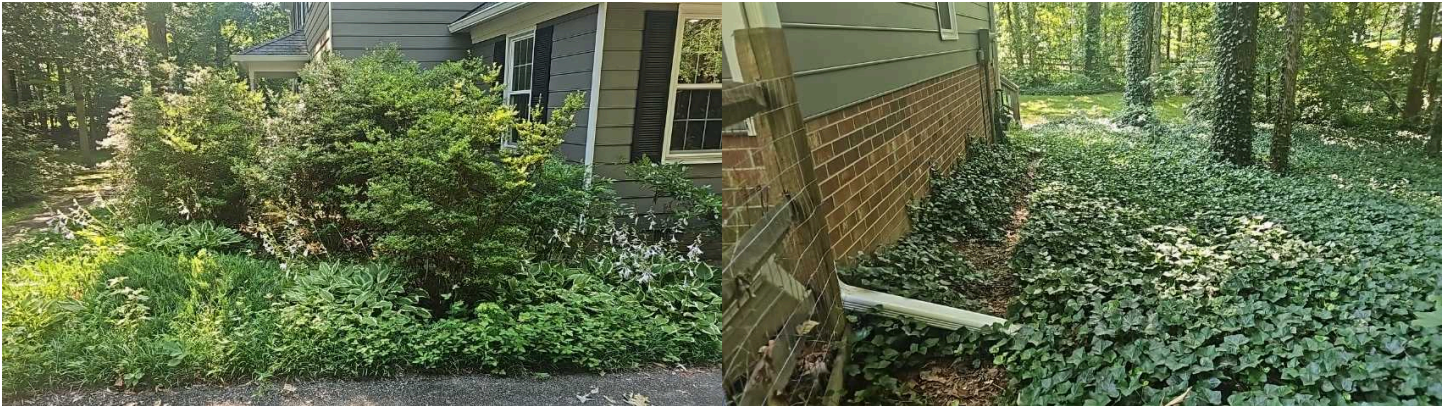
13.1. Vegetation around the home is overgrown. There is Poison Ivy/ Poison Oak growing on home on rear left. There is thick vine growth in rear yard. Recommend trimming back / removing as necessary.

Ivy vegetation is overgrown

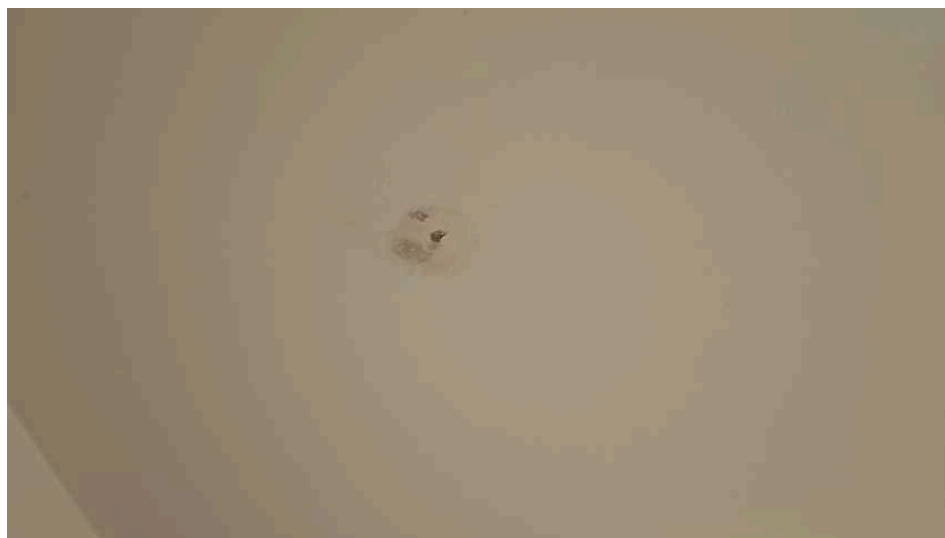
2.1. There is a moisture stain in upper rear middle bedroom. The stain is an old stain that occurred before the new roof was installed.

Stain in Upper rear middle bedroom...old

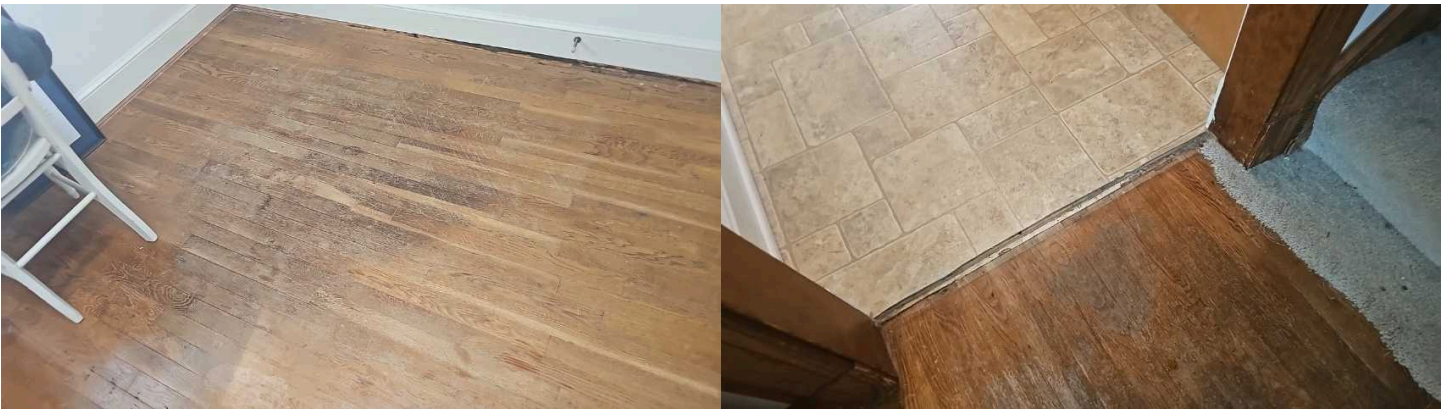
3.1. The floor coverings are worn and stained.

3.2. Missing a transition strip at entrance to kitchen and bottom of stairs.

Dark stain on hardwood flooring

Missing transition strip at entrance to kitchen

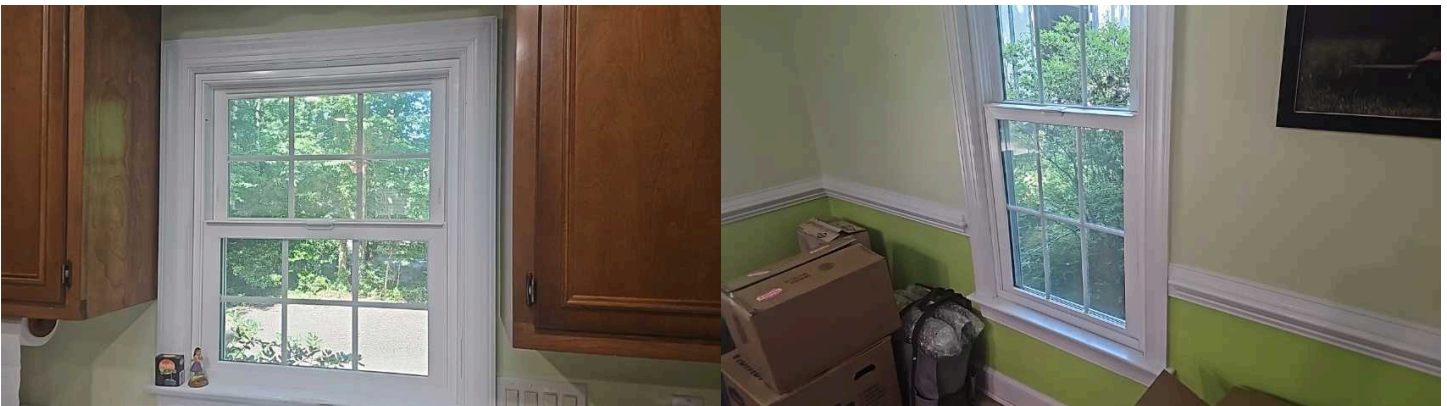
4.1. The following insulated glass windows have seal failure (fogged): kitchen, eat in kitchen. 3 in Florida room.

Fogged

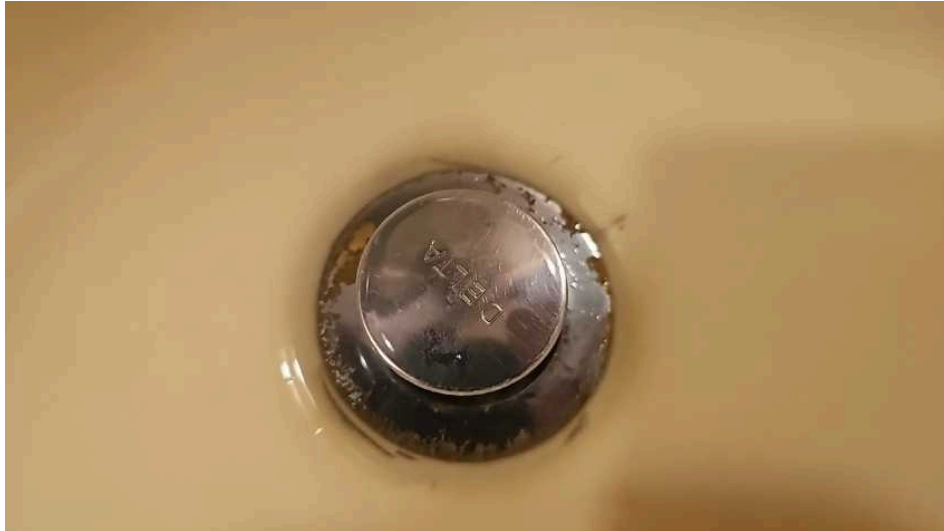
2.1. The cultured marble sink has discoloration around the drain which is considered a typical cosmetic issue for the material.

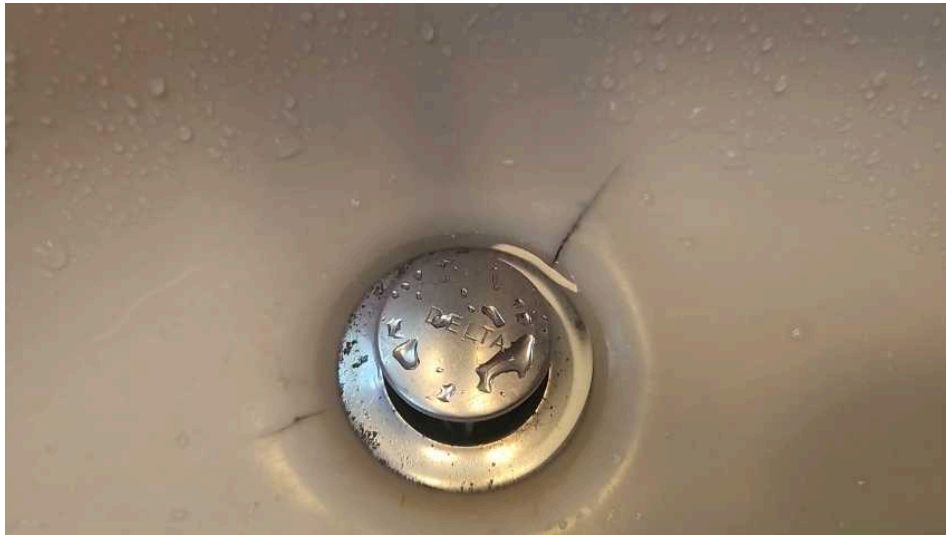
3.1. The cultured marble sinks have surface cracking and/or discoloration which is not unusual for the material. No leak observed. Considered a cosmetic issue.

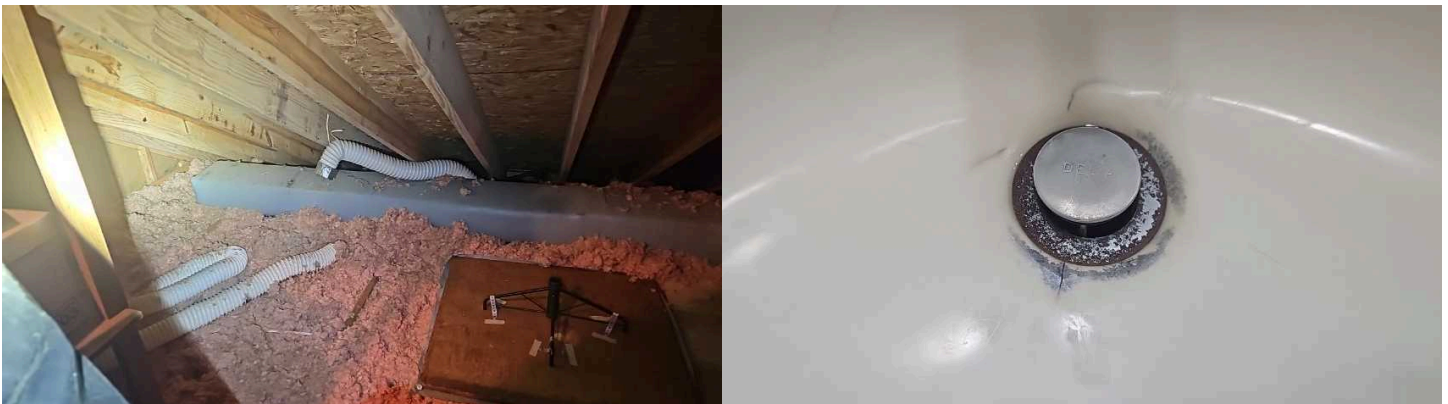
Exhaust duct disconnected in attic

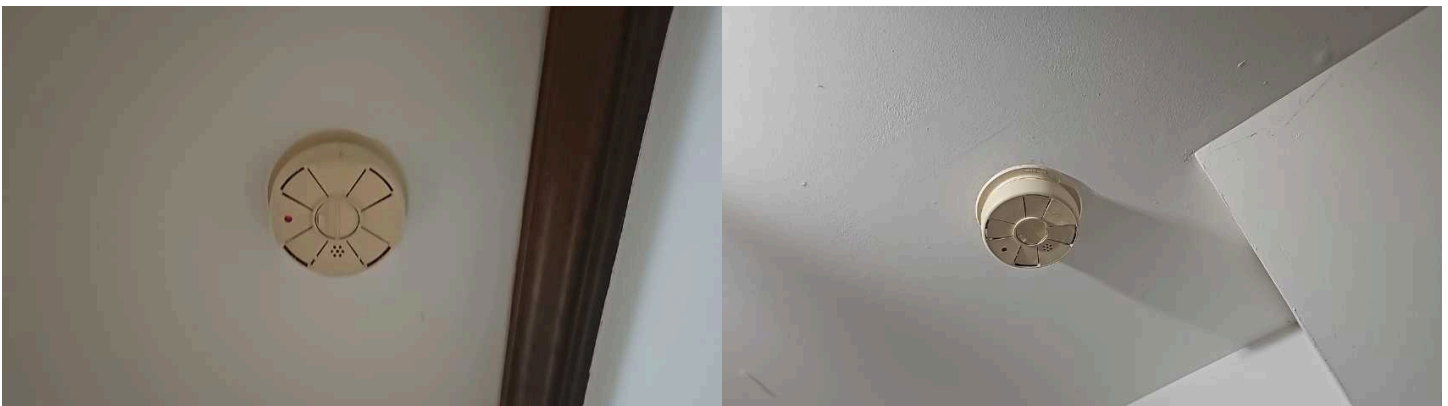
**1.2. The smoke alarms are old and beyond their expected service life. Recommend replacing alarms.**

Old smoke alarm

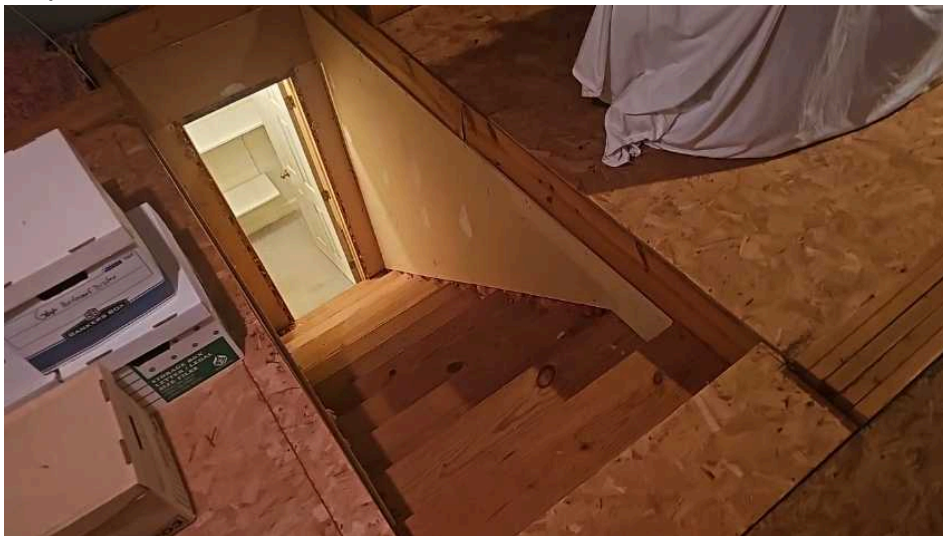
1.1. No handrail on walk up attic stairs and open around top. There probably was no requirement for handrail or guardrail around the top when this home was built but its still considered an unsafe concern. Safety improvement recommended.

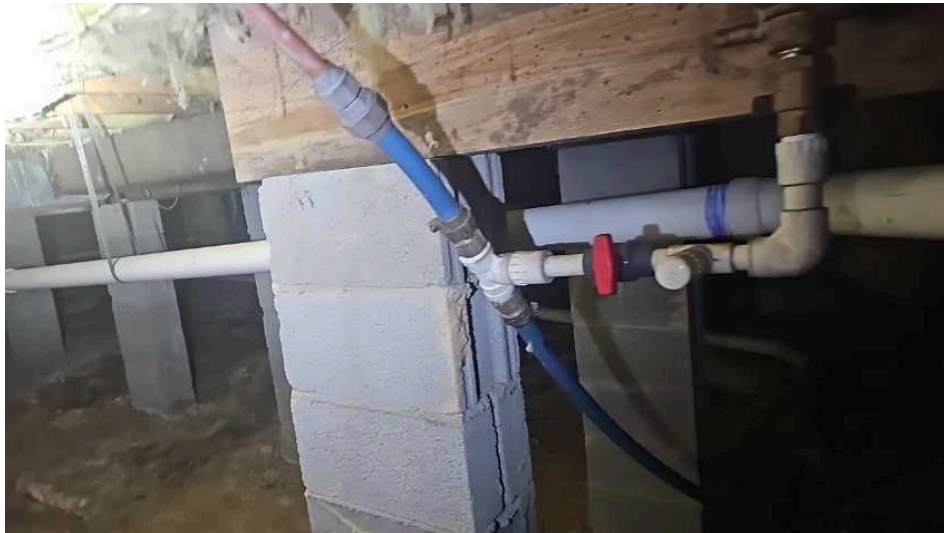
1.1. Polybutylene was a commonly used plumbing material from about 1978 through the middle 1990's. The material was involved in several class action settlements (all now closed) due to problems with leaking. More information is available on the web or at: [http://inspectapedia.com/plumbing/PB\\_Piping.php](http://inspectapedia.com/plumbing/PB_Piping.php) If concerned, please consult with a Licensed Plumbing Contractor.

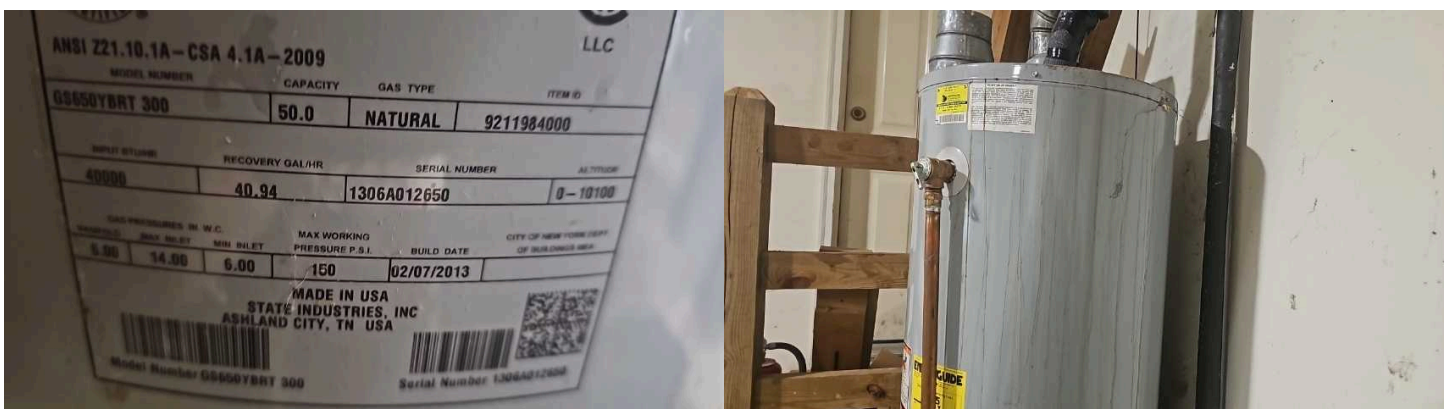
2013 model

1.1. There are moisture stains trailing down the water heater. I suspect these stains are from a past roof leak.

**1.3. The water heater located in the garage has no barrier to protect it from impact. The generally accepted construction practice as well as the gas company recommends that appliances in garages be protected from impact from automobiles.**

**1.4. The metal flue vent sections serving the gas water heater are not secured together properly, there should 3 screws per joint. Recommend correction.**

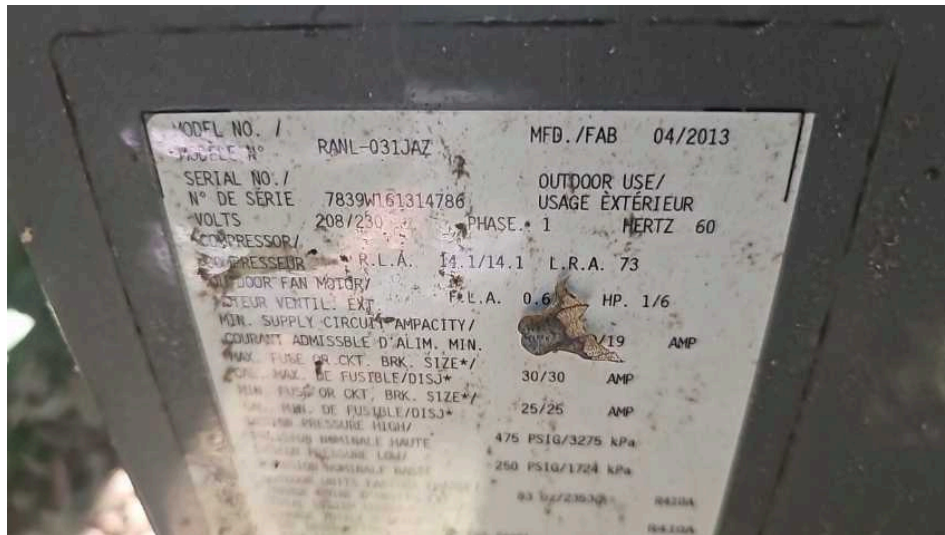
2013 model

3.1. System is near end of its expected service life

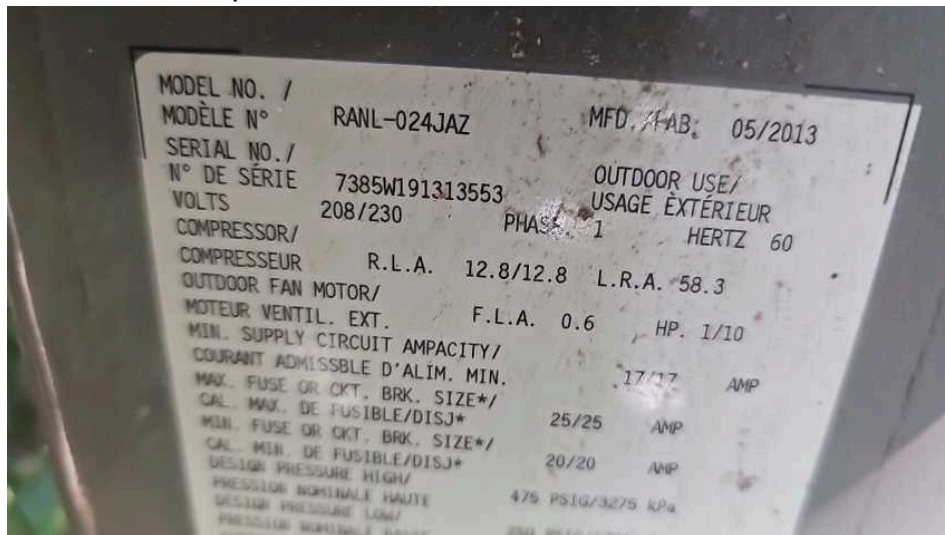
2013 model

4.1. System is near end of its expected service life

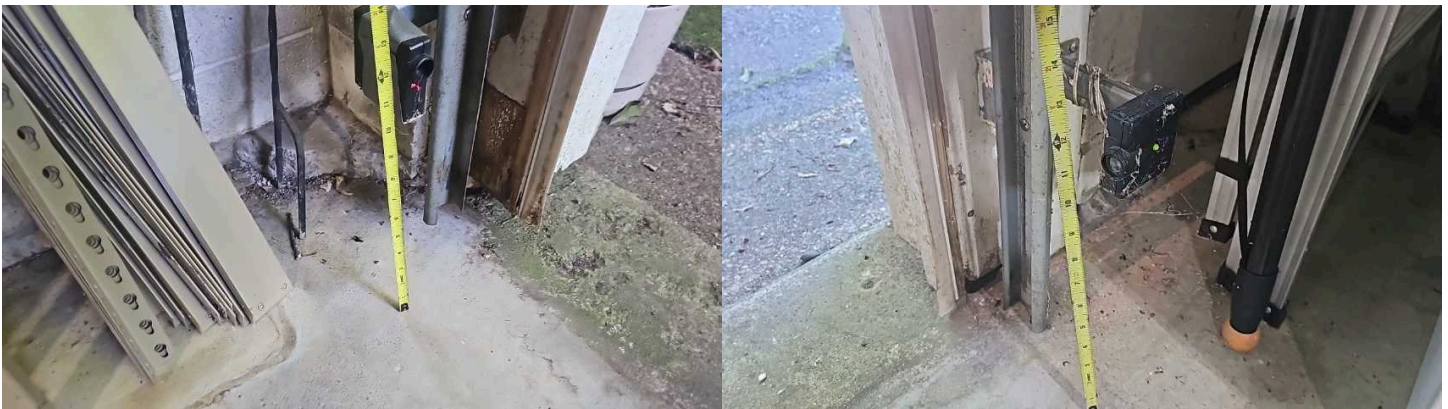
1.1. The garage vehicle door opener photoelectric sensors that reverse the door are improperly installed too far off the floor which is unsafe. There is a serious risk of injury, particularly to children and pets, under this installation. The safety sensors should be installed within 4 to 6 six inches of the floor. Recommend having evaluated and corrected by a licensed garage door contractor.

Photo sensor measuring 12" off floor on side where floor has settled

Sensor measuring 11" off floor

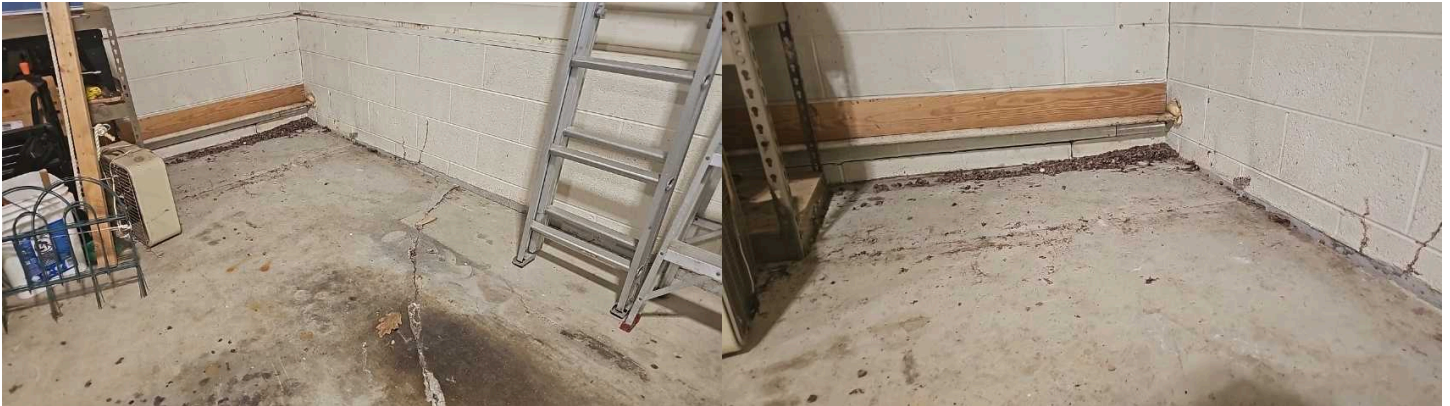
3.2. The garage foundation has significant vertical and horizontal cracking and obvious settlement. The concrete floor slab also has cracking and settlement. Recommend having evaluated by a structural engineer and have repaired by a licensed foundation contractor.

Unusual horizontal crack in foundation

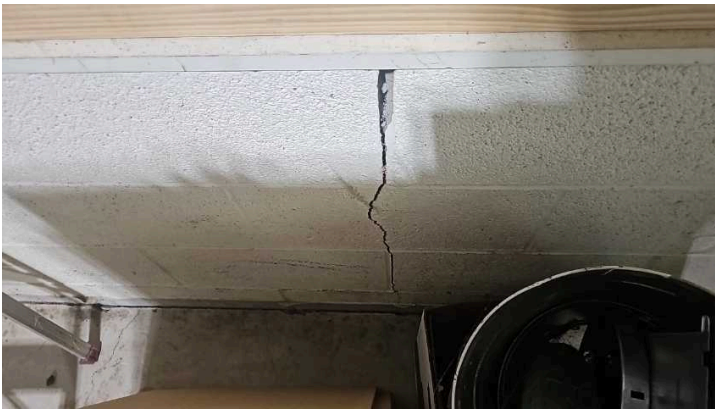
Unusual vertical crack in foundation

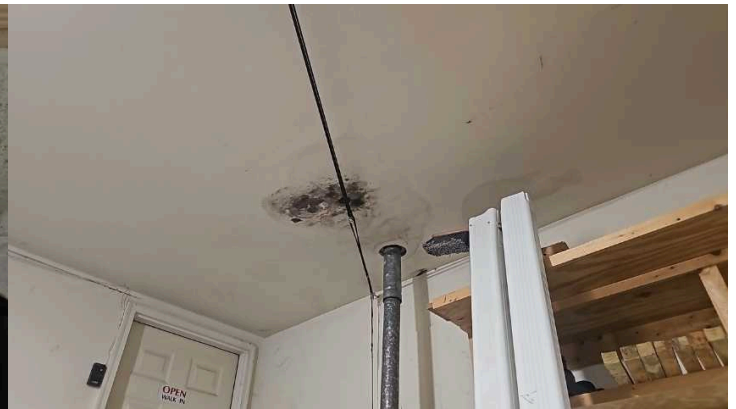
3.1. There are large moisture stains in in garage ceiling over the water heater. The stain is an old stain that occurred before the new roof was installed. The stain appears to have a black fungal like growth that probably should be corrected.

Large black stain

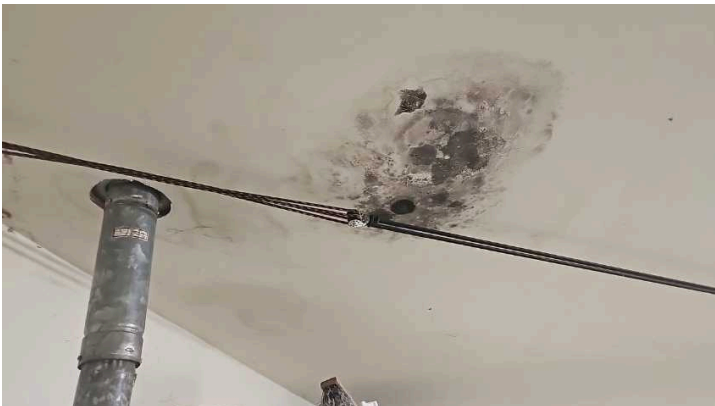
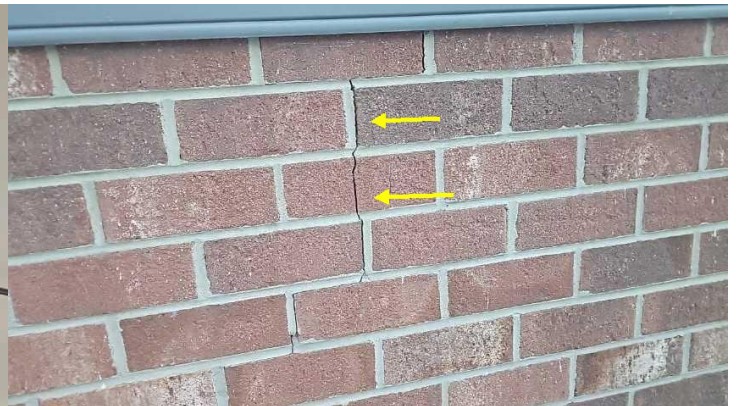
Cracking in brick on rear exterior of garage
