**Cranor Inspection Services, LLC**

# Inspection Report

**8939 Cardiff Rd, Richmond, VA 23236**

Yr Blt:1987 Sq Ft: 3180

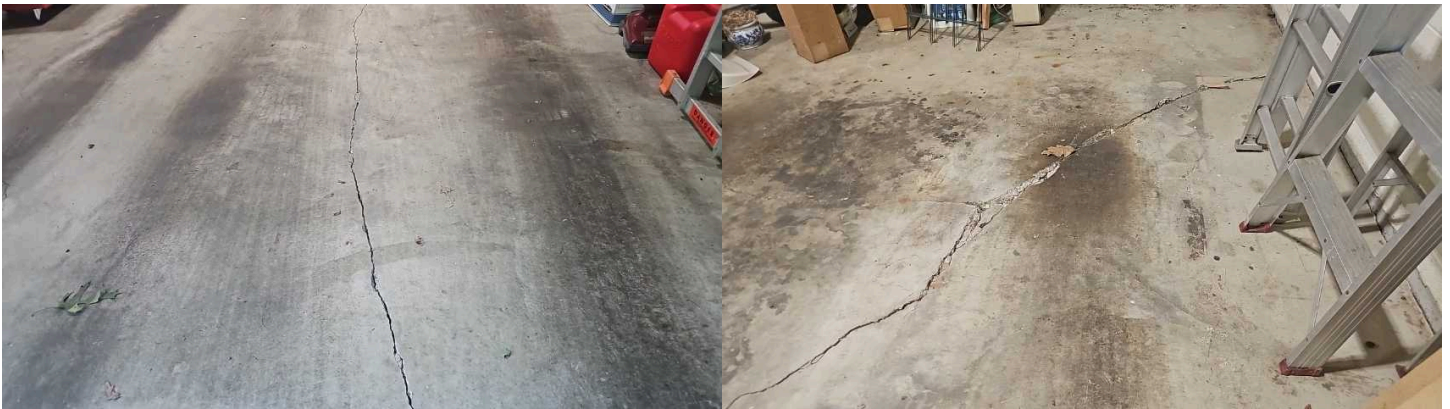
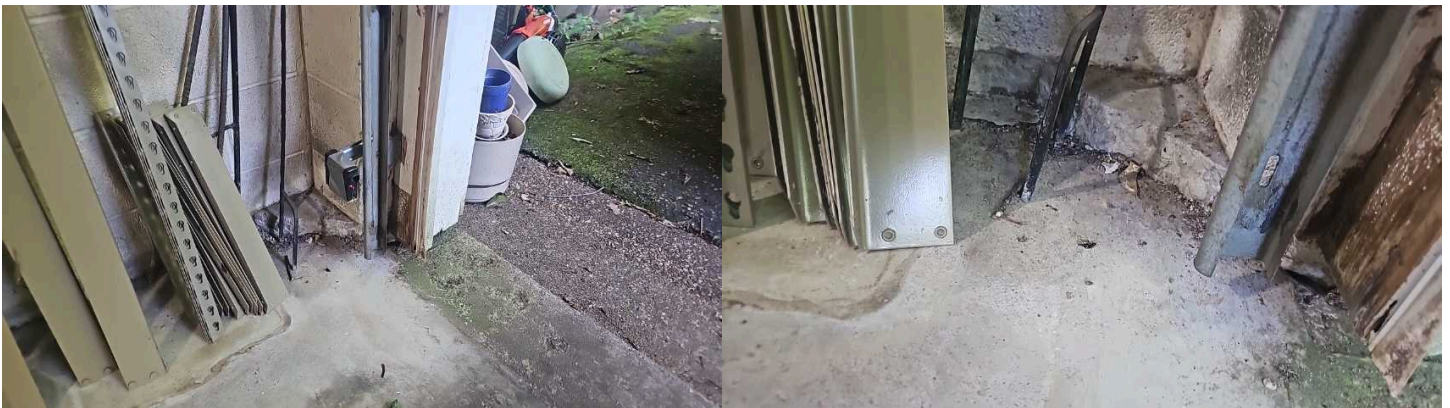
4.1. The concrete slab has cracked and settled down at least 3-inches along the rear. Also see garage structure comments. The degree of settlement is more than normal which may require demo and re pour.

Concrete settled at least 3"

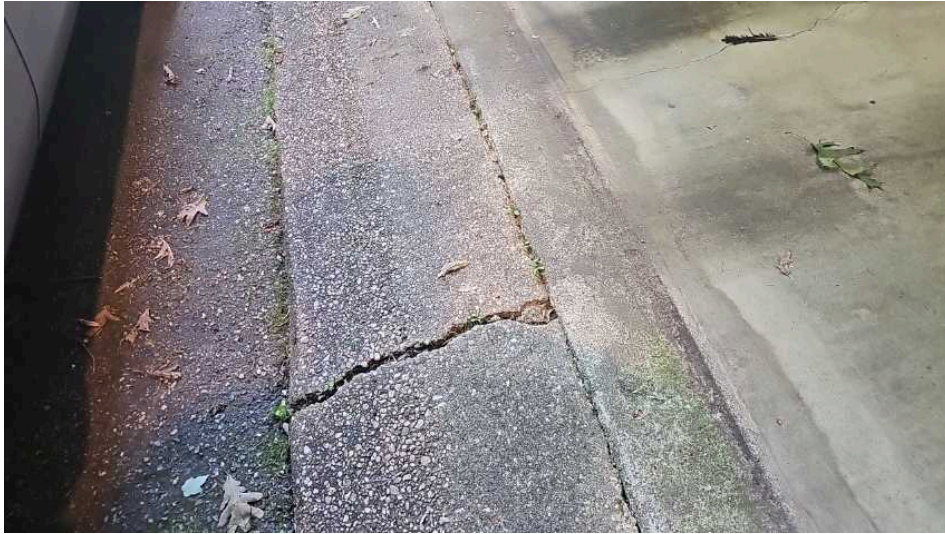
Concrete apron at garage door is cracked

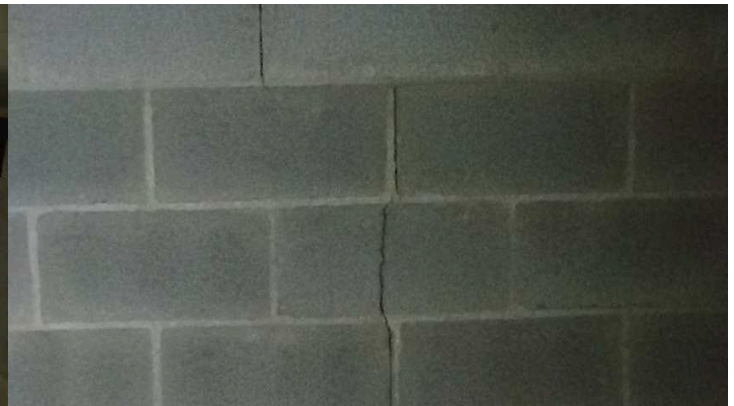
Unusual cracking in foundation on far left

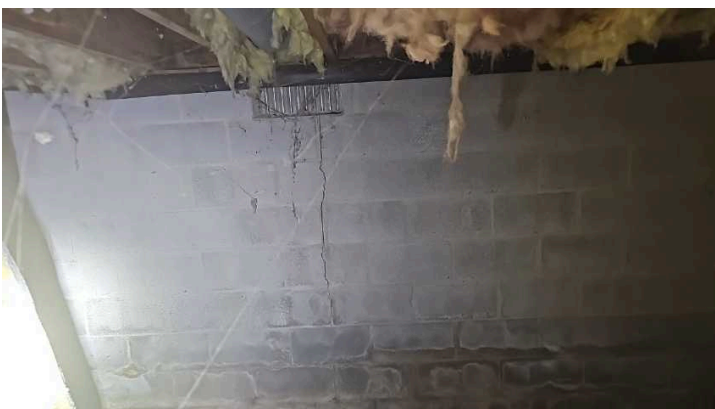
Unusual cracking in foundation on far left

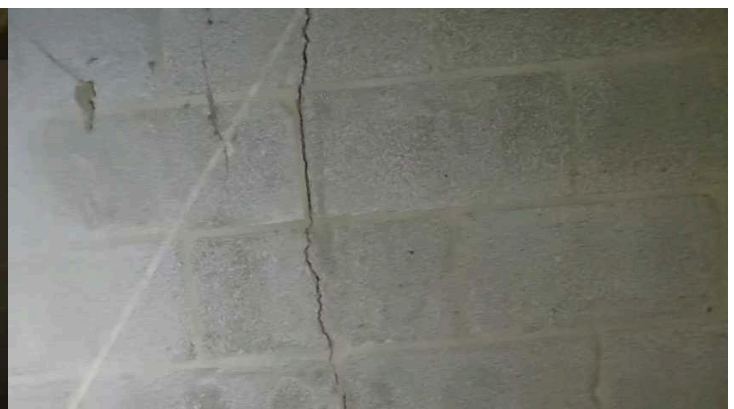
Unusual cracking in foundation on far left

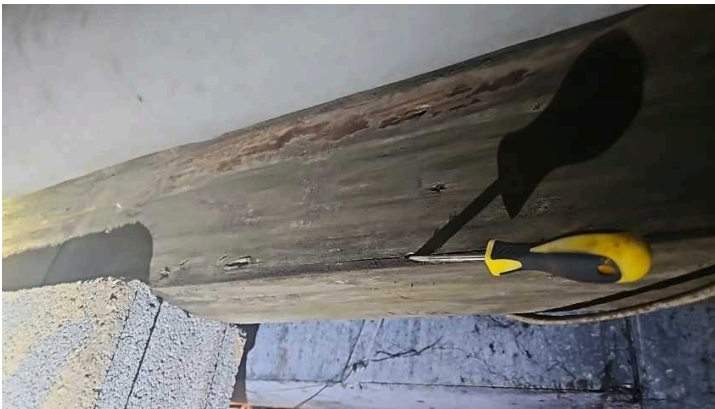
3.1. The floor structure including the main support beam and joists have moisture related damage (rot). The floor structure is covered with a dark fungal like growth. Recommend having floor structure evaluated and repaired by a licensed contractor.

Probing rot on floor structure

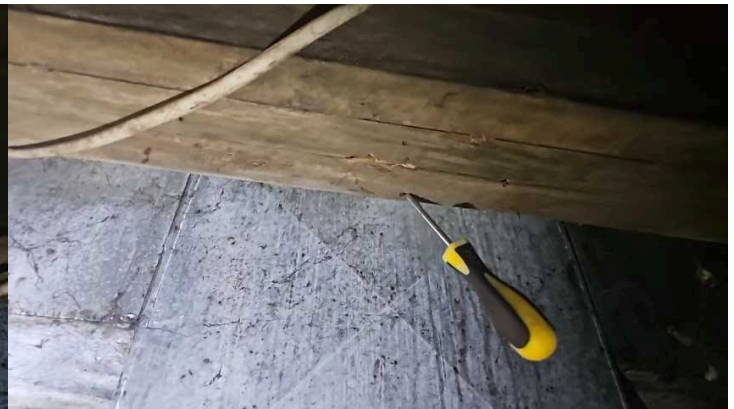
Probing rot on floor structure

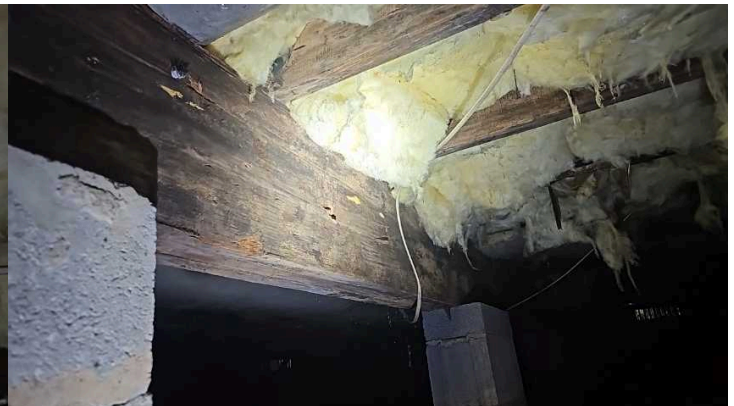
Black fungal like growth and rot on floor structure

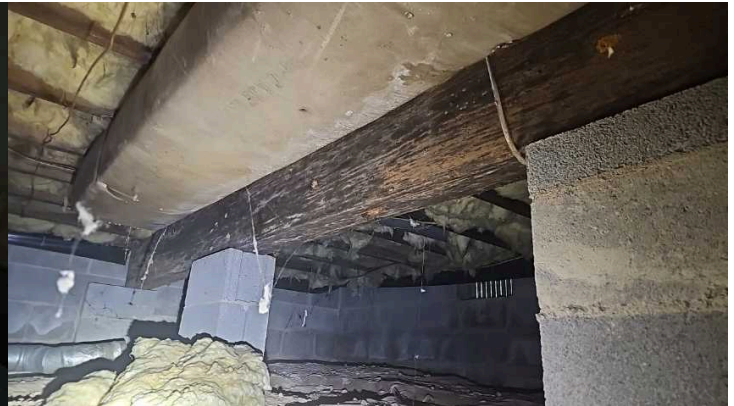
Black fungal like growth and rot floor structure

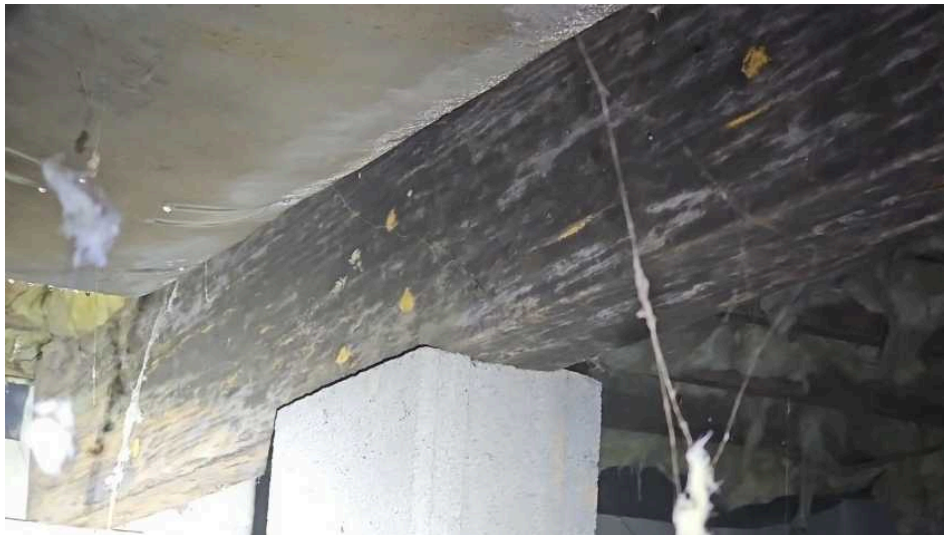
Black fungal like growth and rot floor structure

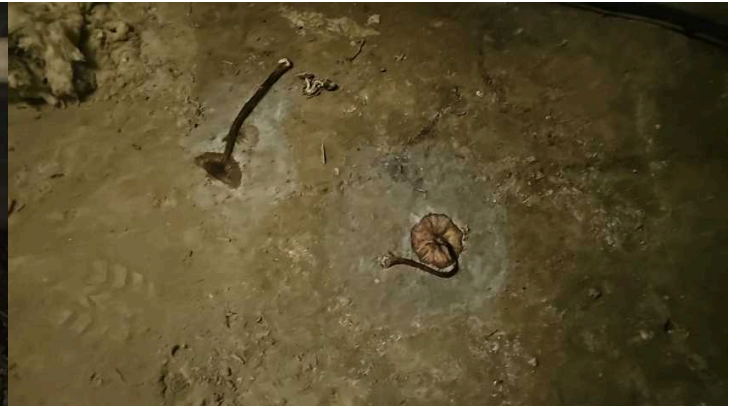
Mushroom growth indicates long term wet conditions

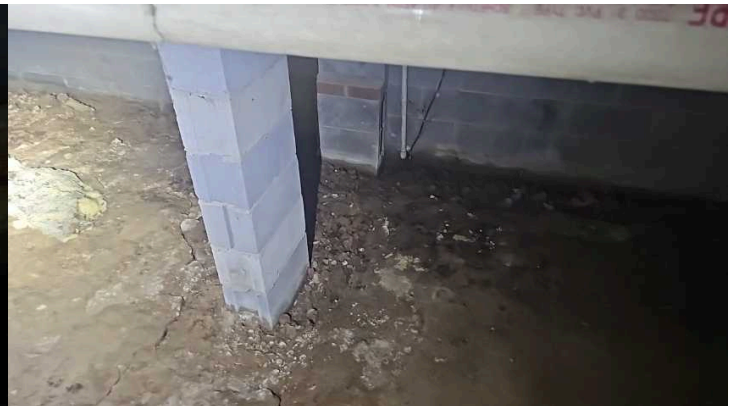
Wet conditions

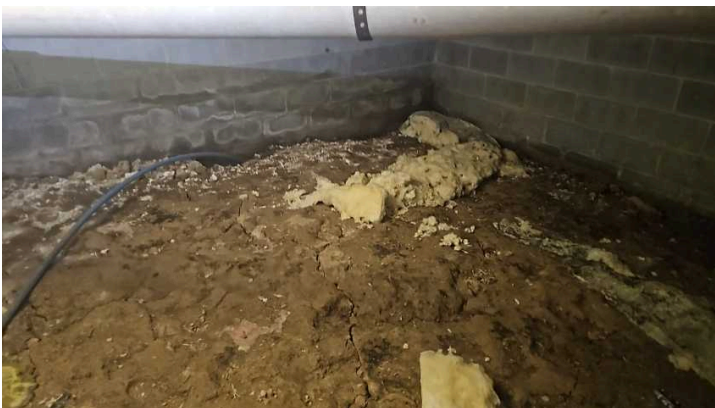
Wet conditions

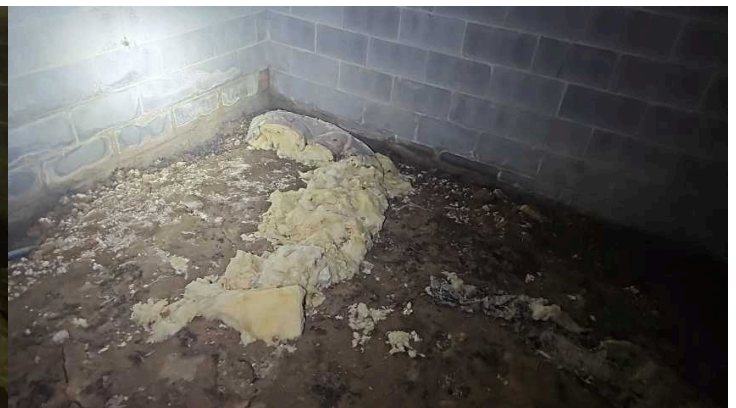
Wet

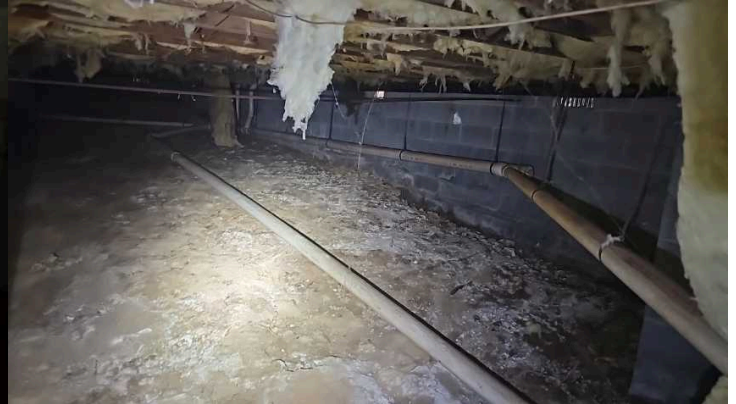
Wet condition

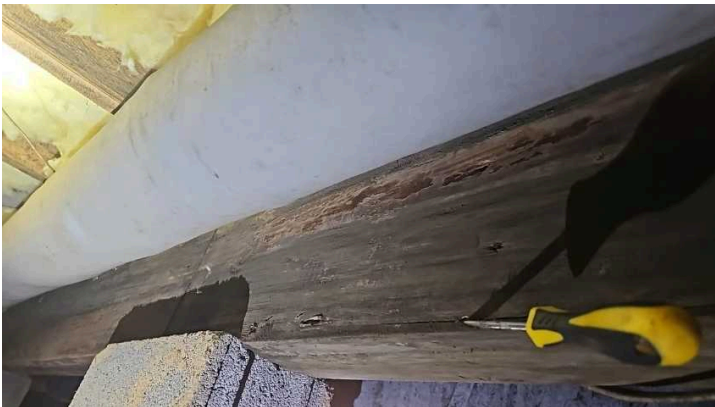
Black fungal like growth and rot on floor structure

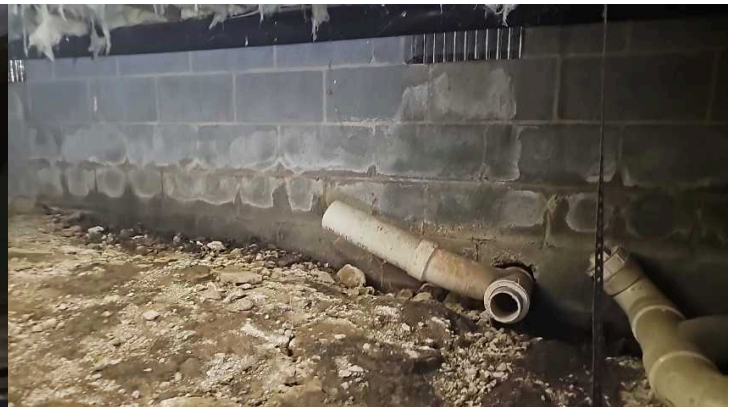
Wet conditions

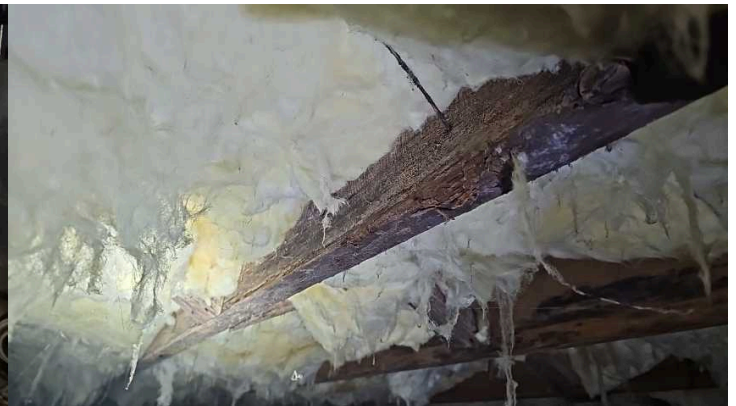
Black fungal like growth and rot on floor structure

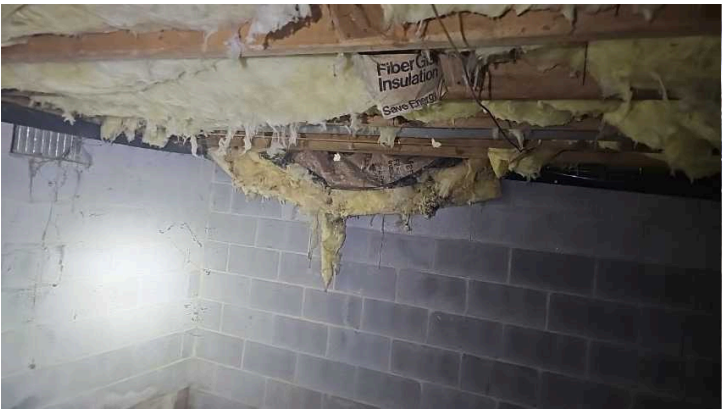
5.1. The crawl space shows indications of chronic wet conditions and there is visible fungal or mold like growth. As a result of the wet conditions the insulation is in poor condition and all should be replaced.

Stringy insulation

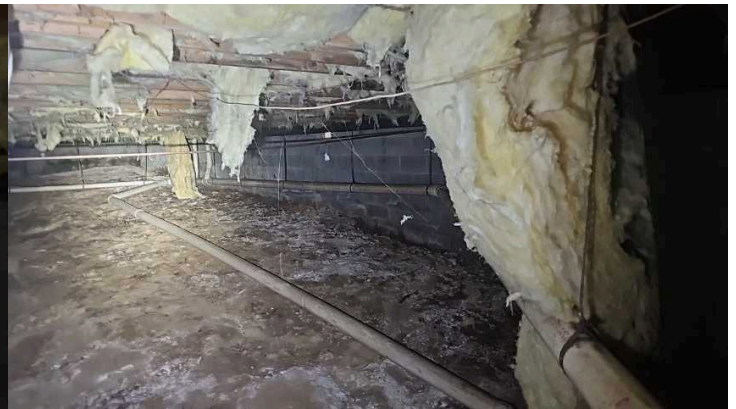
Stringy insulation indicates long term moisture problem
