**[Docket No. FAA-2012-1135; Directorate Identifier 2012-SW-097-AD;  
Amendment 39-17281; AD 2012-21-52]**

**Airworthiness Directives; Agusta S.p.A. (Type Certificate currently held by  
AgustaWestland S.p.A) (Agusta) Helicopters**

2012-21-52 **AGUSTA S.P.A. HELICOPTERS (TYPE CERTIFICATE**

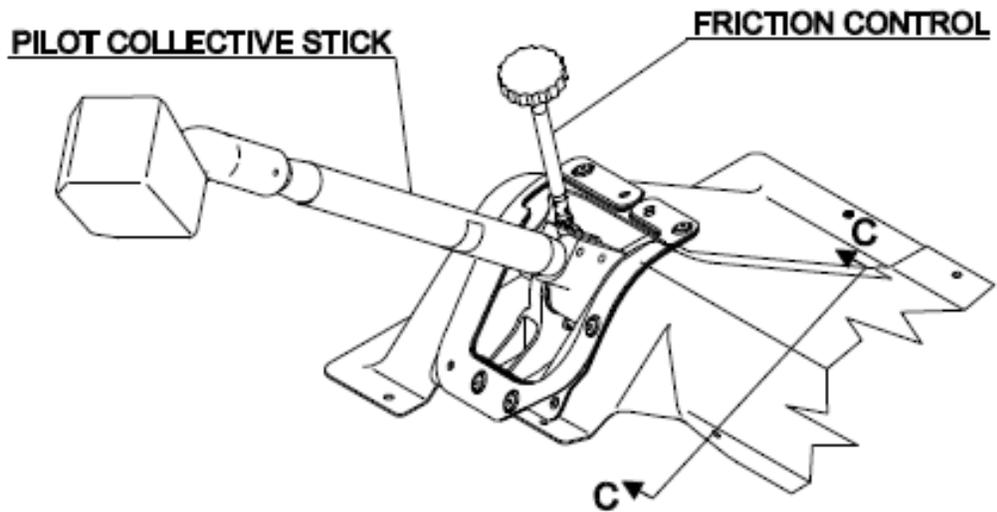
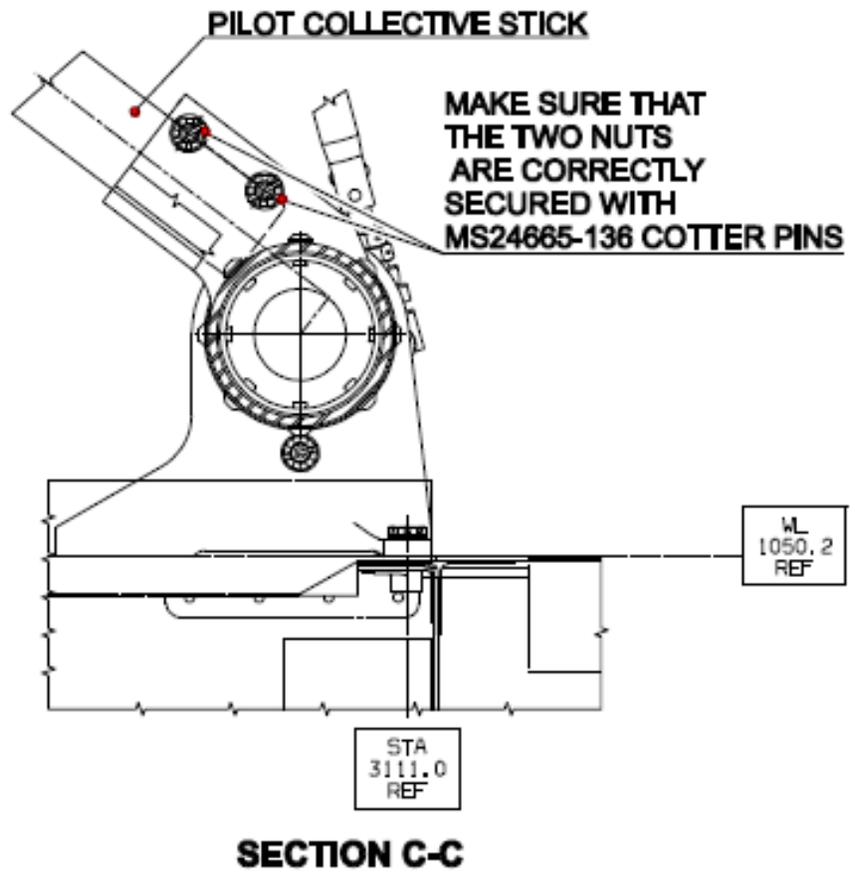
(1) Inspect the pilot collective stick installation to determine whether the self-

locking nuts, part-number (P/N) MS17825-4, are secured with cotter pins, P/N MS24665-136, as depicted in Figure 1 to paragraph (e) of this AD. If the self-locking nuts are not secured with cotter pins, before further flight, reinstall the pilot collective stick.

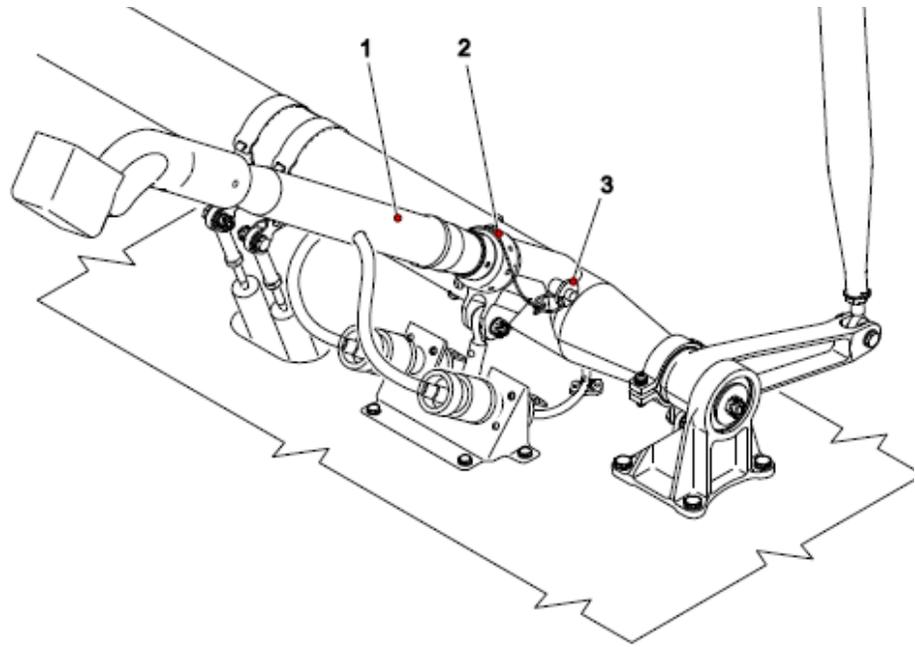
(2) Inspect the co-pilot collective stick installation to determine whether the ring nut (item 2) is loose and the quick-release pin (item 3) is installed as depicted in Figure 2 to paragraph (e) of this AD. If the ring nut is loose or the quick-release pin is not installed, before further flight, reinstall the co-pilot collective stick.

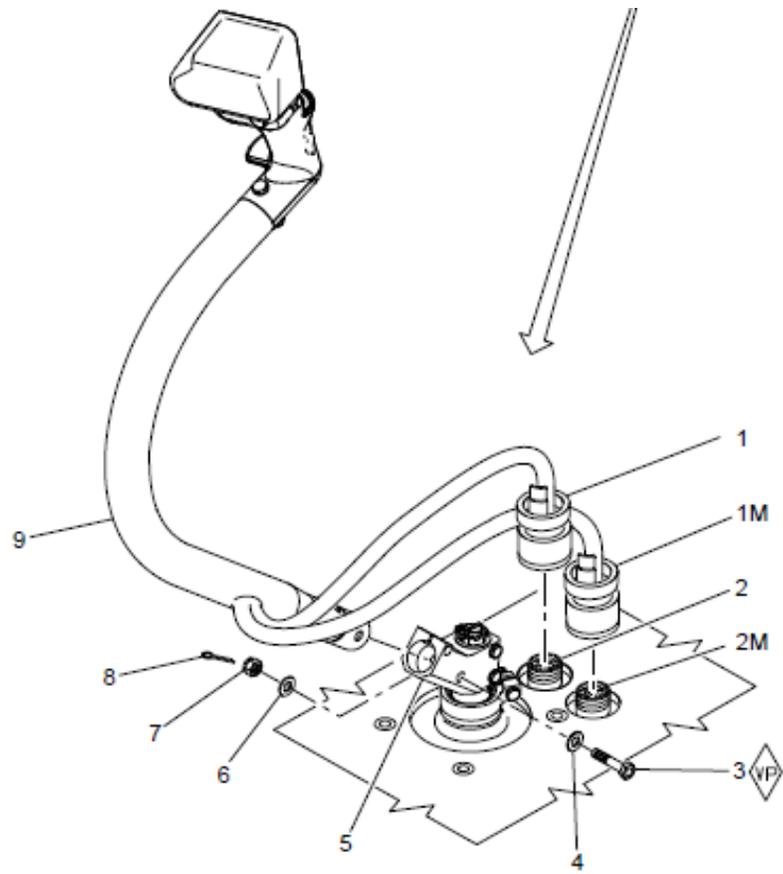
(3) Inspect the pilot cyclic stick installation for proper installation of the bolt (item 3), washer (item 4), self-locking nut (item 7), washer (item 6), and the cotter pin (item 8), as depicted in Figure 3 to paragraph (e) of this AD. If the pilot cyclic stick is not installed as depicted, before further flight, reinstall the pilot cyclic stick.

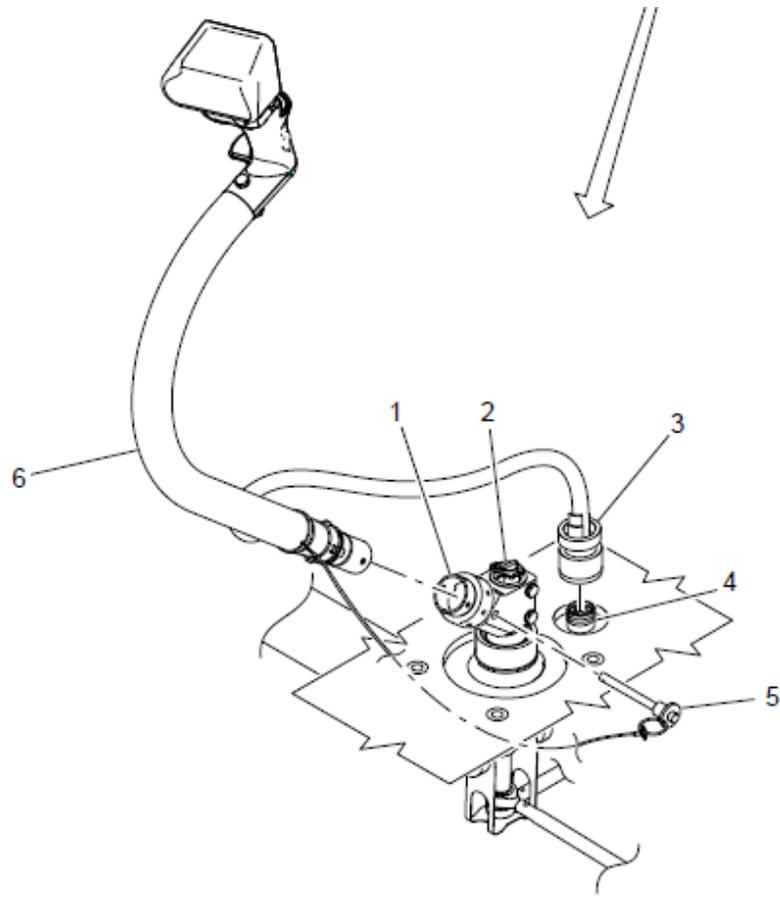
(4) Inspect the co-pilot cyclic stick installation to determine whether the ring nut (item 1) is loose and the quick-release pin (item 5) is installed as depicted in Figure 4 to paragraph (e) of this AD. If the ring nut is loose or the quick-release pin is not installed as depicted, before further flight, reinstall the co-pilot cyclic stick.
