**[Docket No. FAA-2011-1231; Directorate Identifier 2011-NM-088-AD; Amendment 39-17418; AD 2013-08-01]**

**Airworthiness Directives; The Boeing Company Airplanes**

**ACTION:** Final rule.

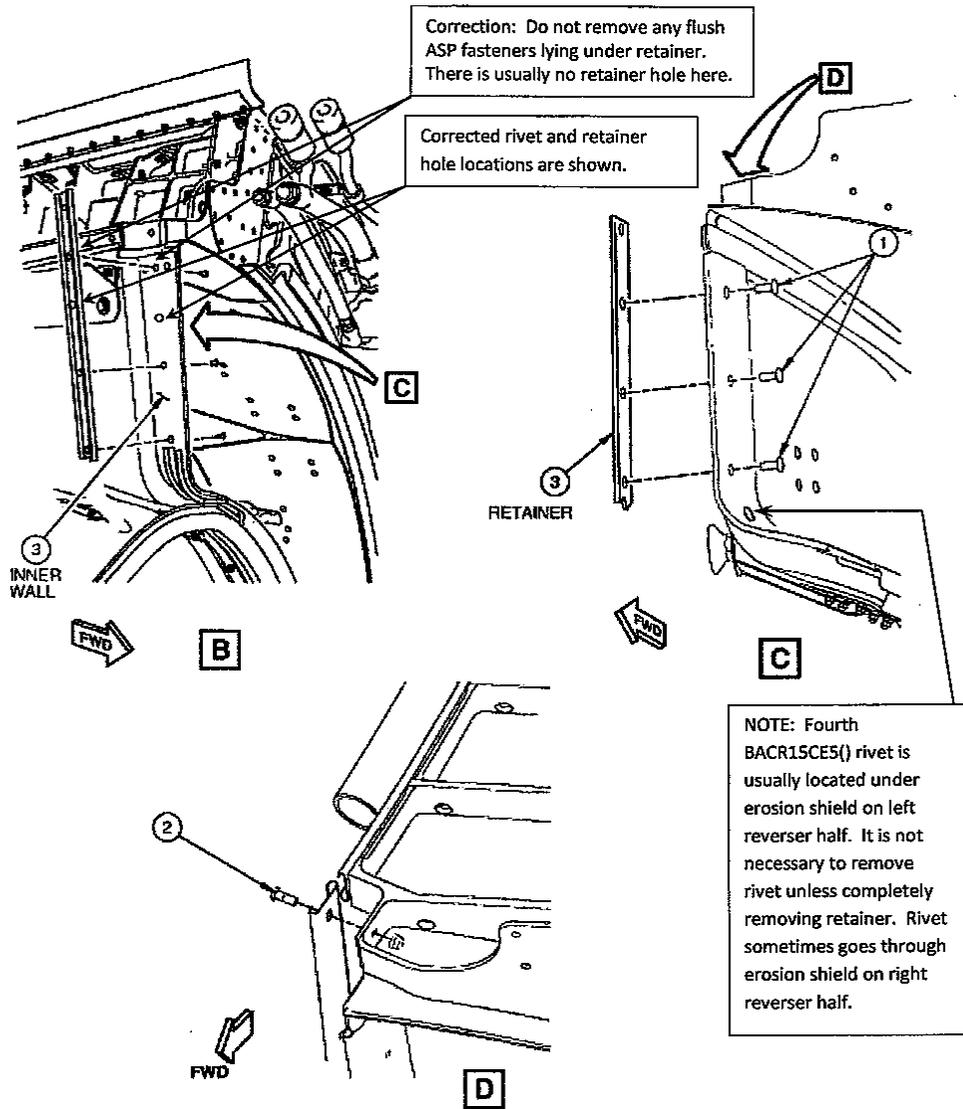
Figure 1, Fastener Removal of the Retainer Support on the Left Thrust Reverser Half

(2) Figures 1 and 3 of this AD, titled “Fastener Removal of the Retainer Support on the Left (Right) Thrust Reverser Half,” have View B showing the top fastener in the center of three adjustable sustained preload (ASP) fasteners. That top fastener does not require removal in order to remove the retainer. The figures in this AD point to the correct information for those fasteners.

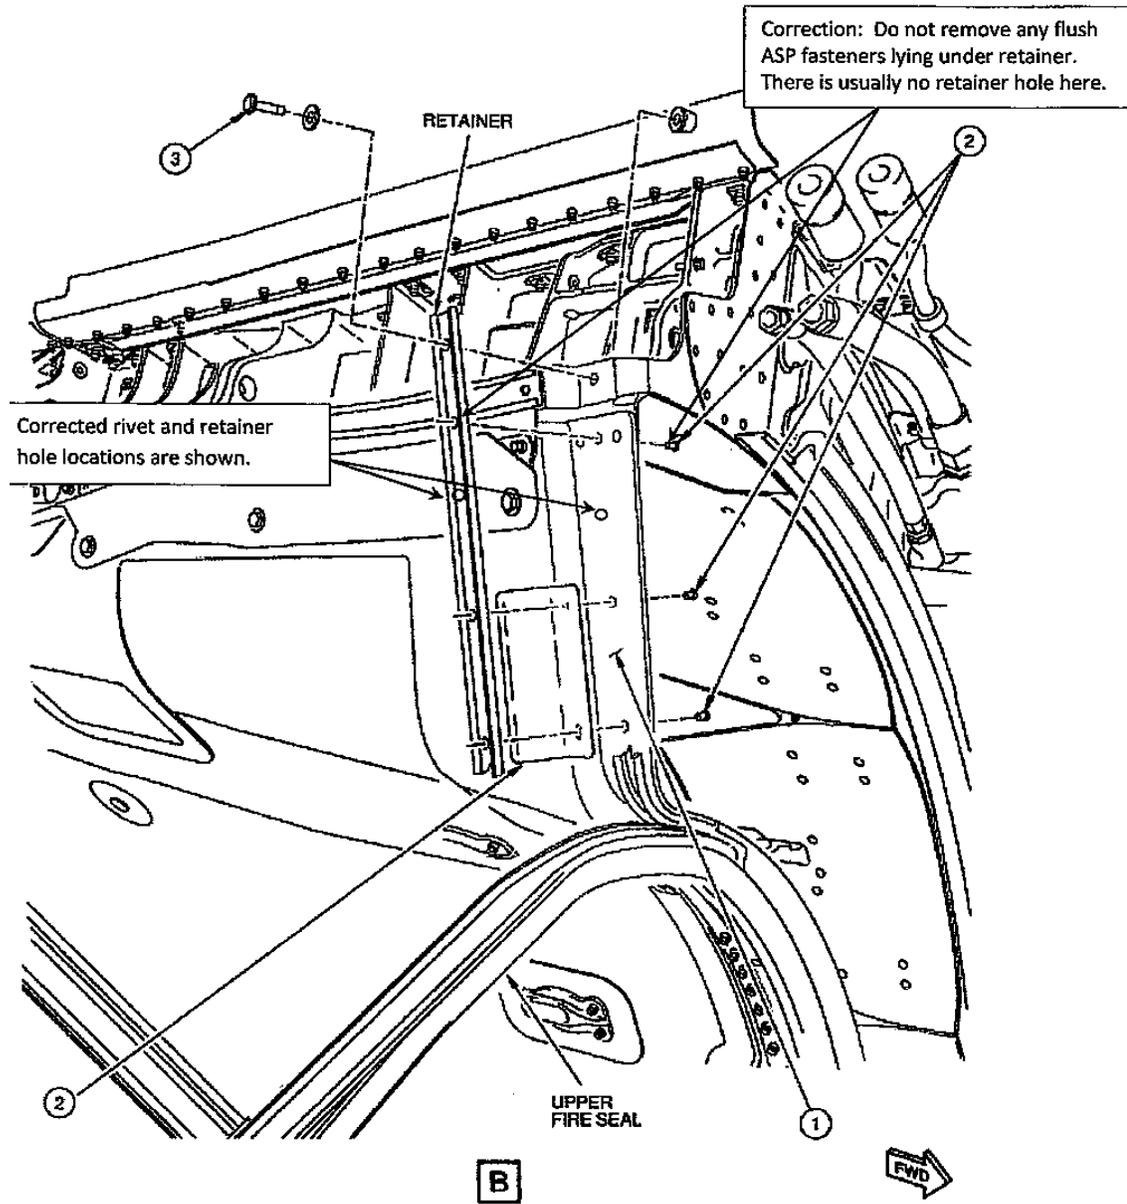
Figure 2, Installation of the New Bracket behind the Retainer Support on the Left Thrust Reverser Half

(3) Figures 2 and 4 of this AD, titled “Installation of the New Bracket behind the Retainer Support on the Left (Right) Thrust Reverser Half,” have View B showing the

top rivet hole. That rivet hole is actually below the row of three ASP fasteners. The figures in this AD point to the correct information for those rivet holes.
