[Docket No. FAA-2013-0019; Directorate Identifier 2010-SW-051-AD; Amendment 39-17485; AD 2013-12-07]

Airworthiness Directives; Bell Helicopter Textron Canada Helicopters

ACTION: Final rule.

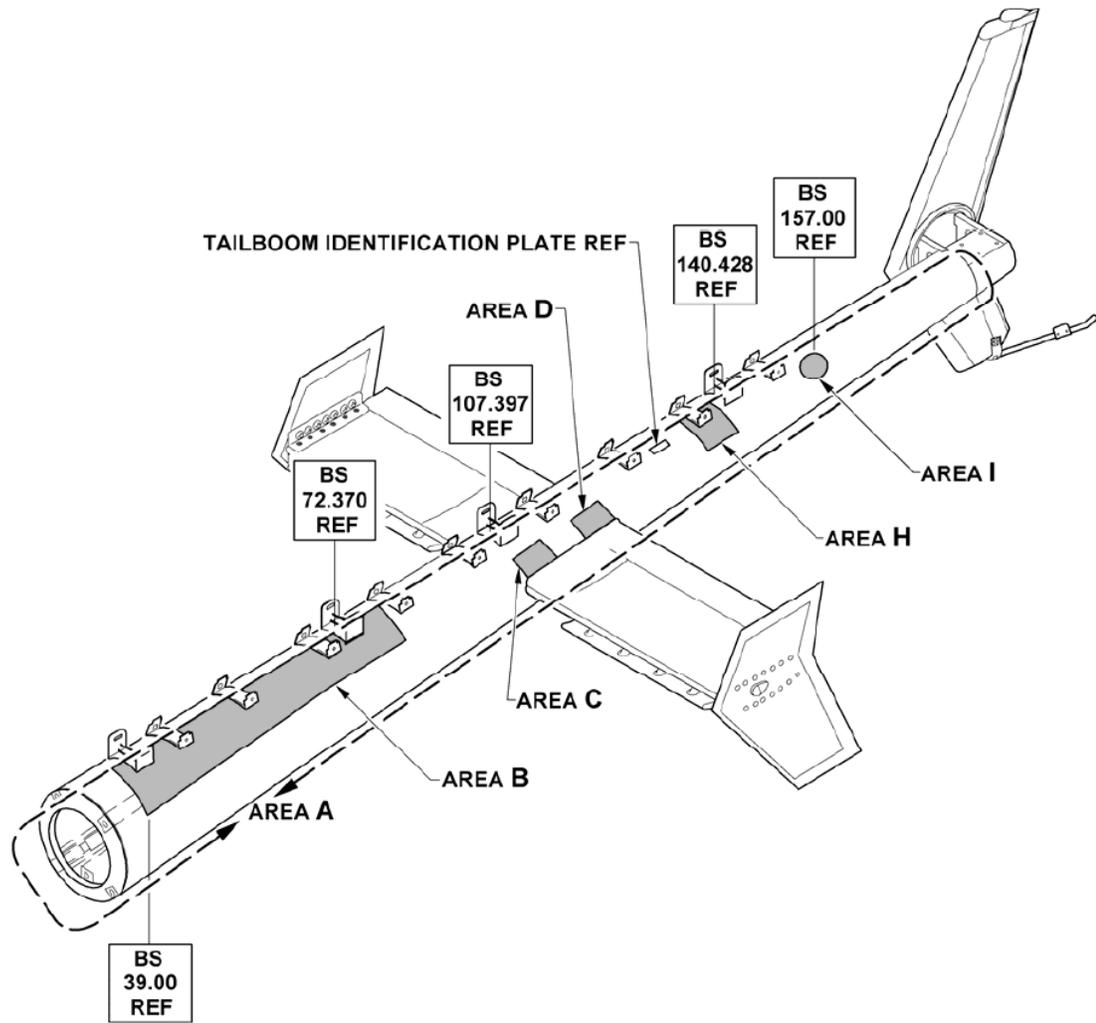
Figure 1 to Paragraph (e)

This AD defines the unsafe condition as high-stress-concentration areas in the tailboom skin that are at risk of cracking. This condition could result in a crack in the tailboom assembly, failure of the tailboom, and subsequent loss of helicopter control.

(A) Before the first flight of each day, visually check for a crack in the “C” and “D” areas depicted in Figures 1 and 2 to Paragraph (e) of this AD. The actions required by this paragraph may be performed by the owner/operator (pilot) holding at least a private pilot certificate, and must be entered into the aircraft records showing compliance with this AD in accordance with 14 CFR §§ 43.9 (a)(1)-(4) and 14 CFR § 91.417(a)(2)(v). The record must be maintained as required by 14 CFR §§ 91.417, 121.380, or 135.439; or

(5) If there is a crack in the tailboom assembly, before further flight, replace it with an airworthy tailboom assembly.

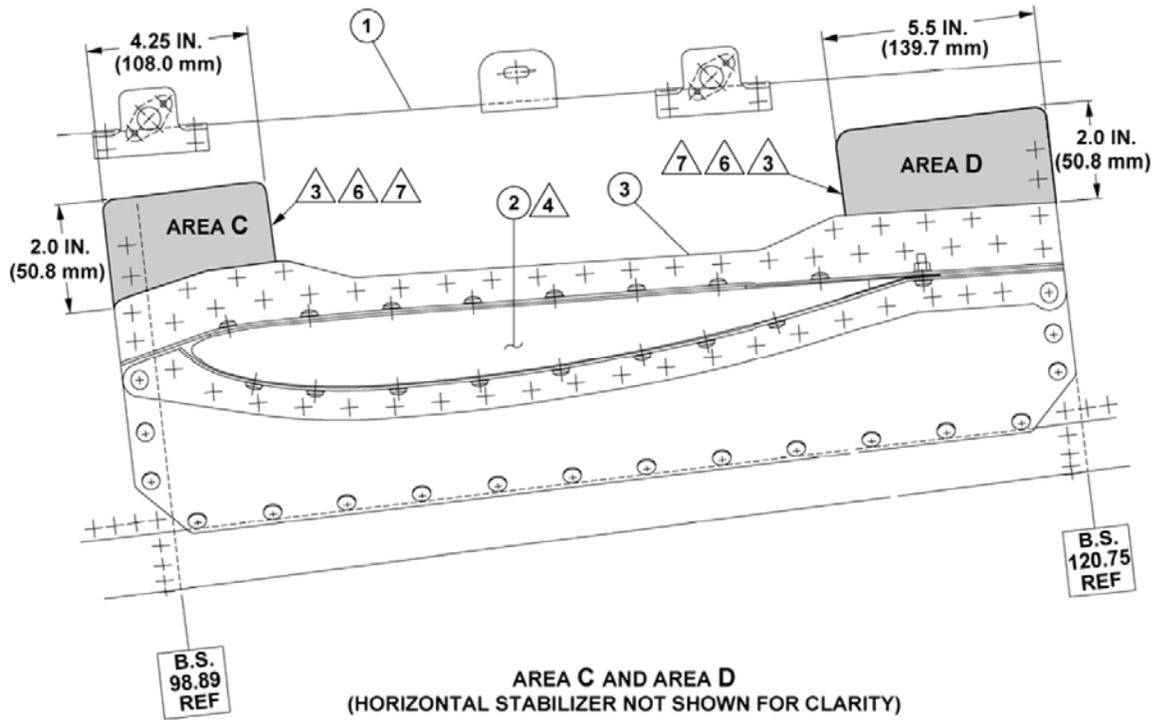
(B) Within 25 hours TIS, or 30 days, whichever comes first, and thereafter at intervals not to exceed 50 hours TIS, clean and inspect for a crack around each fastener and just above the edge of the upper stabilizer support in the “C” and “D” areas on the left side of the tailboom assembly, as depicted in Figure 2 to Paragraph (e) of this AD, using a 10X or higher power magnifying glass.
