DEPARTMENT OF TRANSPORTATION

Federal Aviation Administration

[Docket No. FAA-2013-0574; Directorate Identifier 2008-SW-22-AD]

Airworthiness Directives; Bell Helicopter Textron Canada (Bell) Helicopters

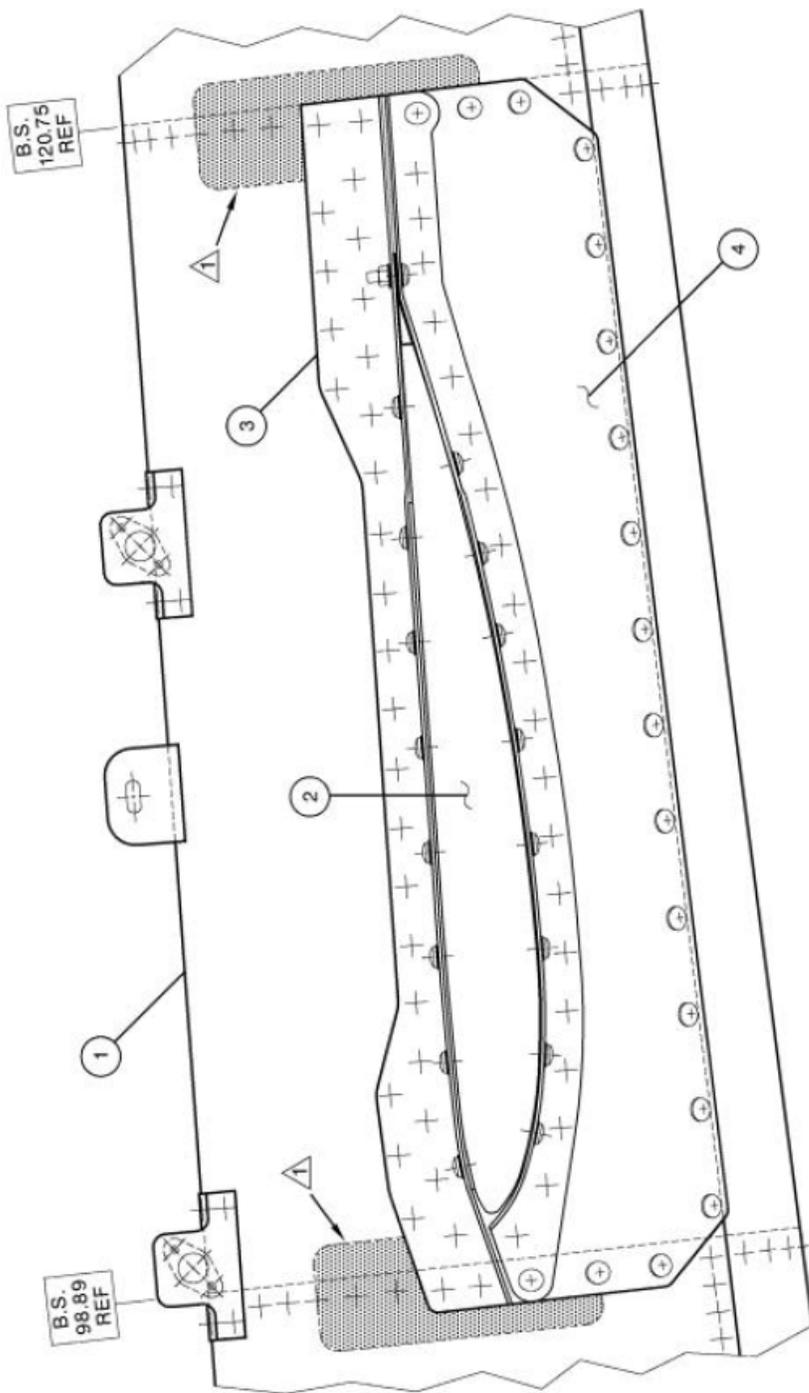
Figure 1 to Paragraph (f)(1)(i)(A)

(A) Before the first flight of each day, visually check the tailboom for a crack, as depicted in Figure 1 to paragraph (f)(1)(i)(A) of this AD.

△ Examine these areas for cracks on left side of tailboom only.

(3) If there is a crack, before further flight, replace the tailboom.

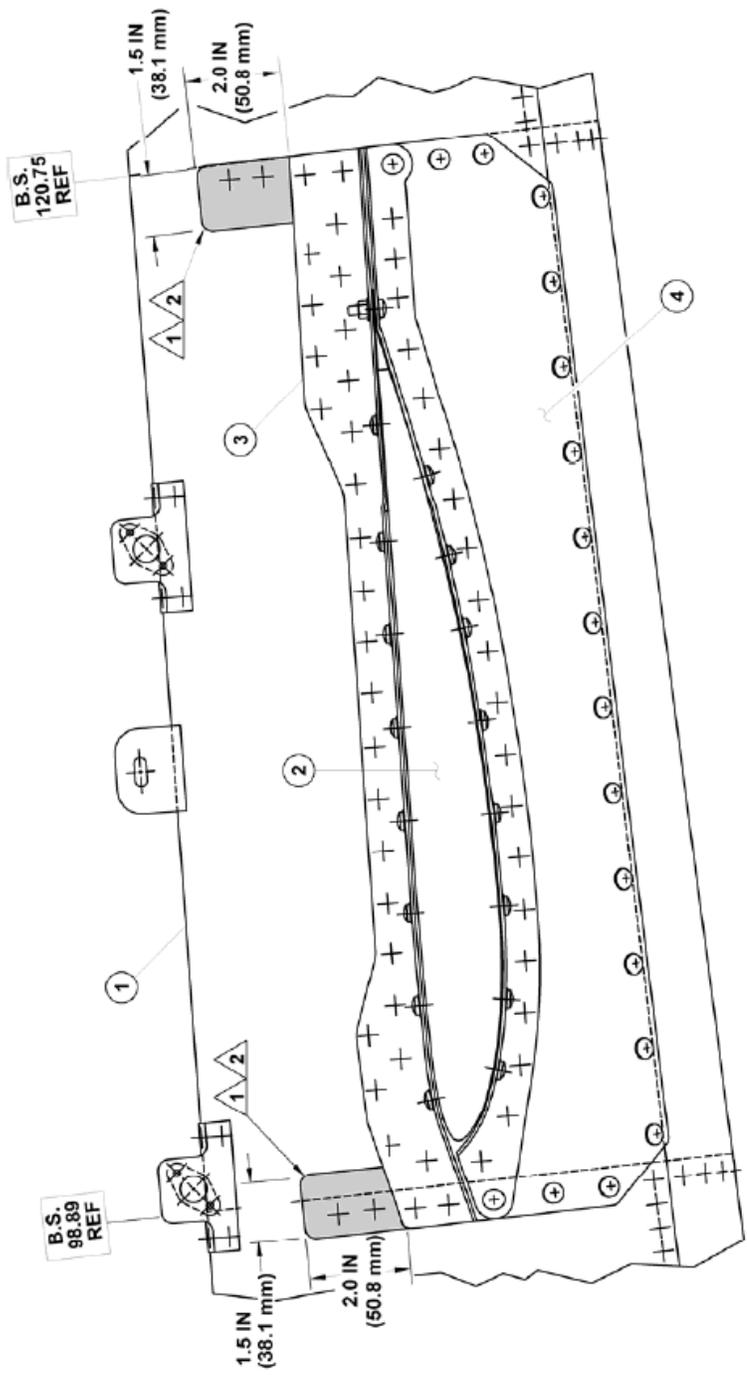
(iii) Thereafter, before the first flight of each day, clean the area on the tailboom where paint has been removed and visually check the tailboom for a crack as depicted in Figure 2 to Paragraph (f)(2)(iii) of this AD.

- △ 1 Paint and primer to be removed from these areas (see PART II).
- △ 2 Examine these areas for cracks on left side of tailboom only.
- 3. Horizontal stabilizer not shown for clarity.
- Daily check area

(4) If there is no crack, make sure both of the inspection area surfaces are dry and protect each reworked area with a thin coat of clear coating.
