Airworthiness Directives; Agusta S.p.A. (Type certificate currently held by

AgustaWestland S.p.A) (Agusta) Helicopters

ACTION: Final rule.

2013-16-21 **AGUSTA S.p.A. (Agusta)**: Amendment 39-17559; Docket No. FAA-2013-0146; Directorate Identifier 2012-SW-060-AD.

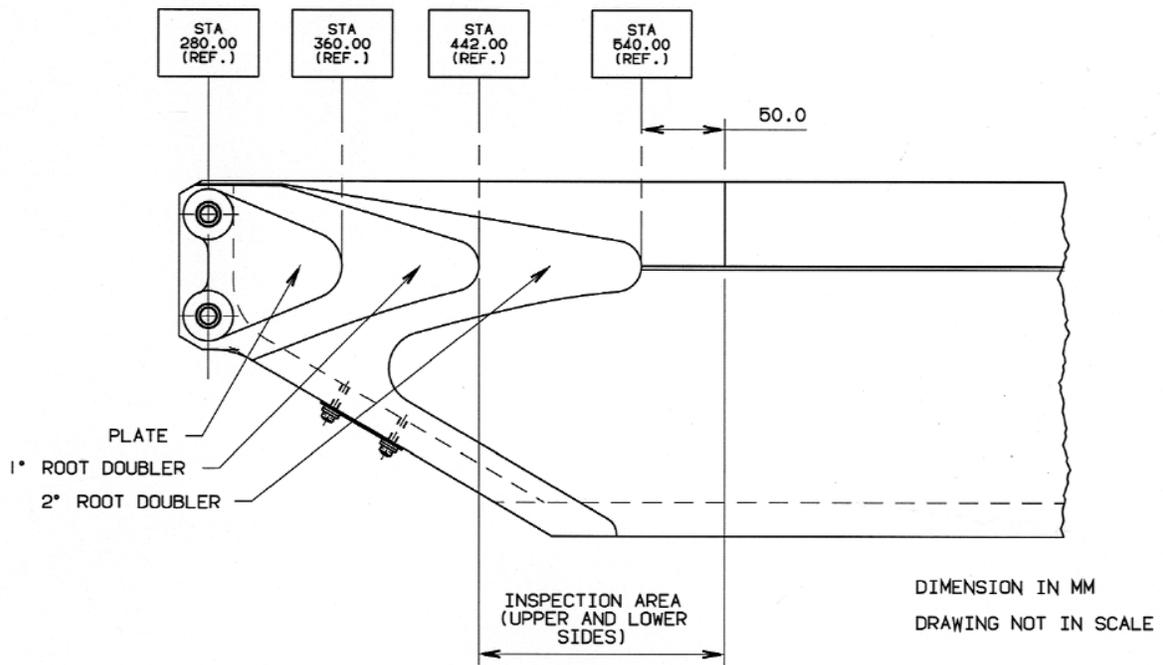
Figure 1 to Paragraph (f)(1), T/R Blade, P/N 109-8132-01-111

This AD defines the unsafe condition as a fatigue crack in a T/R blade. This condition could result in failure of the T/R blade and subsequent loss of control of the helicopter.

(1) Before each start of the helicopter engines, visually check both sides of each T/R blade for a crack in the inspection area depicted in Figure 1 to paragraph (f)(1) of

(5) If there is a crack in a T/R blade, before further flight, replace the cracked T/R blade.
