[Docket No. FAA-2013-0822; Directorate Identifier 2013-SW-004-AD]

Airworthiness Directives; Eurocopter France Helicopters

ACTION: Notice of proposed rulemaking (NPRM).

EUROCOPTER FRANCE: Docket No. FAA-2013-0822; Directorate Identifier 2013-SW-004-AD.

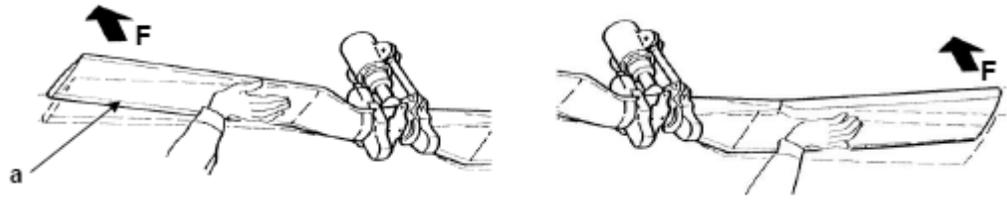
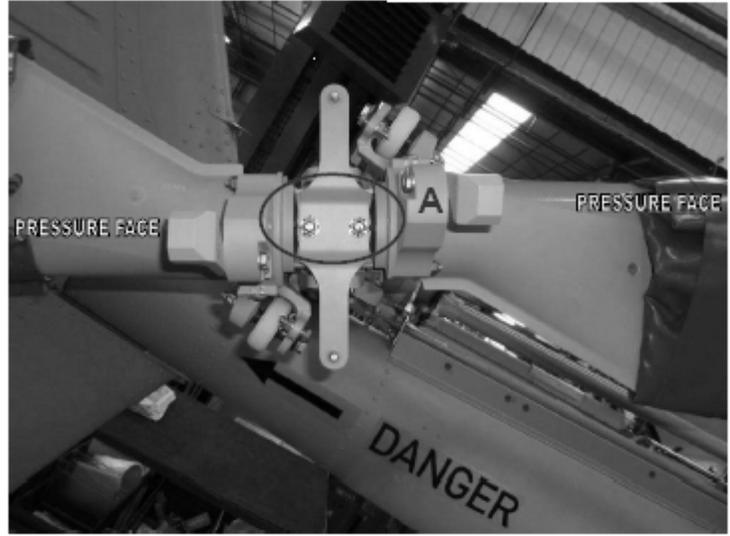
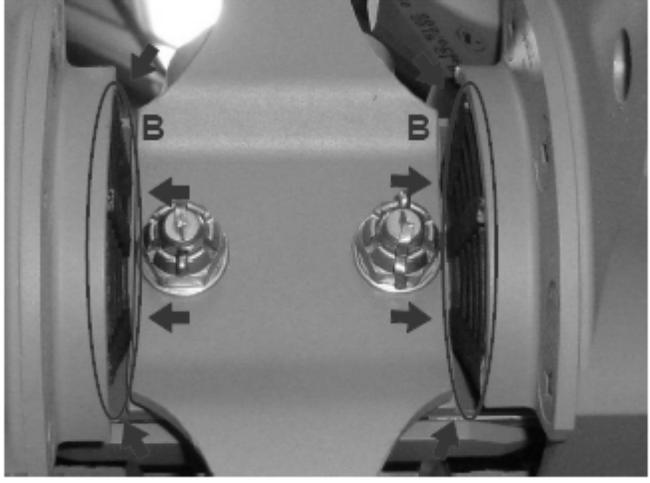
(C) While maintaining the load, check all the visible faces of the bearings (front and side faces) in area B of DETAIL A of Figure 1 to paragraph (f) of this AD for separation between the elastomer and metal parts, a crack in the elastomer, or an extrusion (see example in Figure 2 to paragraph (f) of this AD). A flashlight may be used to enhance the check.

(v) If there is an extrusion on any bearing, before further flight, replace the four bearings with airworthy bearings.

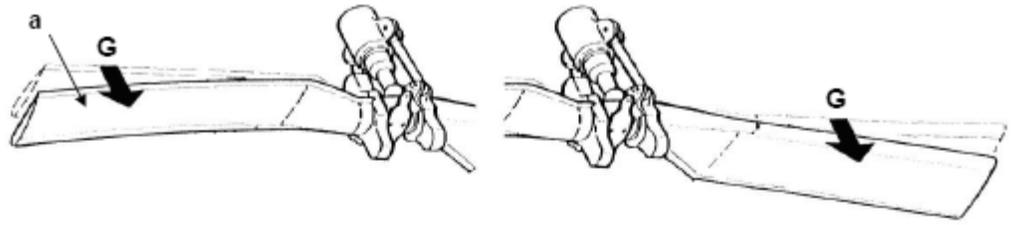
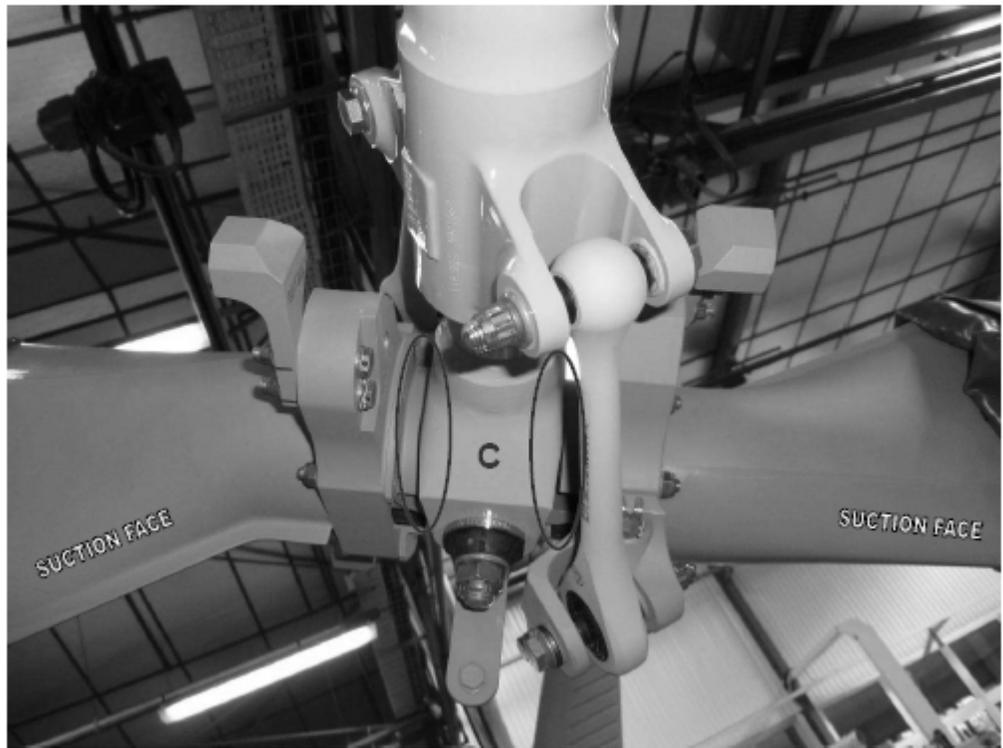
(F) While maintaining the load, check visible faces of Area C as shown in Figure 3 to paragraph (f) of this AD for any extrusion. A flashlight may be used to enhance the check.

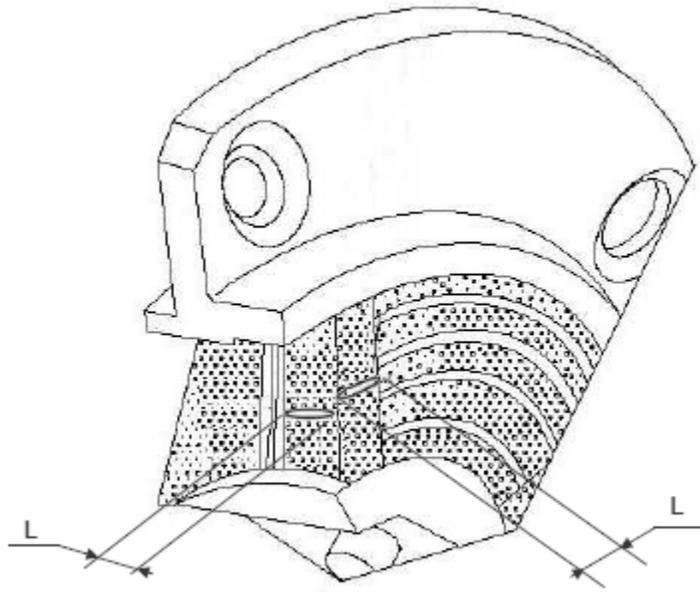
(vi) If there is a separation or a crack on the pressure side bearing, measure the separation or the crack. If the separation or crack is greater than 5 millimeters (.196 inches) as indicated by dimension "L" in Figure 4 to paragraph (f) of this AD, before further flight, replace the four bearings with airworthy bearings.
