**Amendment 39-17765; AD 2011-22-05 R1]**

**Airworthiness Directives; Airbus Helicopters (Type Certificate Previously Held By Eurocopter France) (Airbus Helicopters)**

**ACTION:** Final rule.

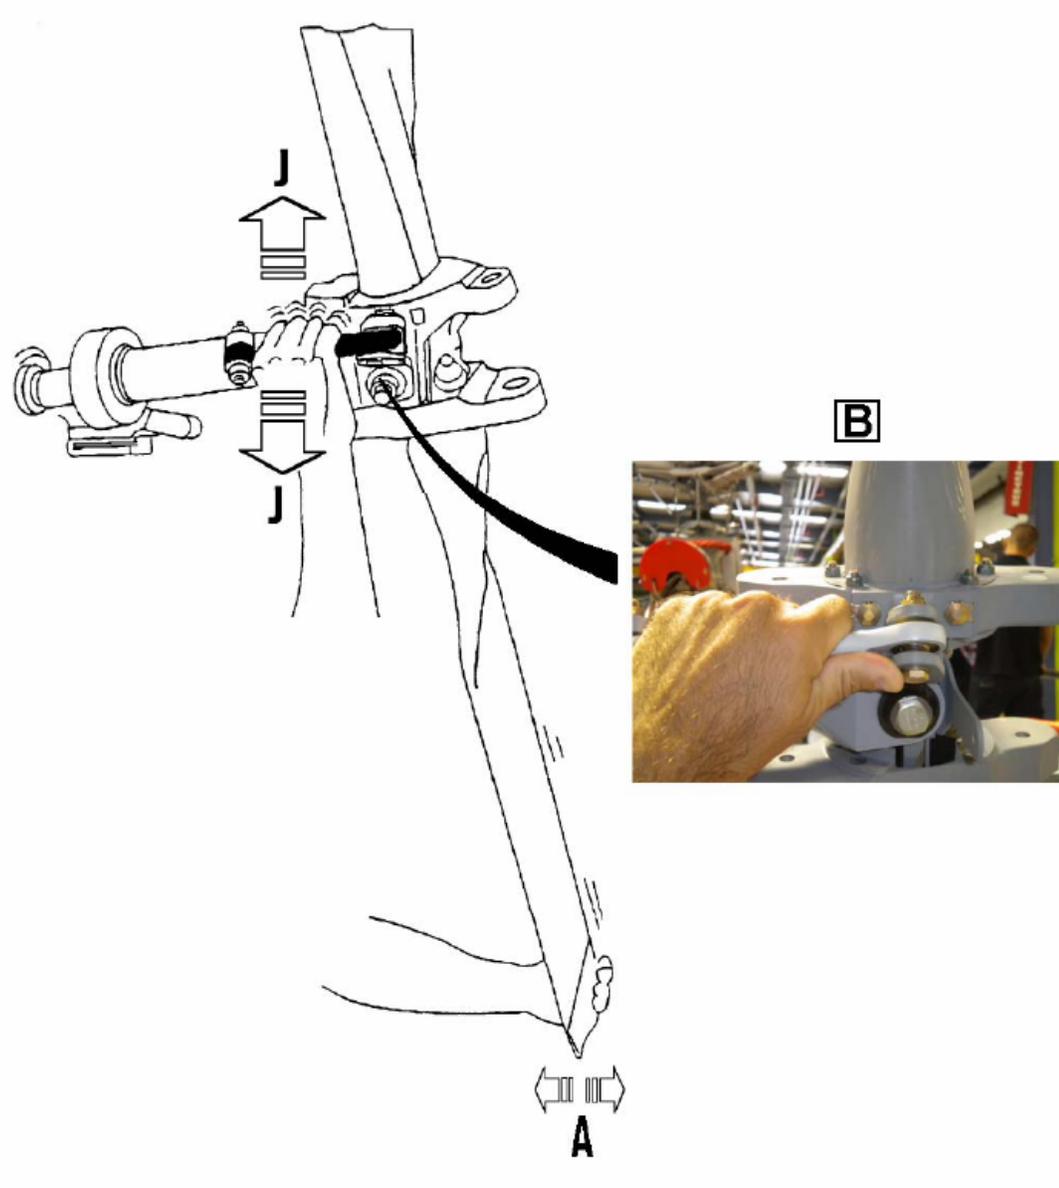
Figure 1 to Paragraph (f)  
Manual Check for Play of the Tail Rotor Pitch Control Rod

This AD defines the unsafe condition as excessive play in the control rod. This condition could result in failure of a T/R control rod, loss of T/R control, and subsequent loss of control of the helicopter.

(1) Within 30 hours time-in-service (TIS) and, if no bearing play is detected, thereafter at intervals not to exceed 30 hours TIS, place the T/R pedals in the neutral position. If the helicopter is fitted with a T/R load compensator, discharge the accumulator as described in the rotorcraft flight manual. Check the control rod bearing (bearing) for play on the helicopter, by observation and feel, by slightly moving the T/R blade in the flapping axis while monitoring the bearing for movement. See the following Figure 1 to Paragraph (f) of this AD. The actions required by this paragraph may be

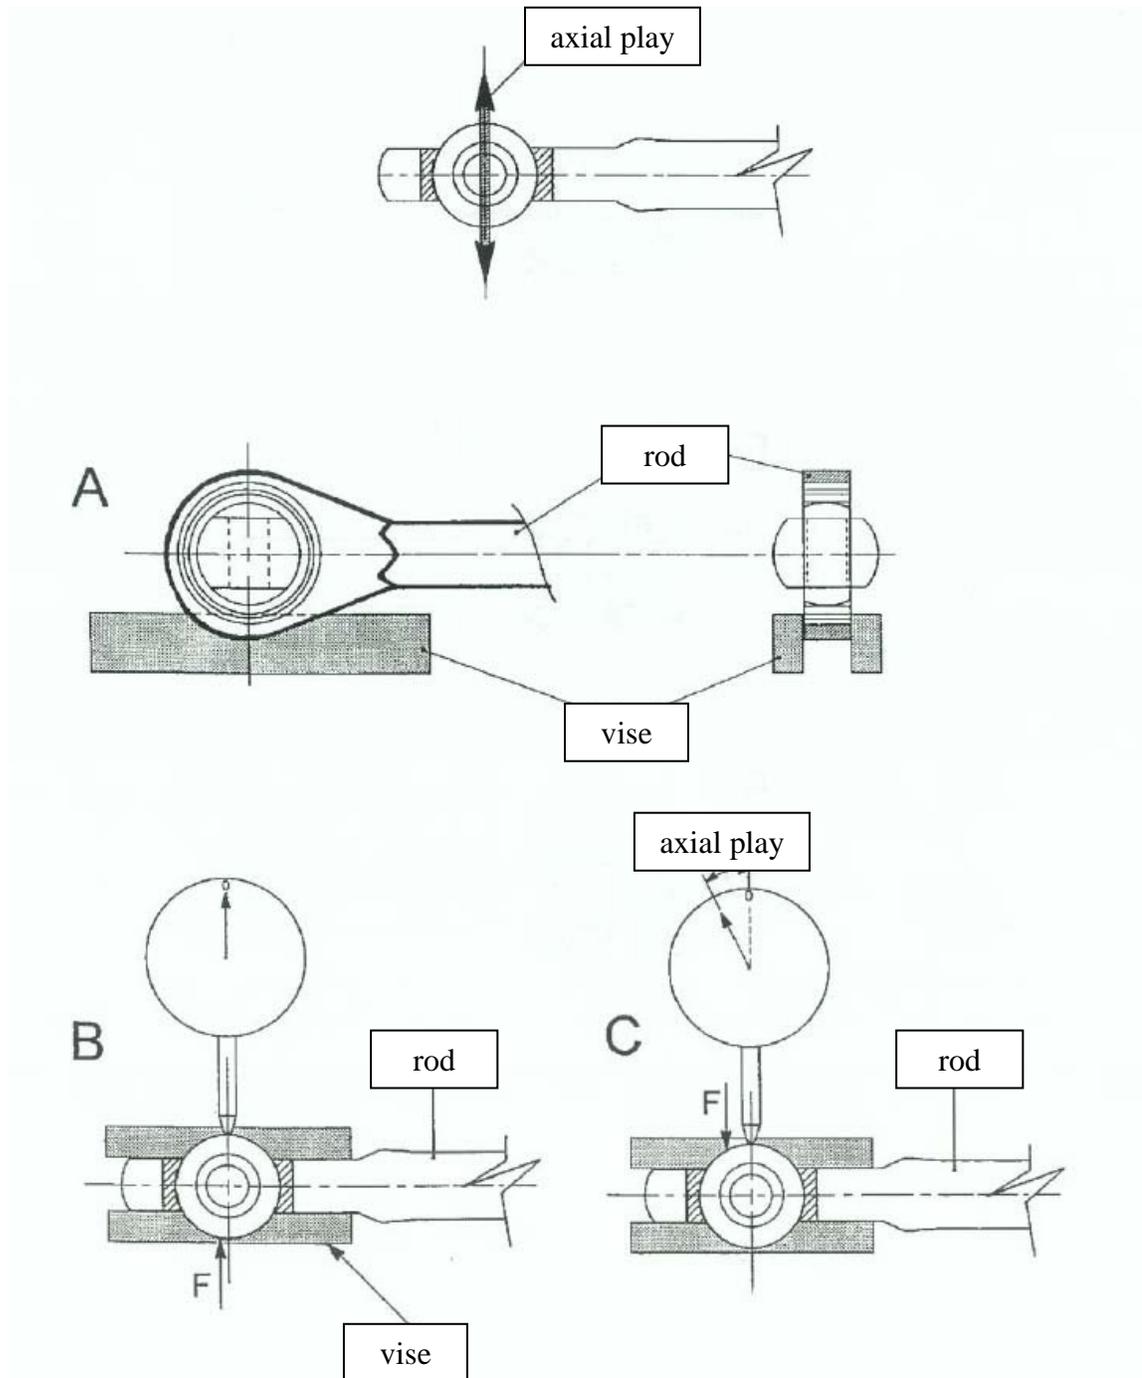
Figure 2 to Paragraph (f)  
Measurement of the Axial Play (A) of the Bearing

(2) If a pilot or mechanic detects play in the bearing, before the next flight, a mechanic must remove the control rod from the helicopter, and using a dial indicator, measure the bearing wear according to the following and as shown in Figures 2 and 3 to Paragraph (f) of this AD:

(ii) Mount the control rod in a vise as shown in Figure 2 to Paragraph (f) of this AD.

(iii) Using a dial indicator, take axial play readings by moving the spherical bearing in the direction F (up and down) as shown in Figure 2 to Paragraph (f) of this AD.

(viii) If the radial play exceeds 0.008 inch or axial play exceeds 0.016 inch, replace the control rod with an airworthy control rod before further flight.

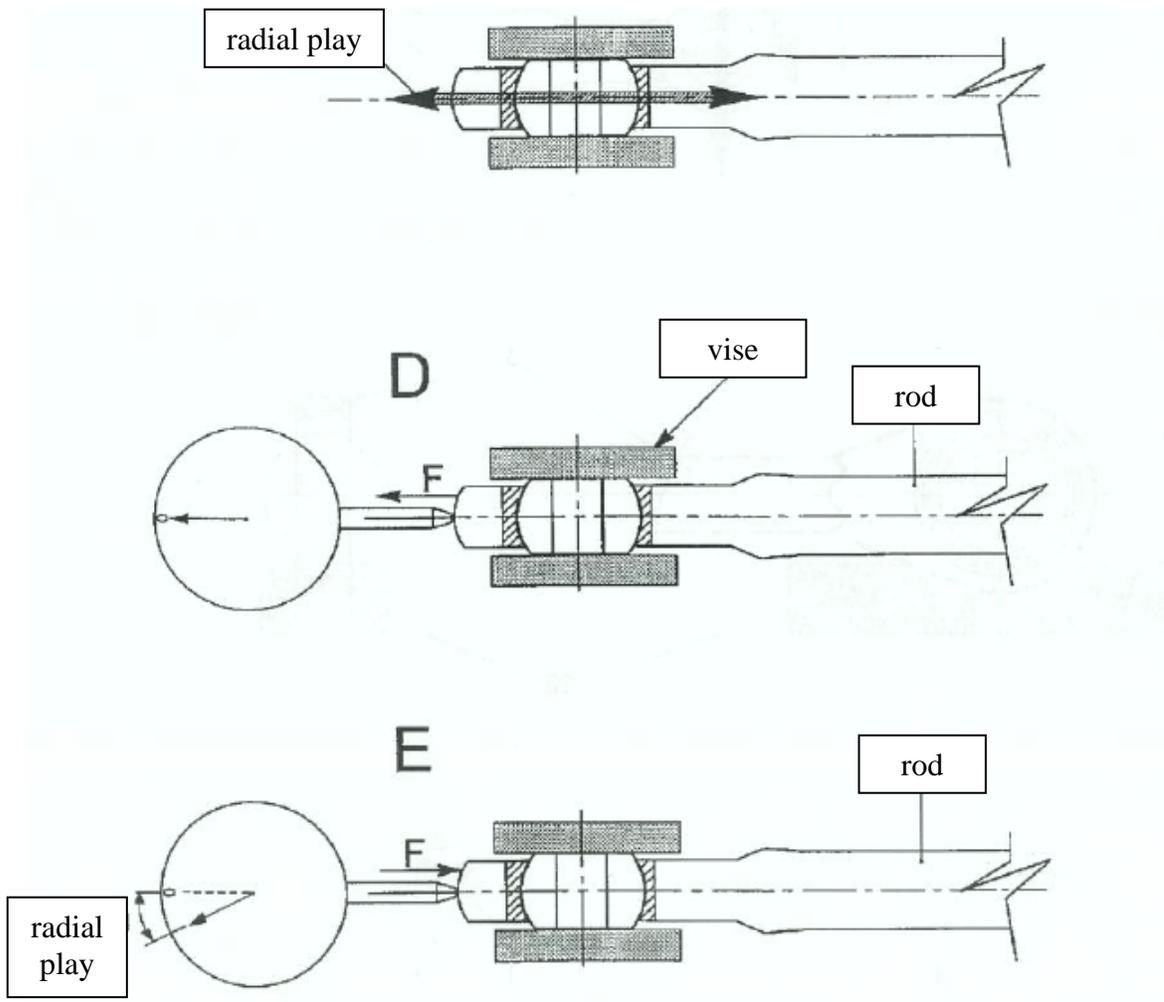
Figure (3) to Paragraph (f)  
 Measurement of the Radial Play (R) of the Bearing

(v) Mount the control rod and bearing in a vise as shown in Figure 3 to Paragraph (f) of this AD.

(vi) Using a dial indicator, take radial play measurements by moving the control rod in the direction F as shown in Figure 3 to Paragraph (f) of this AD.
