Federal Aviation Administration

Amendment 39-17766; AD 2014-04-07]

Airworthiness Directives; Bell Helicopter Textron Canada (Bell) Helicopters

ACTION: Final rule.

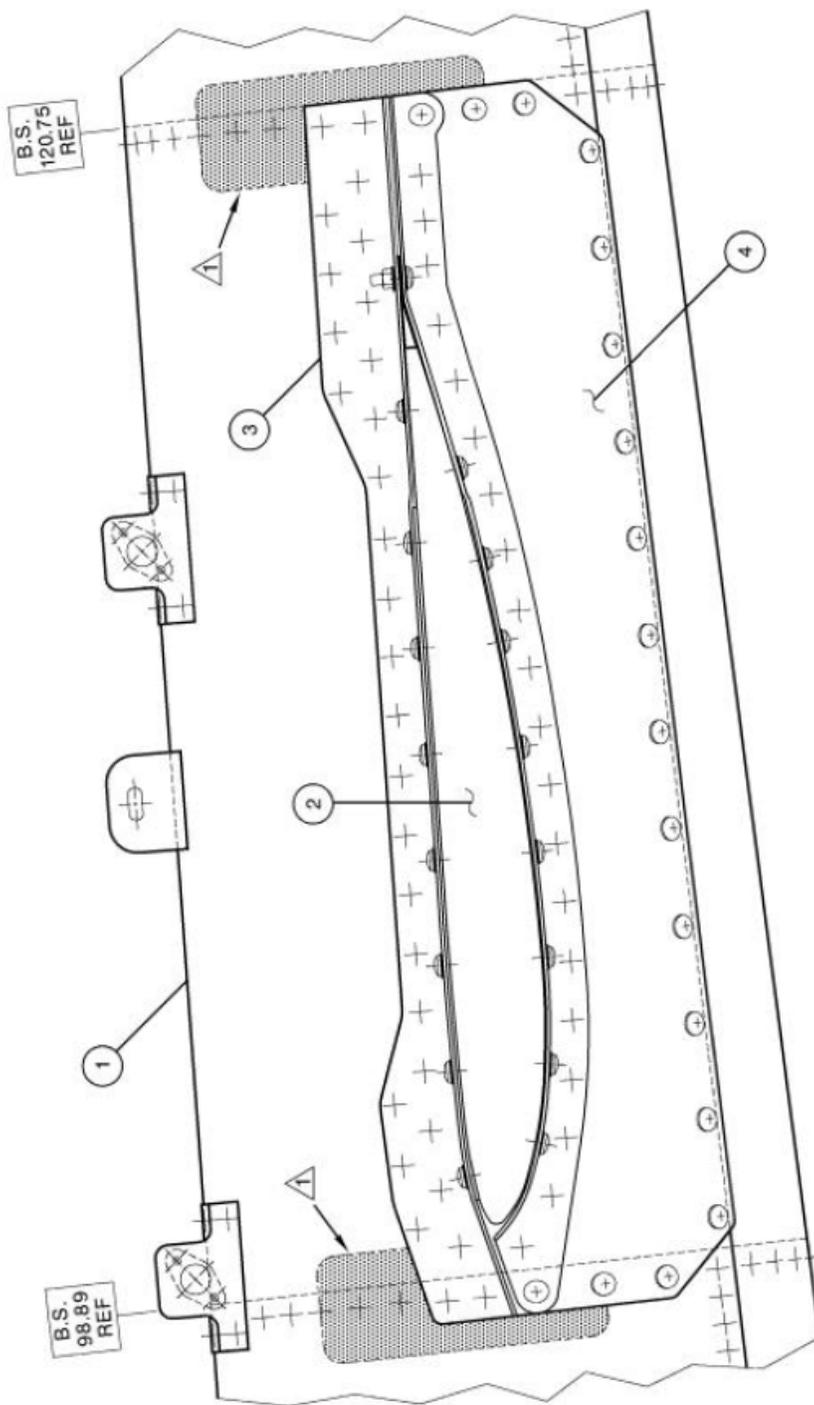
This AD defines the unsafe condition as cracks in the tailboom skin on the left side in the area of horizontal stabilizer, which could result in separation of the tailboom and subsequent loss of control of the helicopter.

(A) Before the first flight of each day, visually check the tailboom for a crack, as depicted in Figure 1 to Paragraph (f)(1)(i)(A) of this AD.

Δ Examine these areas for cracks on left side of tailboom only.

(B) For a tailboom with 600 or more hours time-in-service (TIS), within 25 hours TIS and thereafter at intervals not to exceed 50 hours TIS, visually inspect the tailboom for a crack using a 10X or higher magnifying glass by following the Accomplishment Instructions, Part II, of Bell ASB 407-99-26, Revision C, dated February 28, 2002, except this AD does not require you to contact Bell.

(3) If there is a crack, before further flight, replace the tailboom.
