[Docket No. FAA-2015-0497; Directorate Identifier 2012-NM-192-AD; Amendment 39-18128; AD 2015-06-10]

Airworthiness Directives; ATR-GIE Avions de Transport Régional Airplanes

2015-06-10 ATR-GIE Avions de Transport Régional: Amendment 39-18128. Docket No. FAA-2015-0497; Directorate Identifier 2012-NM-192-AD.

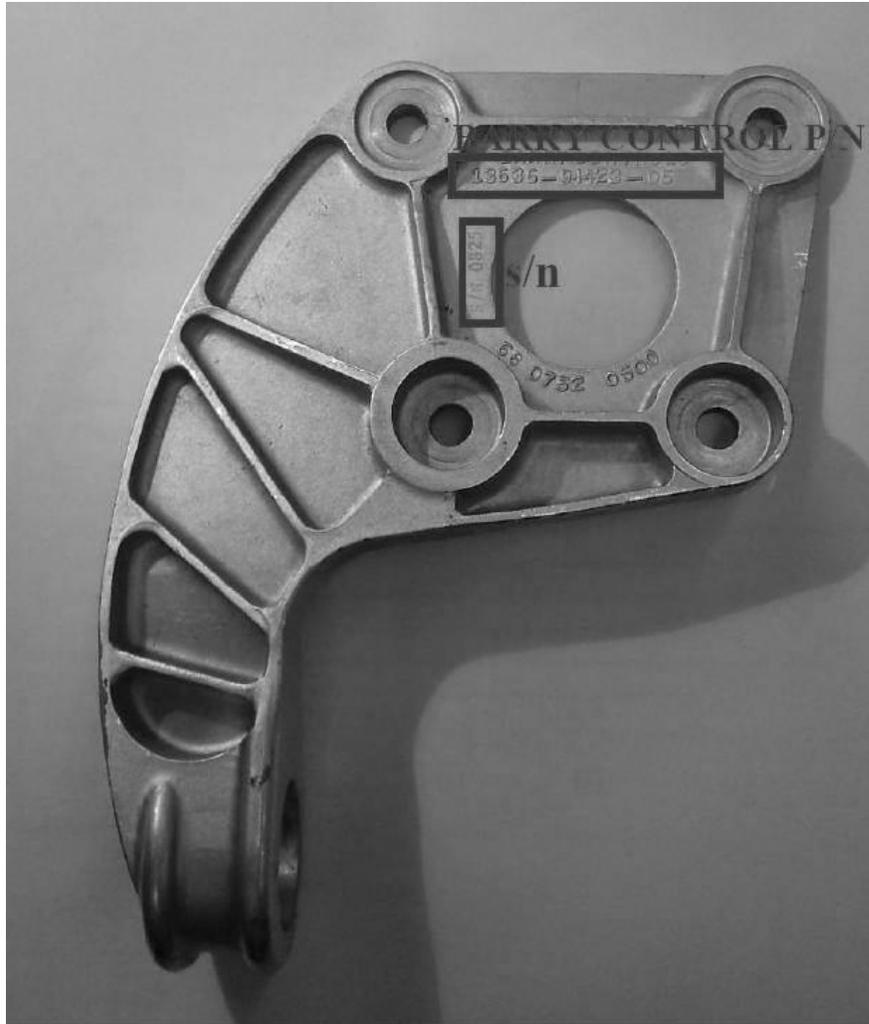
Figure 1 to paragraph (g)(1) of this AD - Location of Fitting Part Number and Serial Number

(1) Identify the serial number (S/N) of the part number (P/N) S54210394200 (Barry Control P/N 94423-05) LH and right-hand (RH) shock mount pick-up fittings installed on both engine nacelles. Figure 1 to paragraph (g)(1) of this AD identifies the fitting part number and serial number locations.

(2) If the serial number of the LH shock mount pick-up fitting, identified during any inspection required by paragraph (g)(1) of this AD, is lower than 2451 or is unreadable, and no crack has been found during any inspection required by paragraphs (g)(2) and (g)(3) of this AD: Within 6 months after the inspection required by paragraph (g)(2) of this AD, replace the LH shock mount pick-up fitting P/N S54210394200 with a serviceable LH shock mount pick-up fitting having a serial number equal to or higher than 2451, in accordance with a method approved by the Manager, International Branch, ANM-116, Transport Airplane Directorate, FAA; or EASA; or ATR – GIE Avions de Transport Régional's EASA DOA.

As of the effective date of this AD, do not install on any airplane a LH shock mount pick-up fitting P/N S54210394200, unless it is serviceable and has been determined to have an S/N equal to or higher than 2451, in accordance with the requirements of paragraph (g)(1) of this AD.

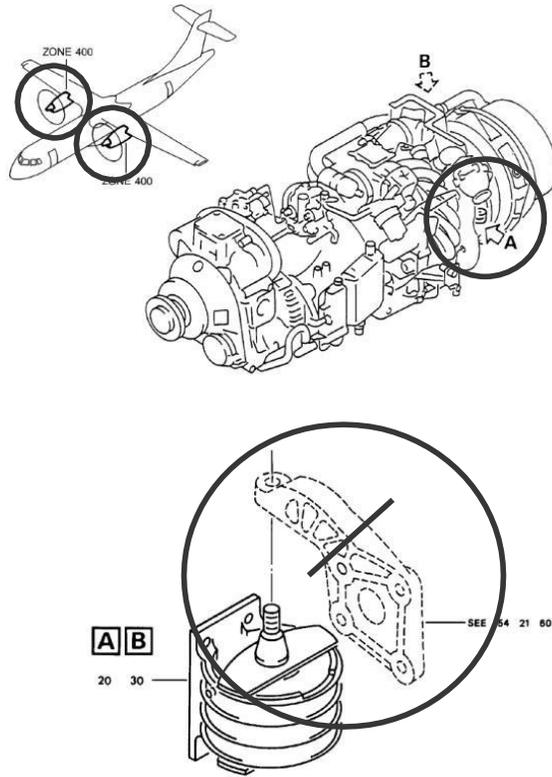
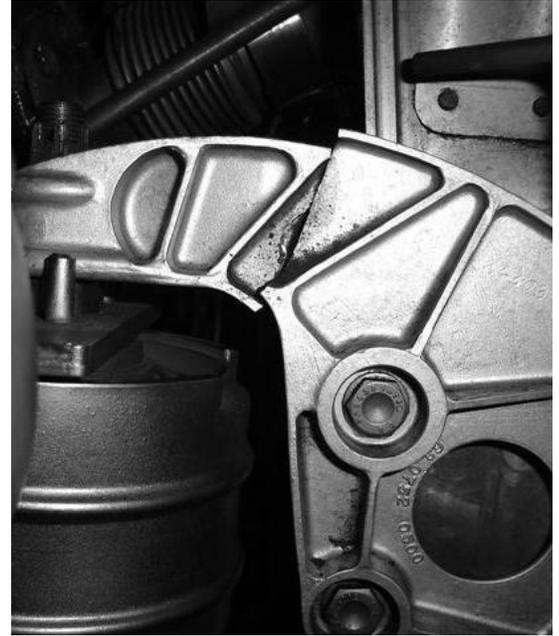
Figure 2 to Paragraph (g)(2) of this AD - Shock Mount Pick-up Fitting

Several cases of engine shock mount pick-up fitting with crack or failure have been reported, always on engine Left Hand (LH) aft side attachment. Prompted by those reports, improved Part Number (P/N) S54210394200 (Barry Control P/N 94423-05) fittings (machined radius modification) have been introduced in production, having serial number (s/n) 2451 and higher. No crack has been reported on aeroplanes equipped with those improved fittings.

(2) Do a detailed inspection of both LH and RH aft side isolator pick-up fittings on both engines to detect cracks, in accordance with paragraph 004.1 of ATR ATR72 Aircraft Maintenance Manual (AMM) Job Instruction Card (JIC) 54-11-61 DVI 10000, dated March 1, 2012. Refer to figure 2 to paragraph (g)(2) of this AD for potential crack location.

(1) If any crack is found during any inspection required by paragraphs (g)(2) and (g)(3) of this AD: Before further flight, repair in accordance with a method approved by the Manager, International Branch, ANM-116, Transport Airplane Directorate, FAA; or EASA; or ATR's EASA Design Organization Approval (DOA).

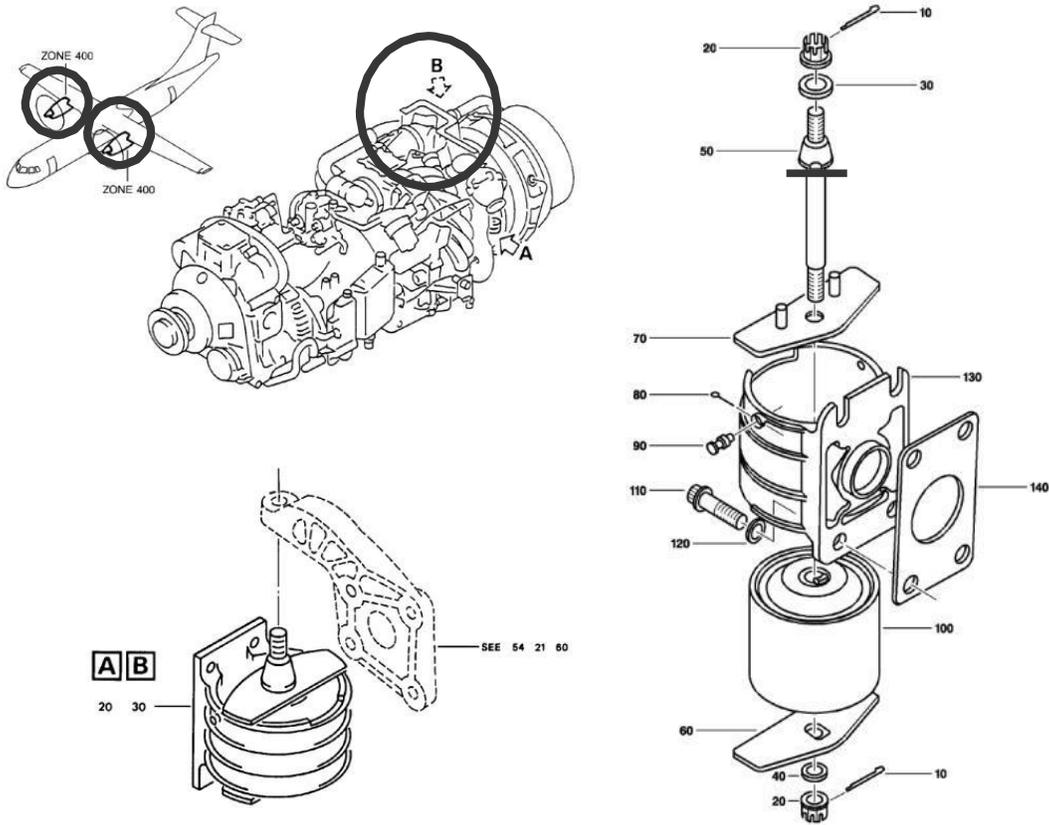
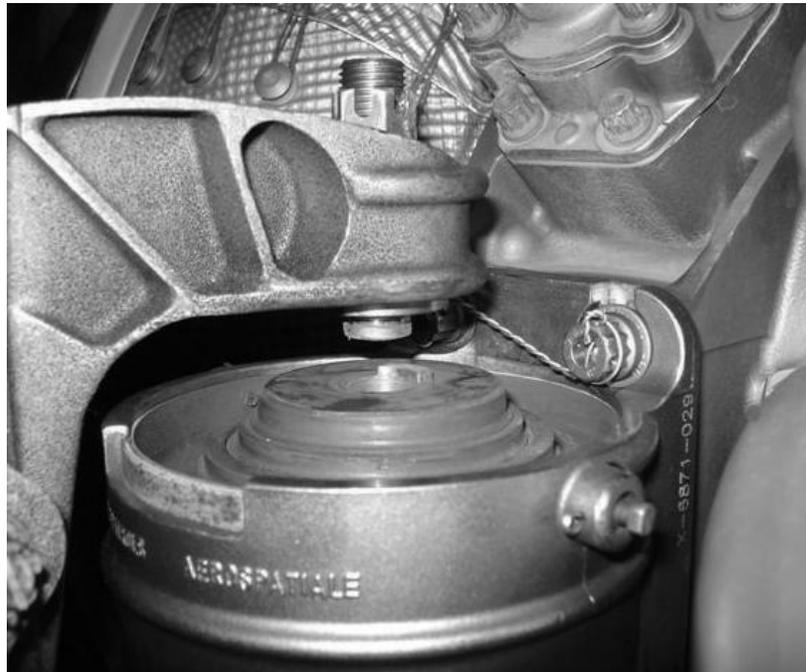
Figure 3 to paragraph (g)(3) of this AD - Shock Mount Cone Bolt

Two recent cases of failed cone bolt have been reported on ATR 72-212A aeroplanes, both on engine Right Hand (RH) aft side isolator.

(3) Do a detailed inspection of both LH and RH aft shock mount cone bolts on both engines to detect cracks, in accordance with paragraph 006.3.A. of ATR ATR72 AMM JIC 71-20-00 DVI 10000. Refer to figure 3 to paragraph (g)(3) of this AD for potential crack location.
