Airworthiness Directives; Airbus Airplanes

ACTION: Notice of proposed rulemaking (NPRM).

Airbus: Docket No. FAA-2015-8463; Directorate Identifier 2014-NM-226-AD.

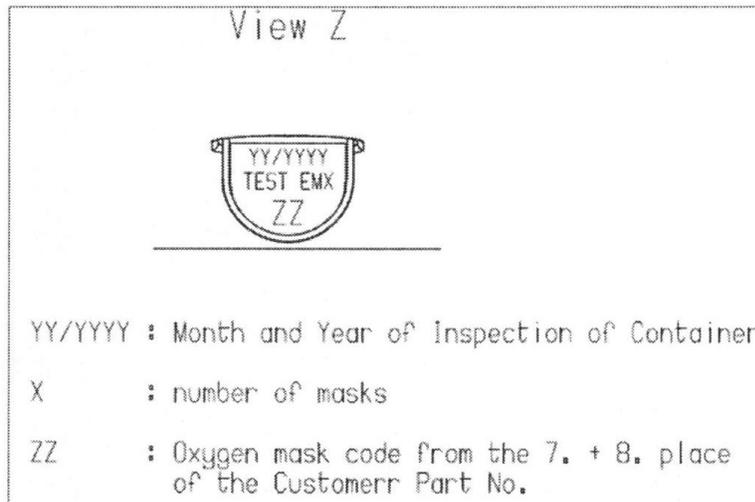
Picture A:

(4) Airplanes on which the design of the passenger oxygen container is not Design A, as defined in figure 1 to paragraph (l)(4) of this AD, are excluded from the requirements of paragraph (i) of this AD for that passenger oxygen container.

Note 2 to paragraph (l)(4) of this AD: For “Design A,” the placard on the passenger oxygen container test button is as described in “Picture A” in figure 1 to paragraph (l)(4) of this AD. The mask configuration (“ZZ” in “Picture A”) is a number, and the test button is as shown in “Picture B.”
