**[Docket No. FAA-2015-8463; Directorate Identifier 2014-NM-226-AD; Amendment 39-18612; AD 2016-16-14]**

**Airworthiness Directives; Airbus Airplanes**

**ACTION:** Final rule.

**2016-16-14 Airbus:** Amendment 39-18612; Docket No. FAA-2015-8463; Directorate Identifier 2014-NM-226-AD.

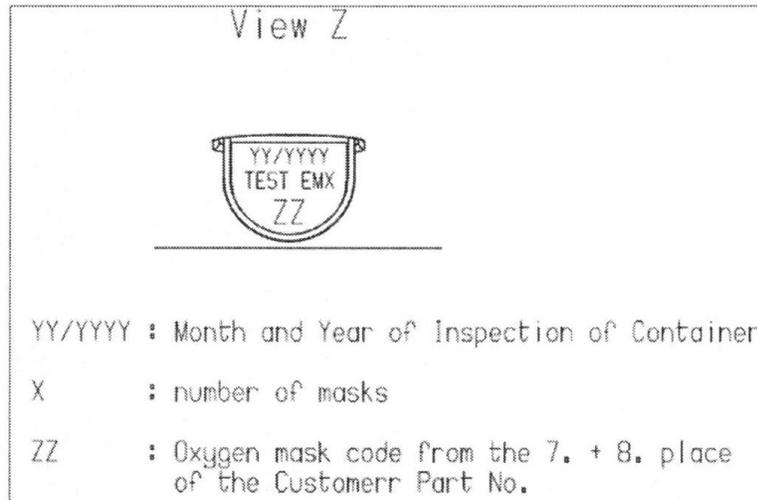
**Picture A:**

(4) Airplanes on which the design of the passenger oxygen container is not Design A, as defined in figure 1 to paragraph (l)(4) of this AD, are excluded from the requirements of paragraph (i) of this AD for that passenger oxygen container.

Note 2 to paragraph (l)(4) of this AD: For “Design A,” the placard on the passenger oxygen container test button is as described in “Picture A” in figure 1 to paragraph (l)(4) of this AD. The mask configuration (“ZZ” in “Picture A”) is a number, and the test button is as shown in “Picture B.”
