**[Docket No. FAA-2016-9254; Directorate Identifier 2015-CE-030-AD;]**

**Airworthiness Directives; Piper Aircraft, Inc. Airplanes**

**ACTION:** Notice of proposed rulemaking (NPRM).

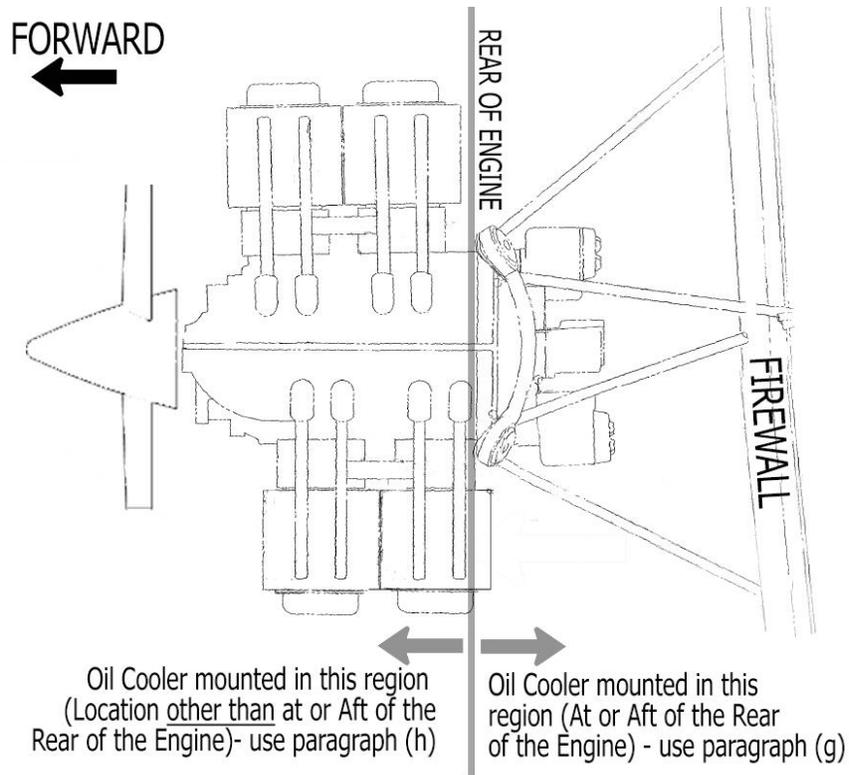
Figure 1 to paragraphs (g) and (h) of this AD: Oil cooler

For applicable airplanes with the oil cooler mounted at or aft of the rear of the engine (See figure 1 to paragraphs (g) and (h)): Within the next 100 hours time-in-service (TIS) after February 5, 1996 (the effective date retained from AD 95-26-13), and repetitively thereafter at intervals not to exceed 100 hours TIS, inspect the oil cooler hose assembly for oil soaked in the fire sleeve of the oil hose assembly, a brownish or whitish color of the fire sleeve of the oil hose assembly, and any evidence of brittleness or deterioration of the fire sleeve of the oil hose assembly as a result of heat or oil seepage.

(1) If any of the conditions described in paragraph (g) of this AD are found on the oil cooler hose assembly during the inspection required in paragraph (g) of this AD, before further flight, replace the oil cooler hose assembly with TSO-C53a Type D oil cooler hose assembly or TSO-C53a Type C oil cooler hose assembly that has been inspected following paragraph (g) of this AD and found to be airworthy.

(2) Replacement of the oil cooler hose assembly with TSO-C53a Type D oil cooler hose assembly is terminating action for this AD.

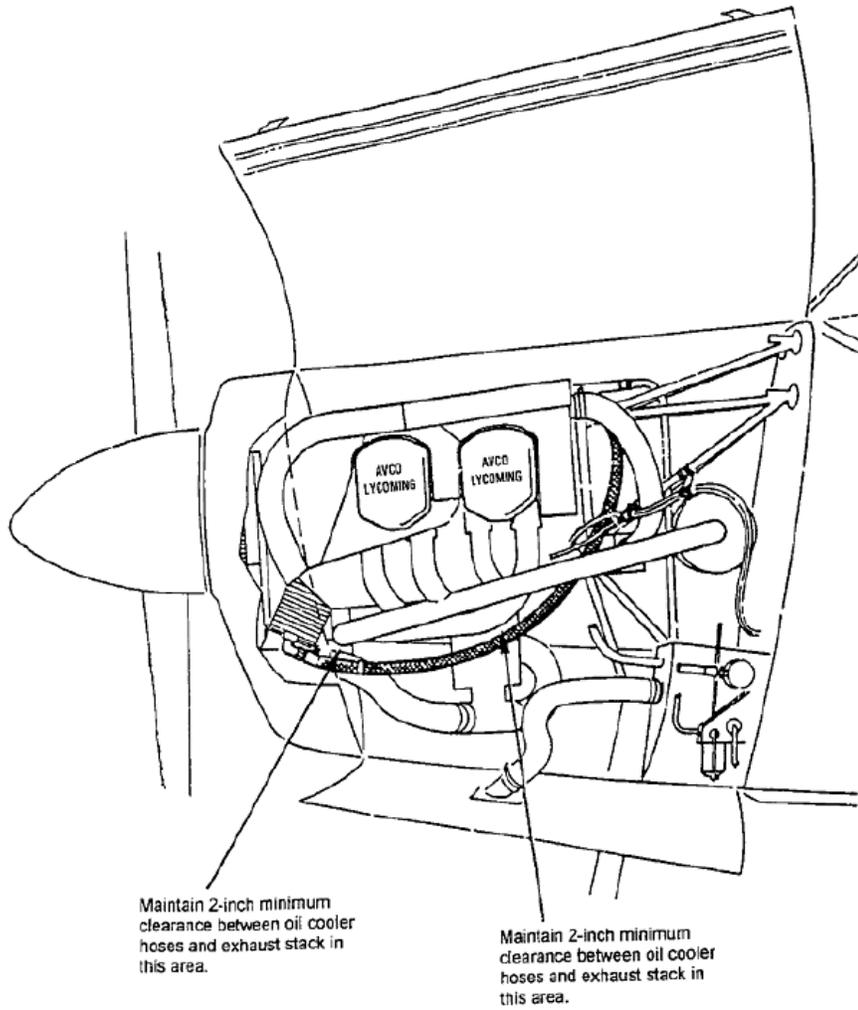
Figure 2 to paragraph (h) of this AD: Acceptable clearances

(3) Within the next 100 hours TIS after February 5, 1996 (the effective date retained from AD 95-26-13) and each time the oil cooler hose assembly is replaced for any reason or inspected following paragraph (h)(1) inspect to ensure the installation conditions in paragraphs (h)(3)(i) through (iii) of this AD are met. If the conditions listed in paragraphs (h)(3)(i) through (iii) of this AD are not met, before further flight, make any necessary adjustments. Please see figure 2 to paragraph (h) of this AD for additional information.

(i) The oil cooler hose assemblies pass underneath and behind the electrical ground cable and in front of the lower of the two engine mount.

(ii) The oil cooler hose assemblies are secured to the engine mount strut and a clearance of at least 2 inches exists between the oil cooler hose assemblies and the exhaust stack.

(iii) Oil cooler hose assemblies with a minimum outer diameter of 0.75 inch are installed with a bend radius of at least 6.5 inches.

(3) Replacement of the oil cooler hose assembly with TSO-C53a Type D oil cooler hose assembly and meeting the installation conditions listed in paragraphs (h)(3)(i) through (iii) of this AD terminate the requirements of this AD.
