[Docket No. FAA-2016-4228; Directorate Identifier 2015-NM-107-AD; Amendment 39-18734; AD 2016-25-08]

Airworthiness Directives; Airbus Airplanes

ACTION: Final rule.

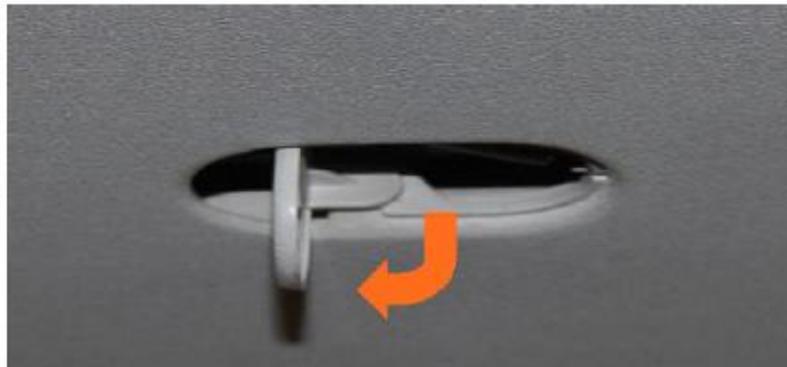
Figure 1 to Paragraph (i)(7) of this AD – Design A of the Passenger Oxygen Containers Affected by this AD

Design A: The placard on the passenger oxygen container test button is as described in Picture A of Appendix 1 of this AD. The Mask configuration (“ZZ” in Picture A) is a number and the test button is as shown in Picture B.

Picture B:

Note 2 to figure 1 to paragraph (i)(7) of this AD: For “Design A,” the placard on the passenger oxygen container test button is as described in “Picture A” in figure 1 to paragraph (i)(7) of this AD. The mask configuration (“ZZ” in “Picture A”) is a number, and the test button is as shown in “Picture B.”
