[Docket No. FAA-2017-0288; Directorate Identifier 2017-CE-007-AD]

Airworthiness Directives; Textron Aviation Inc. Airplanes

ACTION: Notice of proposed rulemaking (NPRM).

Textron Aviation Inc.: Docket No. FAA-2017-0288; Directorate Identifier 2017-CE-007-AD

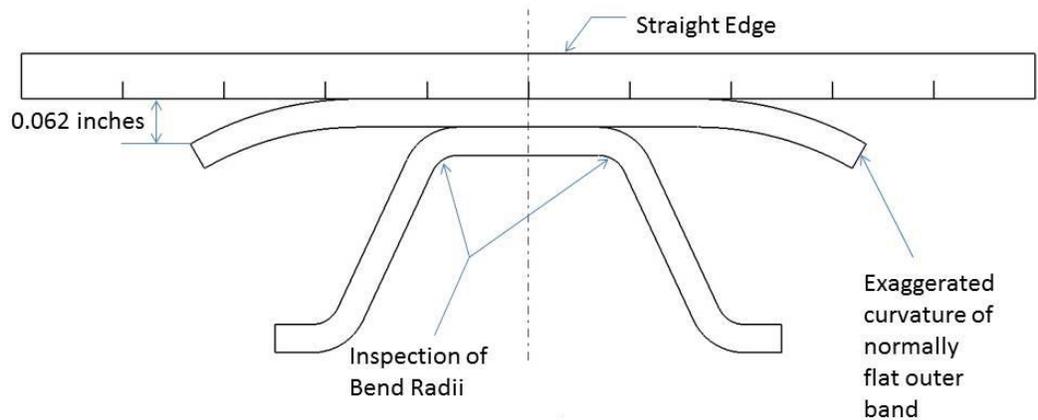
Figure 1 to paragraphs (h)(1)(iii) and (v) of this AD: Cross section of v-band coupling

(iii) Visually inspect the flatness of the outer band using a straight edge. Lay the straight edge across the width of the outer band. The gap must be less than 0.062 inches. See figure 1 to paragraphs (h)(1)(iii) and (v) of this AD. If the gap exceeds 0.062 inches between the outer band and the straight edge, do not re-install the v-band coupling. Before further flight, you must install a new v-band coupling and restart the hours TIS for the repetitive replacement of the v-band coupling.

(v) Visually inspect the bend radii of the coupling v-retainer coupling segments for cracks. Inspect the radii throughout the length of the segment. See figure 1 to paragraphs (h)(1)(iii) and (v) of this AD. If any cracks are found, do not re-install the v-band coupling. Before further flight, you must install a new v-band coupling and restart the hours TIS for the repetitive replacement of the v-band coupling.
