## **DEPARTMENT OF TRANSPORTATION**

### **Federal Railroad Administration**

**[Docket No. FRA-2017-0074; Notice No. 1]**

#### **Addressing Electrode-Induced Rail Pitting from Pressure Electric Welding**

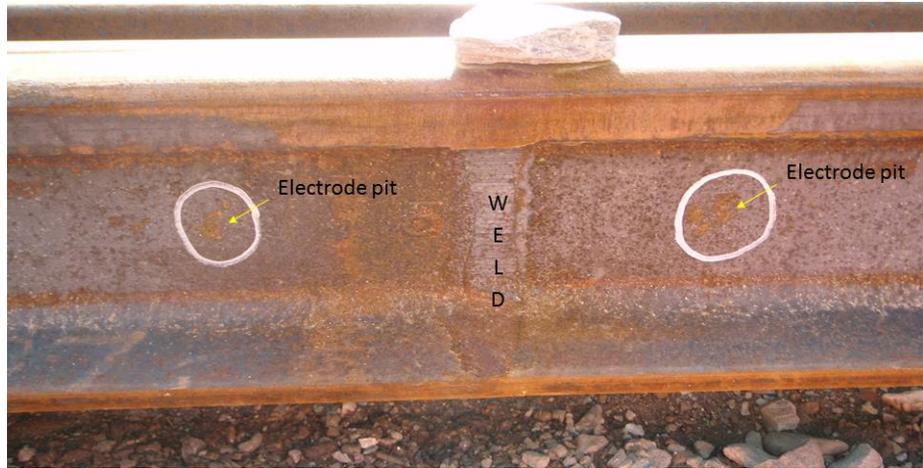
Pressure electric welding is the process of using a hydraulically-operated welding head that clamps around two opposing rail ends, pressing an electrode on each rail, then hydraulically pulling the rail ends together while arcing current through the electrodes into the rails, causing them to essentially melt together to form a continuous rail. FRA believes stray arcing during this process results in the formation of electrode burns or pits on the web, head, or base of the rail. Fractures in the rail may originate from the electrode pits because they behave as stress raisers (also referred to as stress concentrations). Fatigue cracks often develop at locations of stress concentration. Once a fatigue crack initiates, the localized stress encourages the growth of the crack, which may potentially lead to rail failure. FRA believes electrode pitting may be a contributing factor, if not the root cause, in some accidents involving rail web cracking.

Figure 1 below shows a photograph of a rail with electrode pits in the web. The location of these electrode pits, when they occur, is typically four to eight inches on either side of the weld. Electrode-induced pitting from pressure electric welding may also occur in the head and base of the rail. At this time, it is unclear whether traditional ultrasonic rail testing can consistently detect electrode-induced pitting.

Figure 1: Electrode-Induced Pits in a Rail

**Recommended Action:** Based on the discussion above, and to prevent future electrode-induced pitting and fatigue cracking which may lead to premature rail failure, FRA recommends railroads, contractors, and the rail welding industry develop and apply appropriate methods to:

1. Prevent electrode-induced rail pitting from occurring by:
  - a. Reviewing proper pre- and post-weld procedures to avoid the development of electrode pitting;
  - b. Improving welder training programs to ensure consistency in welding procedures, especially for the pressure electric welding process; and
  - c. Developing and scheduling appropriate pressure electric welding maintenance and rail testing programs.
2. Identify electrode-induced rail pitting by:
  - a. Inspecting the rail upon completion of welding, and reviewing the documentation in the weld report to help identify if pitting occurred;
  - b. Visually inspecting existing welds for electrode-induced pitting during routine track inspections; and

- c. Considering alternative methods of identifying electrode-induced pitting, such as ultrasonic testing, machine vision, etc.
3. Remediate any identified electrode-induced pitting by:
- a. Removing the section of rail containing electrode-induced pitting and re-welding the rail; or
  - b. Developing and applying possible alternative methods to remove electrode-induced pitting, such as drilling, if electrode-induced pitting is found and the section of rail cannot be readily removed or re-welded.

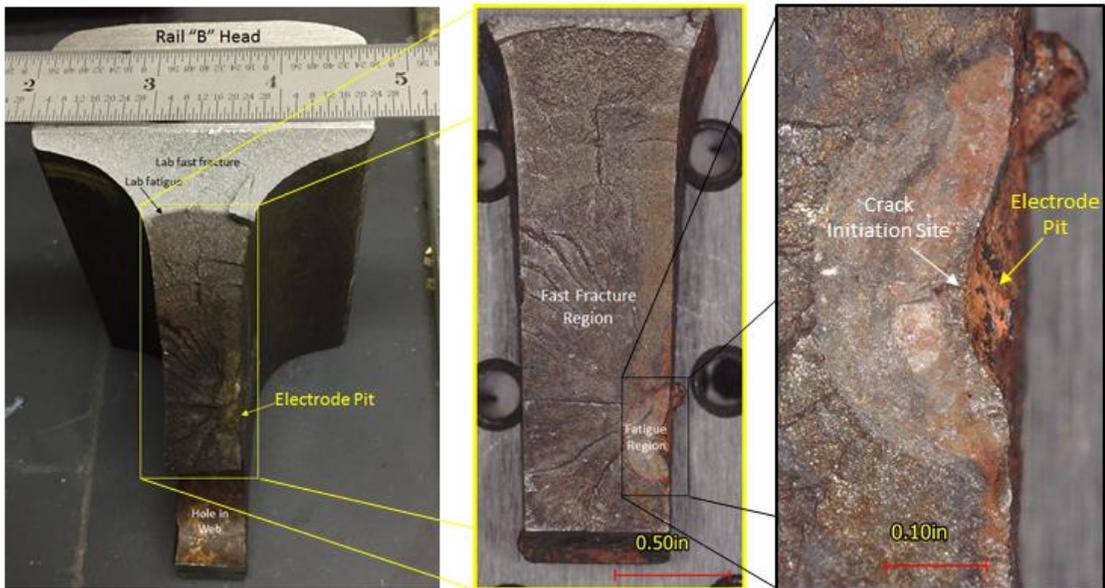
Specifically, Benét's metallurgical analyses concluded the cracking in the rail web originated from the pitting created by inadequate electrode-to-rail contact during the pressure electric welding process. The fractographic and metallographic examinations revealed evidence of fatigue cracking originating from the pitting and fast fracture once the fatigue crack reached a critical length. Figure 2 below shows three photographs of the fracture surface of a crack found in one of the rails Benét examined. These photographs support the metallurgical evidence indicative of three stages of fatigue fracture: (1) Crack initiation or formation originating from the pitting; (2) crack propagation or growth by metal fatigue; and (3) final rupture or fast fracture. Figure 3 below shows photographs of the microstructure near the electrode pits in each examined rail, providing further evidence the cracking originated from the pitting created by improper electrode contact during welding.

Figure 2: Photographs of Crack Fracture Surface in Examined Rail

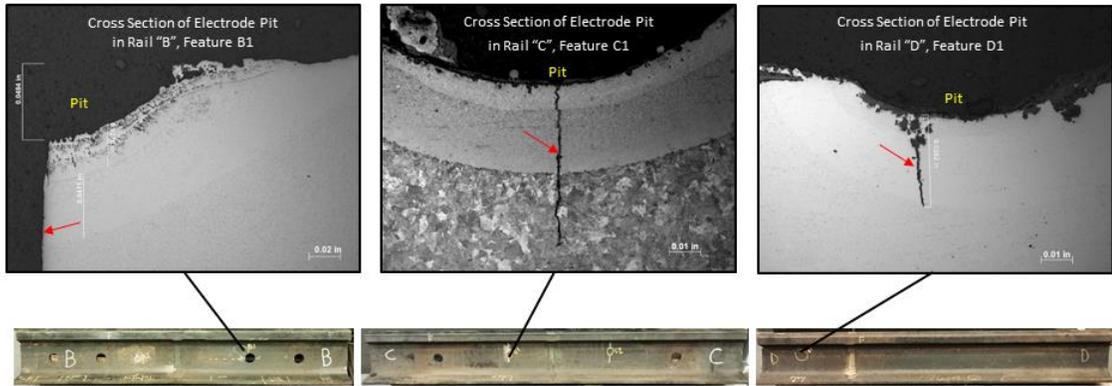
The results from the metallurgical analysis also suggested premature and sudden rail failure may result from high wheel-impact load (e.g., flat wheel), especially in cold-weather environments when the longitudinal rail force is tensile. Results from the chemical analysis and mechanical testing indicated the chemistry and mechanical properties of the rails selected for evaluation were within specifications the American Railway Engineering and Maintenance-of-Way Association (AREMA) published, except for the hardness measurements in one rail, which were slightly lower than the AREMA minimum. Hardness is a measure of the resistance of a material to surface indentation produced by a carbide indenter applied at a given load for a given length of time. The lower hardness in that rail, manufactured in the 1950s, may be attributed to lower concentrations (compared to the other two rails) of alloying elements, specifically carbon, silicon, and chromium, which were still within AREMA tolerances. Testing of the chemistry and the mechanical properties revealed all three rails were made from standard quality steel containing no other defects except the electrode-induced pitting.

Figure 3: Photographs of Rail Cross Sections
