[Docket No. FAA-2020-0455; Product Identifier 2019-SW-105-AD; Amendment 39-21130; AD 2020-11-05]

Airworthiness Directives; Airbus Helicopters

SUMMARY: The FAA is adopting a new airworthiness directive (AD) for all Airbus Helicopters Model EC120B helicopters. This AD was prompted by a report of recurrent loss of tightening torque on several attachment bolts of the tail rotor hub body. This AD requires repetitive inspections of the tail rotor hub body for cracks and applicable corrective actions if necessary, and repetitive replacement of the attachment bolts, washers, and nuts of the tail rotor hub body. The FAA is issuing this AD to address the unsafe condition on these products.

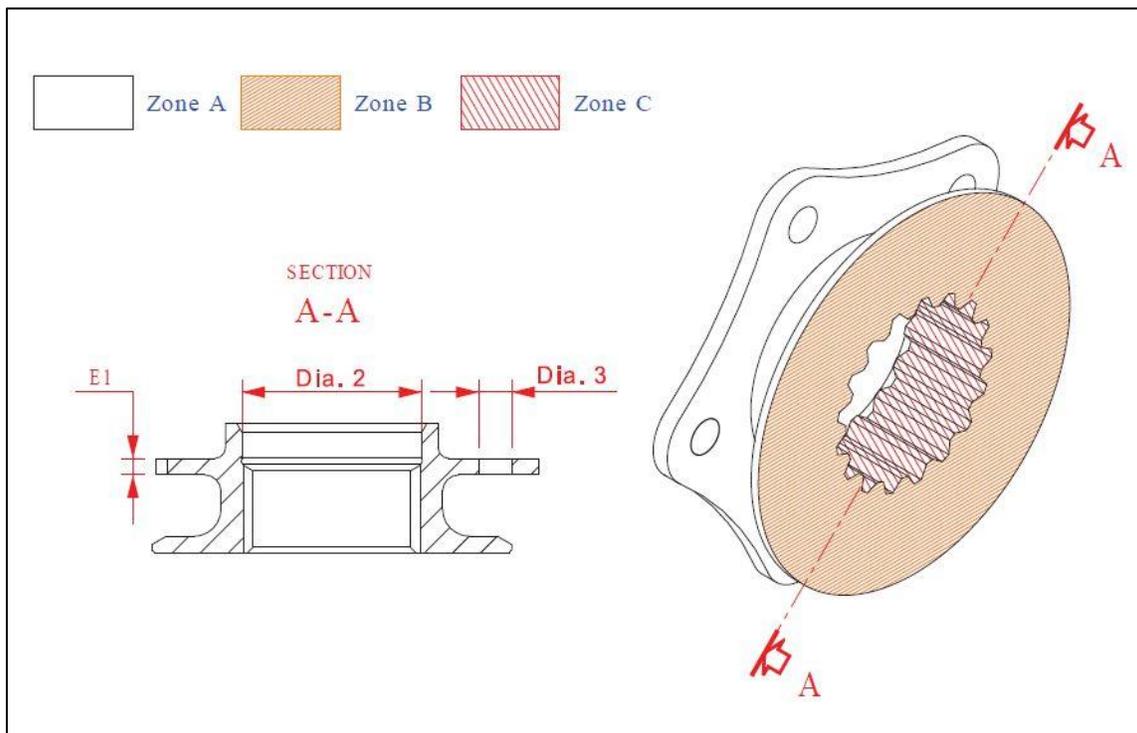
Figure 2 to paragraph (i)(1) – Inspection Areas of Tail Rotor Splined Flange

Location as specified in figure 2 to paragraph (i)(1) of this AD	Maximum damage, which causes replacement (E1, Dia. 2, and Dia. 3 are shown in figure 2 to paragraph (i)(1) of this AD)
Zone A	Score, depth more than 0.2 millimeters (mm) (0.008 in.) Crack E1 less than 2.75 mm (0.108 in.) Dia. 3 more than 6.02 mm (0.2371 in.) Dia. 2 more than 33.03 mm (1.3004 in.)
Zone B	Sanding depth more than 0.1 mm (0.004 in.) Crack
Zone C	Crack Score, depth more than 0.2 mm (0.008 in.)

(2) If, during any inspection of the tail rotor splined flange required by paragraph (i)(1) of this AD, the condition of the part exceeds the criteria as specified in figure 1 to paragraph (i)(1) of this AD, before next flight, replace the tail rotor splined flange with an airworthy tail rotor splined flange in accordance with the instructions of section 3.B.4 of Airbus Helicopters Emergency Alert Service Bulletin 05A020, Revision 1, dated November 8, 2019.
