## Roof Inspection Report

5793 Independence St.  
Arvada, CO 80002

March 4, 2019

Section: 1  
Roof System: Modified GTA  
Size: 1300 Sqft  
Inspection Date: March 1, 2019

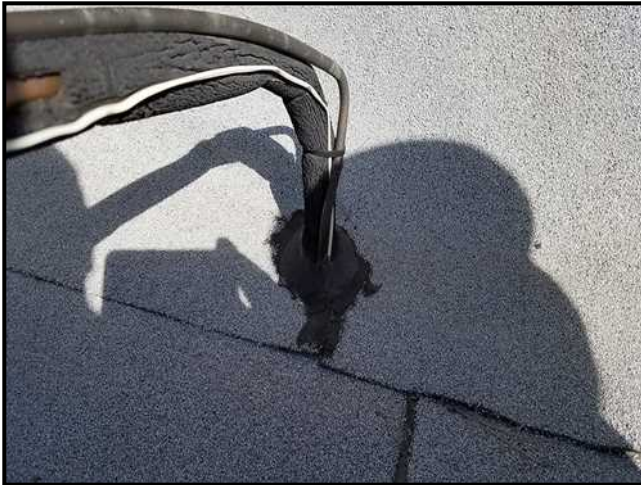
**Deficiency #1** Remedial

**Quantity:** 1 EA

Missing Pitch Pocket.

Monitor or perform repairs to increase its longevity.

Install per manufacture specification once a new roof system is installed.

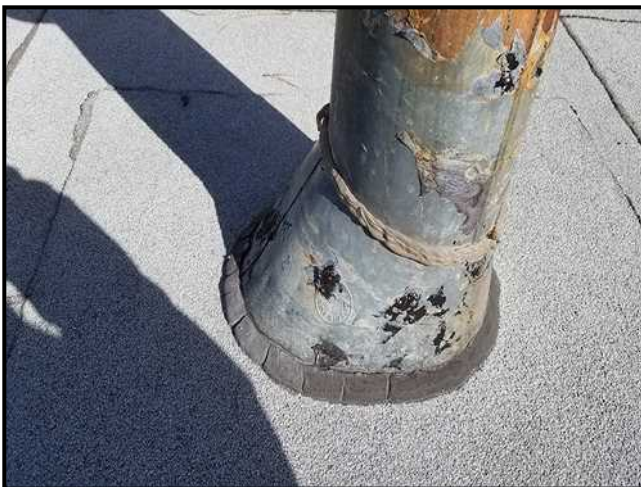
**Deficiency #2** Remedial

**Quantity:** 1 EA

Displaced /Cracked Sealants

Monitor or perform repairs to increase its longevity.

Perform standard modified 3 coarse repairs.

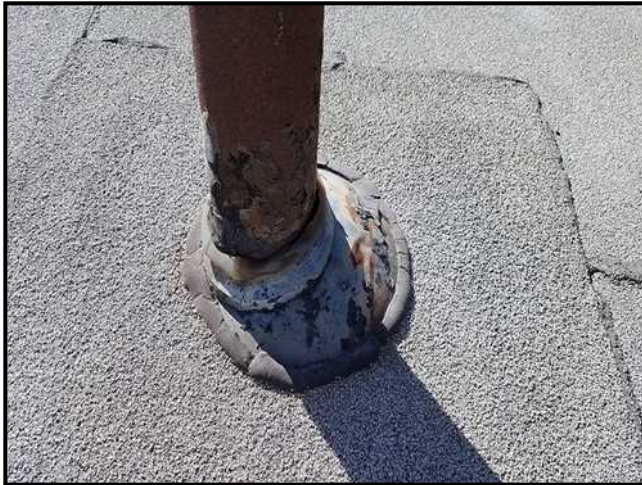
**Deficiency #3** Emergency

**Quantity:** 1 EA

Displaced / Cracked Sealants

Perform a 3 coarse repair to mitigate any leaking into the underlying substrates.

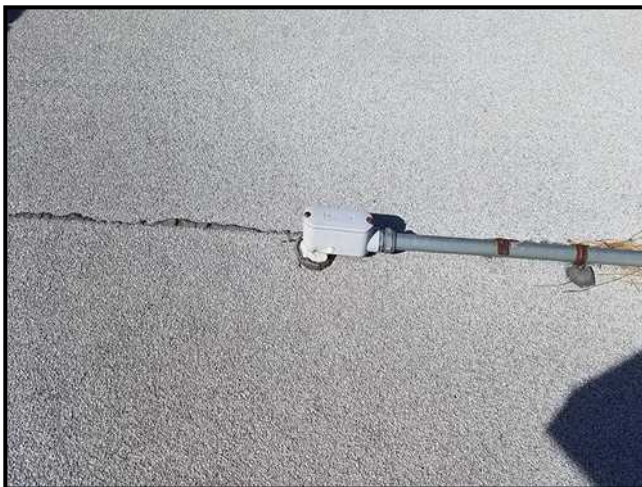
**Deficiency #4** Remedial

**Quantity:** 1 EA

Missing Pitch Pocket.

Monitor or perform repairs to increase its longevity.

Install per manufacture specification once a new roof system is installed.

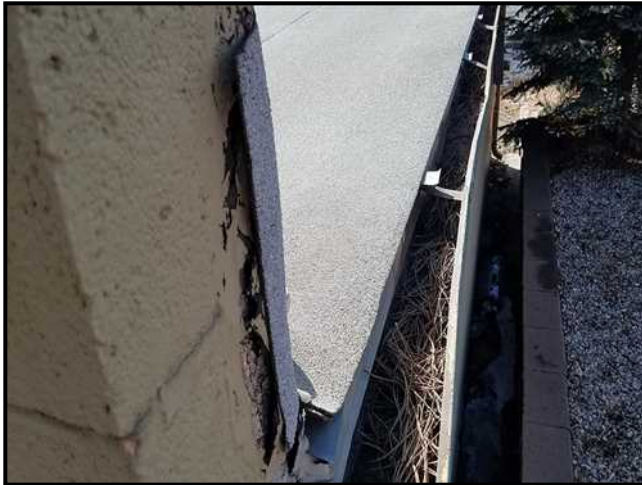
**Deficiency #5** Emergency

**Quantity:** 2 LF

Missing Termination

Install termination bar and sealants per manufactures specifications.

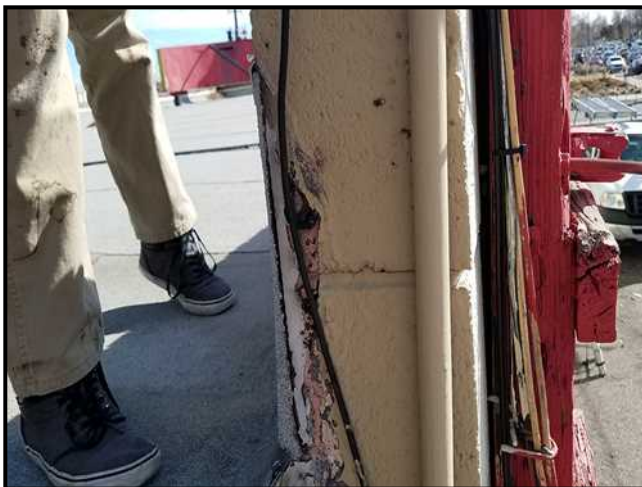
**Deficiency #6** Emergency

**Quantity:** 2

LF  
Missing Termination

Install termination bar and sealants per manufactures specifications.

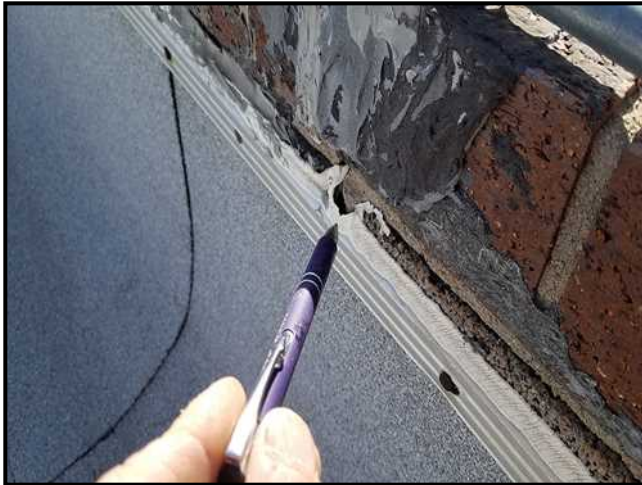
**Deficiency #7** Emergency

**Quantity:** LF

Displaced / Cracked Sealants

Perform a 3 coarse repair to mitigate any leaking into wall flashing and the underlying substrates.

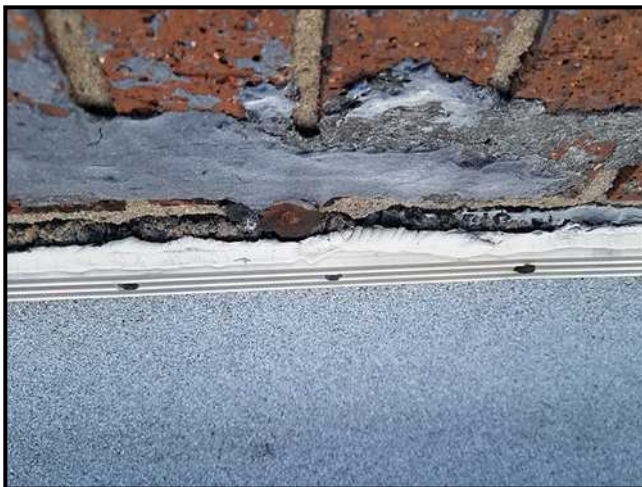
**Deficiency #8** Emergency

**Quantity:** LF

Displaced / Cracked Sealants

Perform a 3 coarse repair to mitigate any leaking into wall flashing and the underlying substrates.

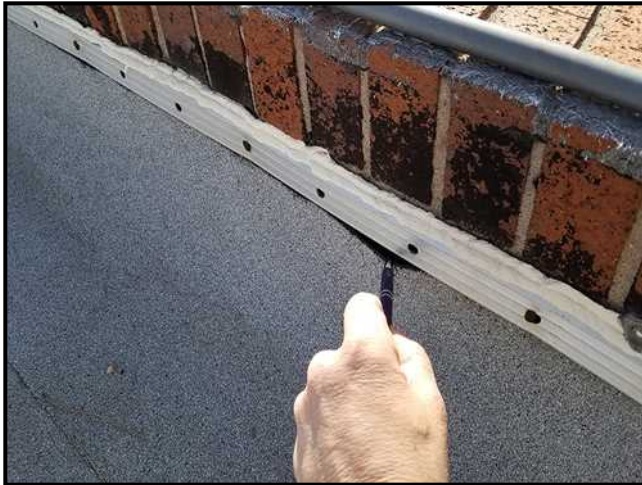
**Deficiency #9** Emergency

**Quantity:** 5 LF

Missing Termination

Install termination bar and sealants per manufactures specifications.

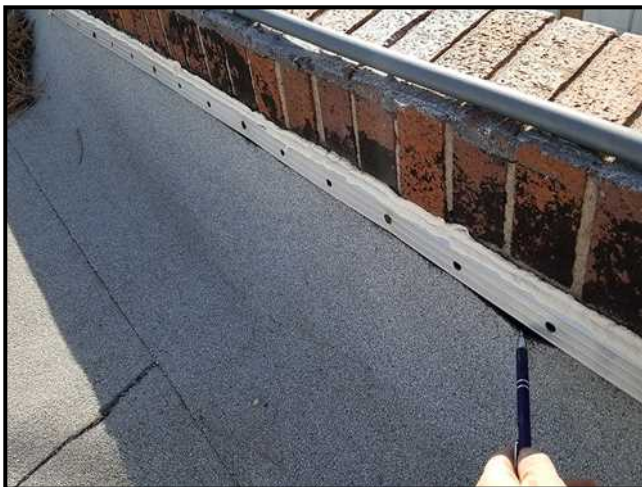
**Deficiency #10** Emergency

**Quantity:** 5 LF

Missing Termination

Install termination bar and sealants per manufactures specifications.

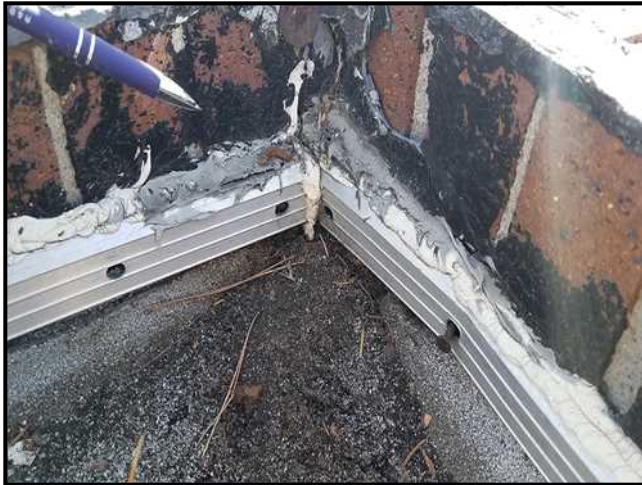
**Deficiency #11** Emergency

**Quantity:** LF

Displaced / Cracked Sealants

Perform a 3 coarse repair to mitigate any leaking into wall flashing and the underlying substrates.

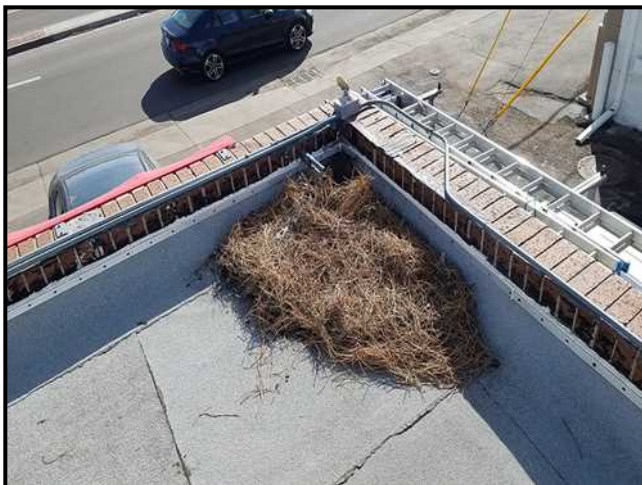
**Deficiency #12** Remedial

**Quantity:** 1

Roof Debris

Bag, clean area and dispose of offsite.

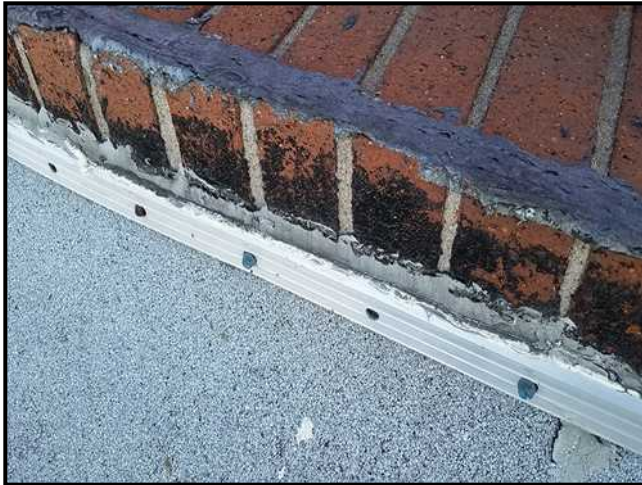
**Deficiency #13** Emergency

**Quantity:** LF

Displaced / Cracked Sealants

Perform a 3 coarse repair to mitigate any leaking into wall flashing and the underlying substrates.

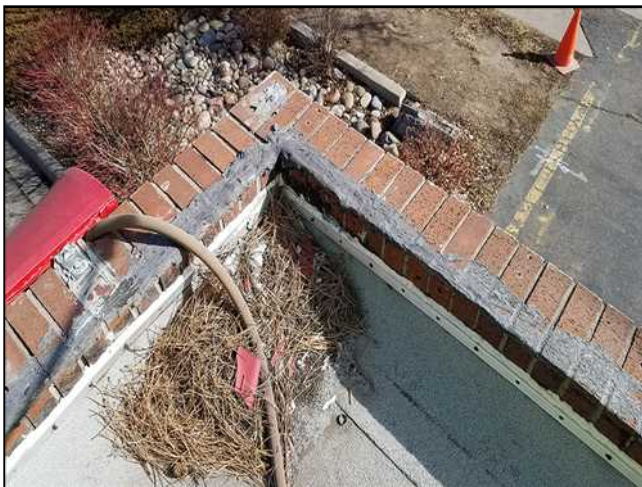
**Deficiency #14** Remedial

**Quantity:** 1

Roof Debris

Bag, clean area and dispose of offsite.

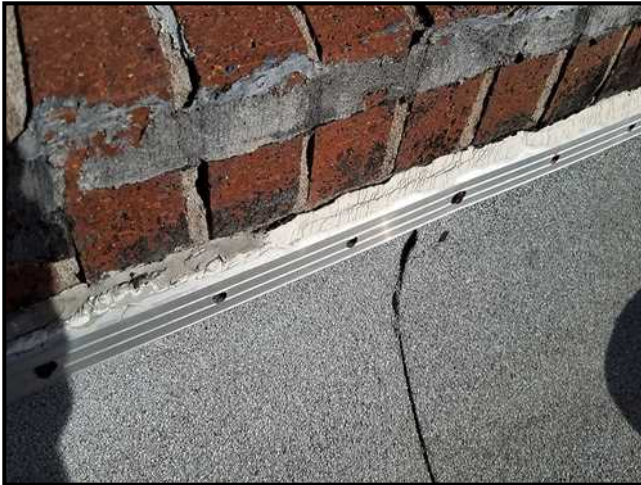
**Deficiency #15** Emergency

**Quantity:** 1 LF

Open Base Flashings

Perform a 3 coarse repair to mitigate any leaking into wall flashing and the underlying substrates.

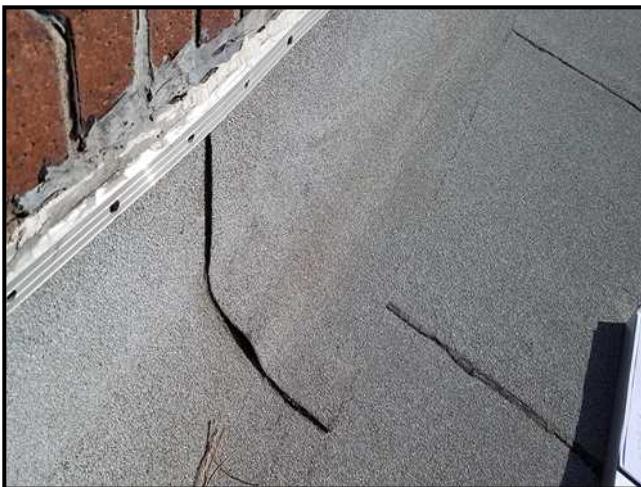
**Deficiency #16** Emergency

**Quantity:** 4 LF

Open Base Flashings

Perform a 3 coarse repair to mitigate any leaking into wall flashing and the underlying substrates.

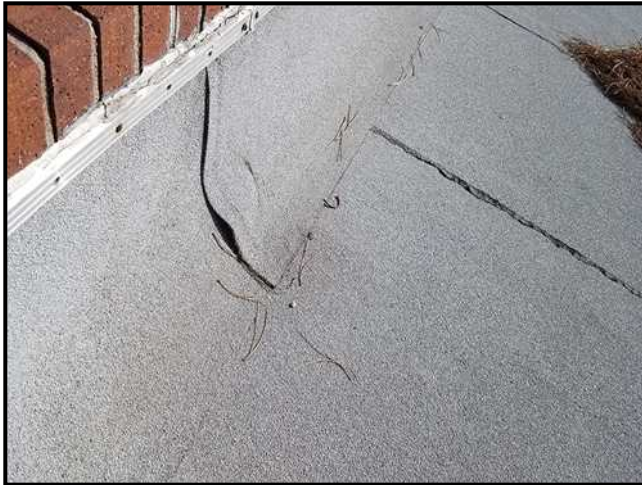
**Deficiency #17** Emergency

**Quantity:** 4 LF

Open Base Flashings

Perform a 3 coarse repair to mitigate any leaking into wall flashing and the underlying substrates.

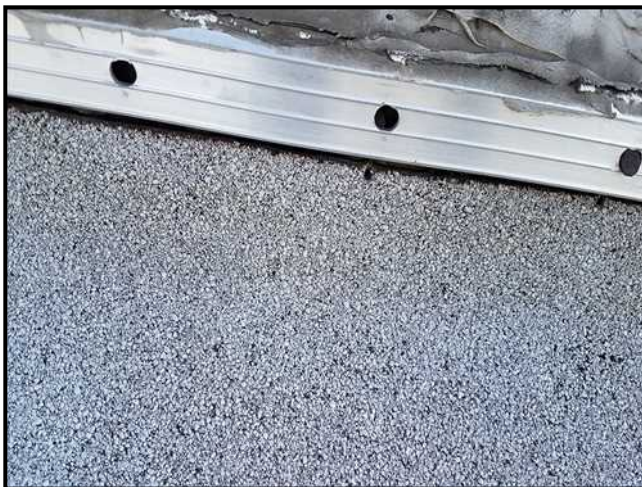
**Deficiency #18** Emergency

**Quantity:** 5 LF

Missing Termination

Install termination bar and sealants per manufactures specifications.

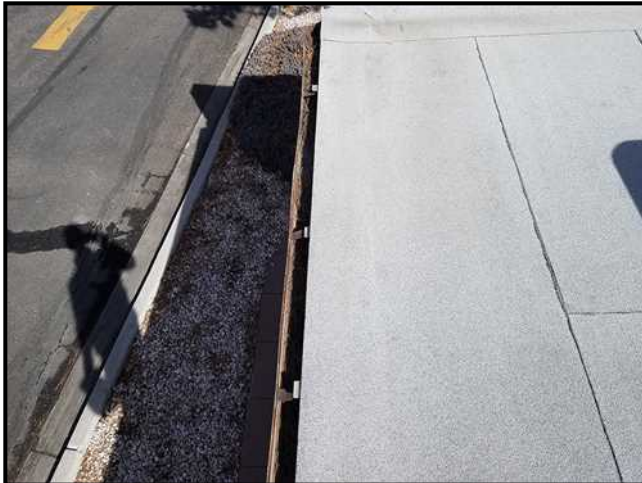
**Deficiency #19** Emergency

**Quantity:** 30

LF  
Debris In Drainage

Clean, bag and dispose off site
