# Inspection Report

1116 Ocean BLVD  
Rye NH 03871

# 1. Septic System

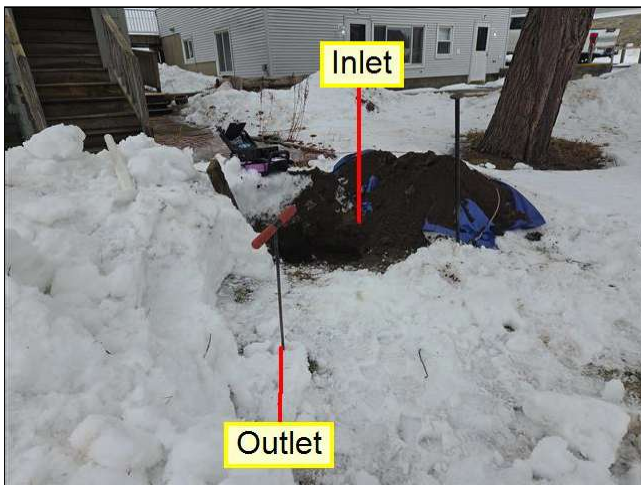
**1.1** The 1000 gallon concrete treatment tank is located approximately five feet from the brick walkway. There is a riser and cover for the inlet end of the tank within five feet of grade, however, the outlet end of the tank is three feet below grade.

Tank location

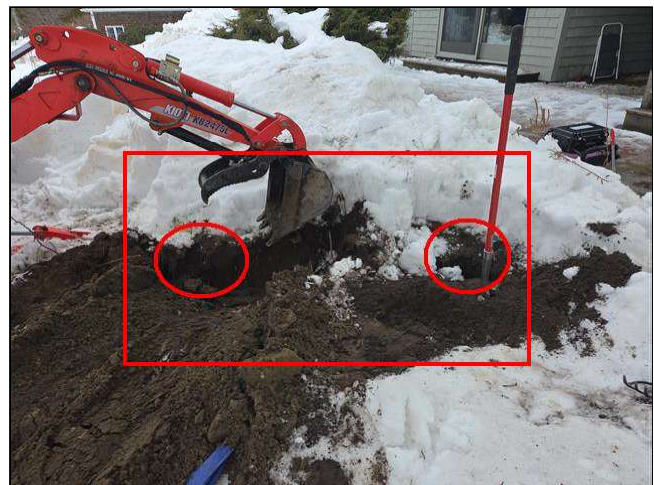
Tank location

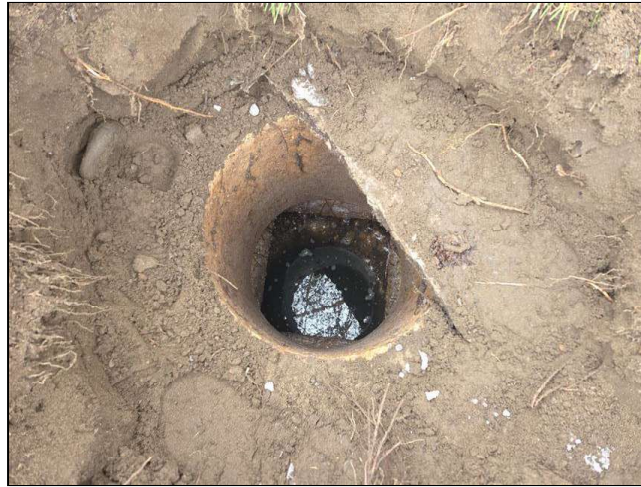
Tank access

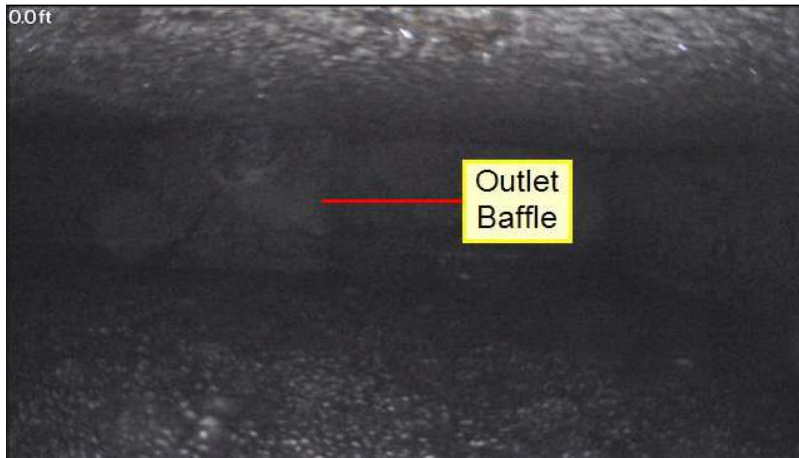
A visual inspection of the treatment tank revealed normal liquid levels and both baffles are intact. The sludge/scum levels appear to be less than 2/3 of the tanks capacity, therefore, I recommend the tank be pumped in one year and subsequently every 3-5 years thereafter.

Outlet baffle intact

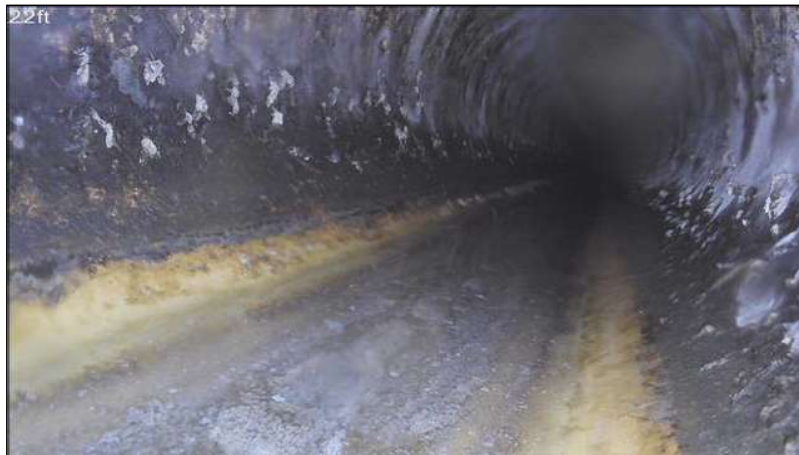
View of main sewer line

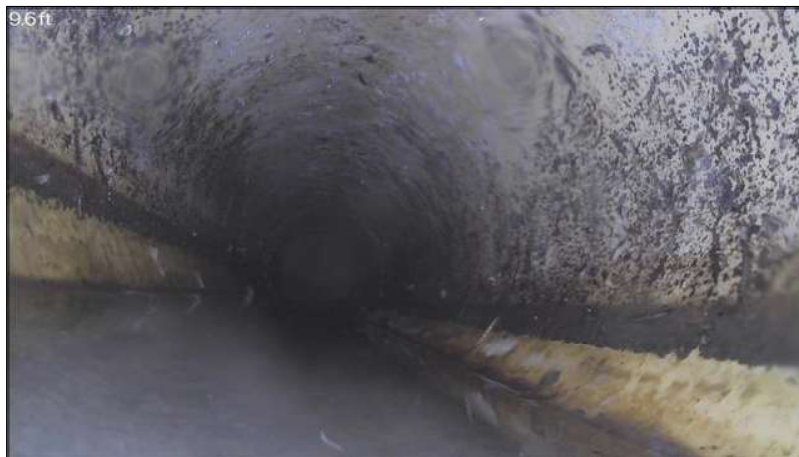
Sewer line intact

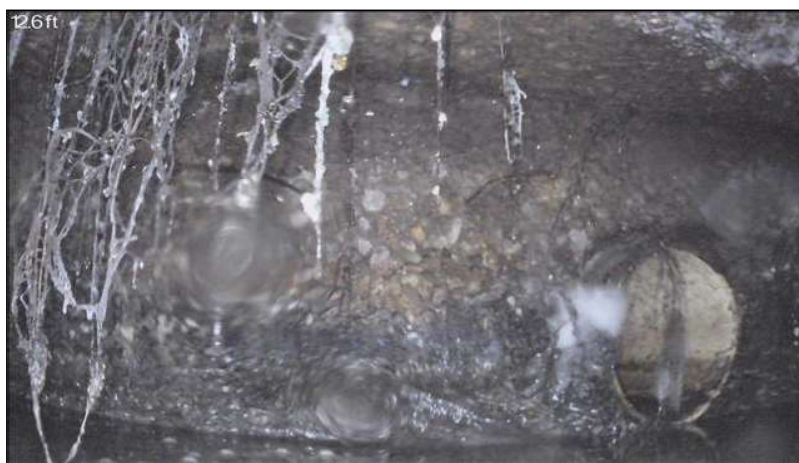
**1.2** The D-Box (Distribution Box) was evaluated using a sewer camera. Normal liquid levels were observed with no apparent defects present.

View inside D-Box

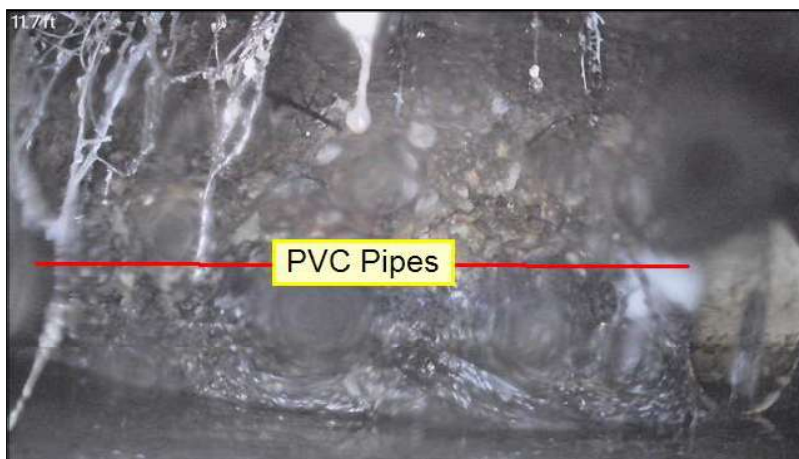
View of PVC Pipes/D-Box

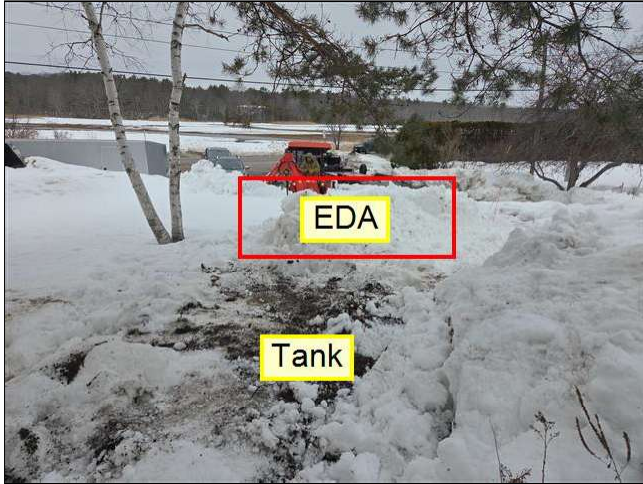
**1.3** The effluent disposal area is located just beyond the treatment tank in the yard in front of the driveway. The EDA consists of two or three rows of PVC perforated pipe installed on a bed of crushed stone. One inspection hole was dug at the middle/end of the EDA where conditions were normal. No significant staining or standing effluent was observed. Overall I found the system to be in satisfactory condition.

View of EDA

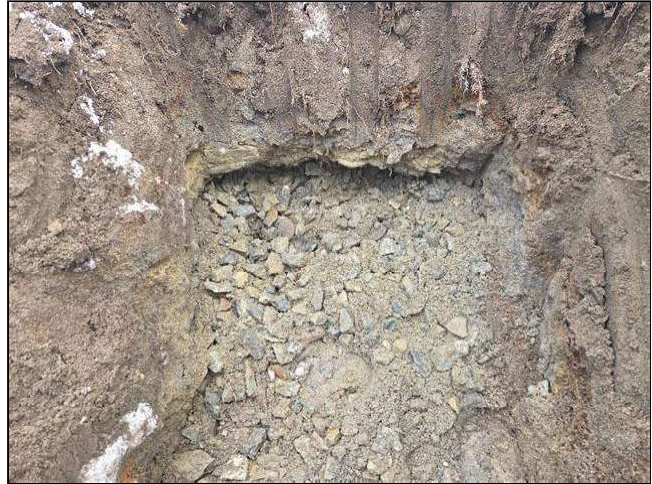
View of EDA/dry

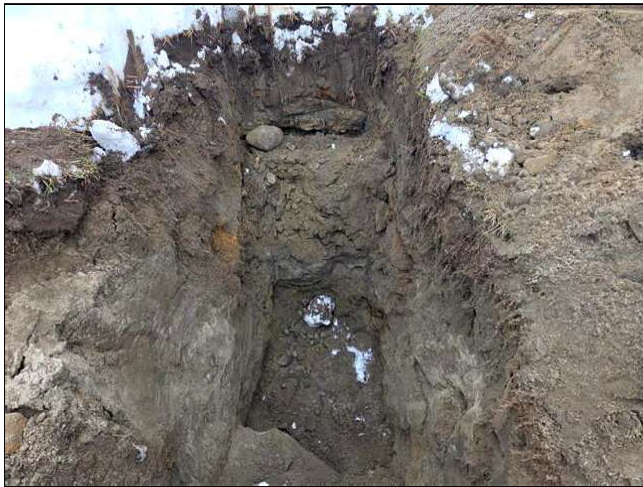
View of inspection hole

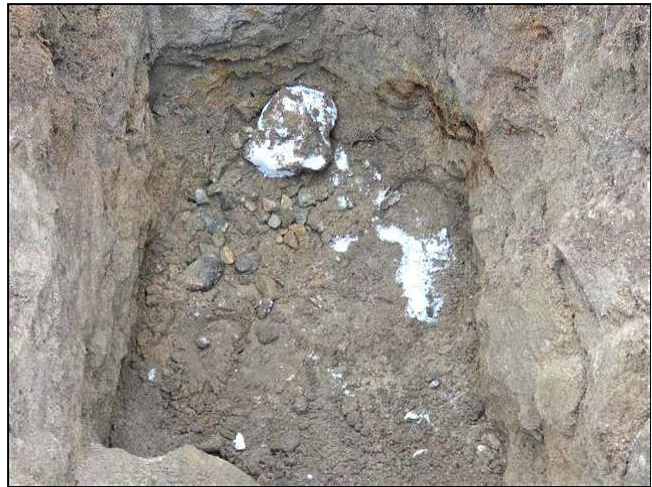
Dry conditions observed
