# Inspection Report

6 Wildwood LN  
Rye NH 03870

# 1. Septic System

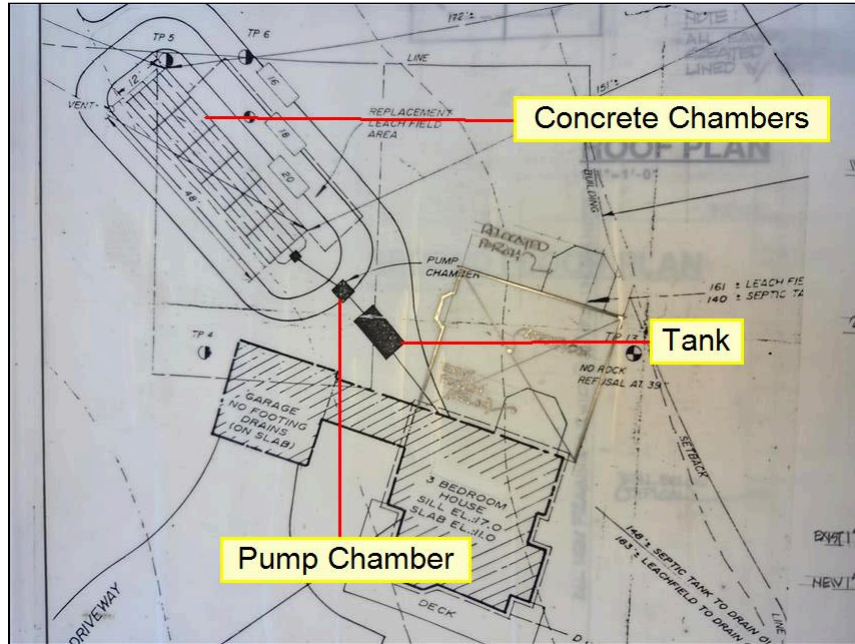
View of system per plan

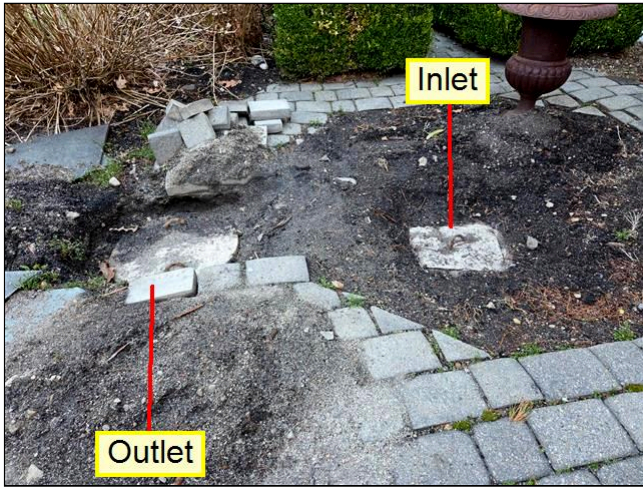
Tank location

1.1 The treatment tank was recently pumped therefore the liquid levels have not reached operating levels yet. Overall the tank was found to be in satisfactory condition and both baffles are intact.

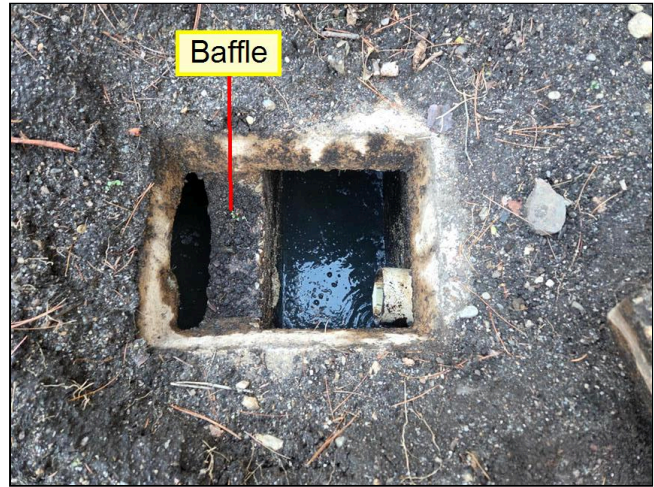
Inlet baffle intact

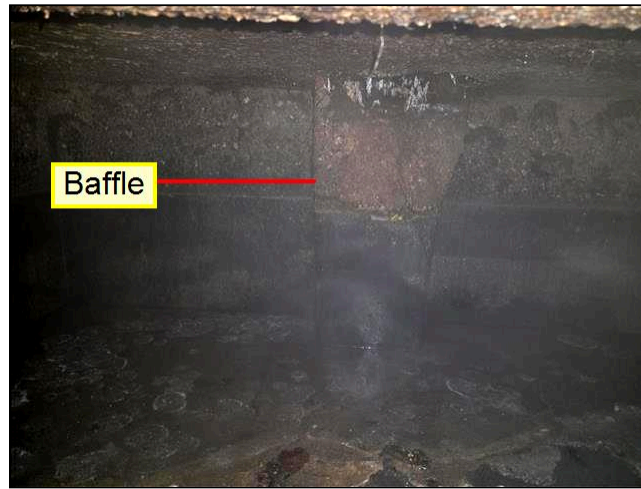
Outlet baffle intact

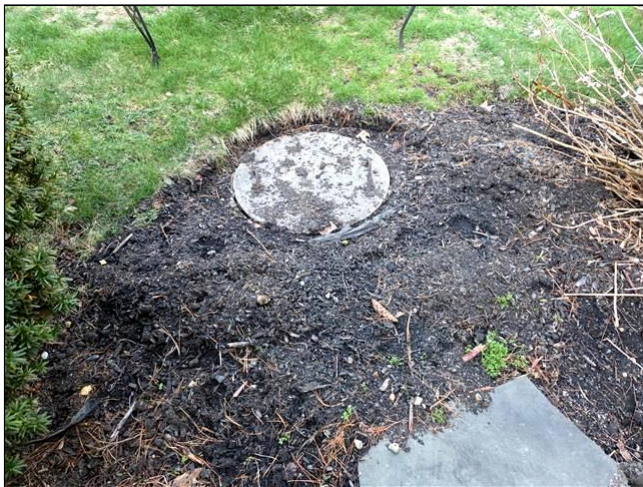
Pump chamber

1.2 The pump chamber is located in front of the septic tank. The pump was activated and functioned as intended.

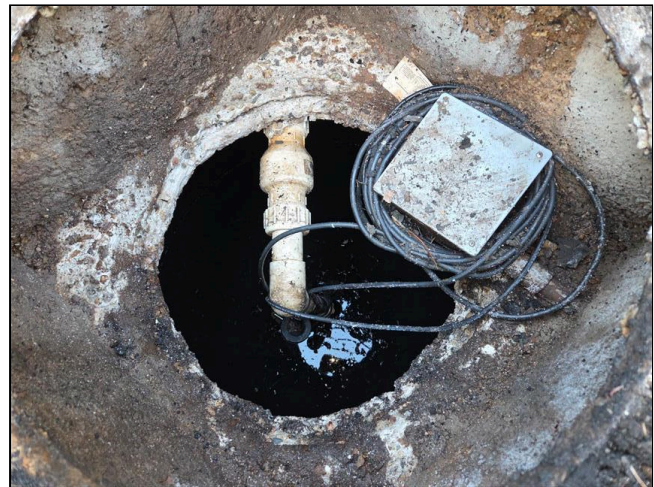
Pump chamber satisfactory

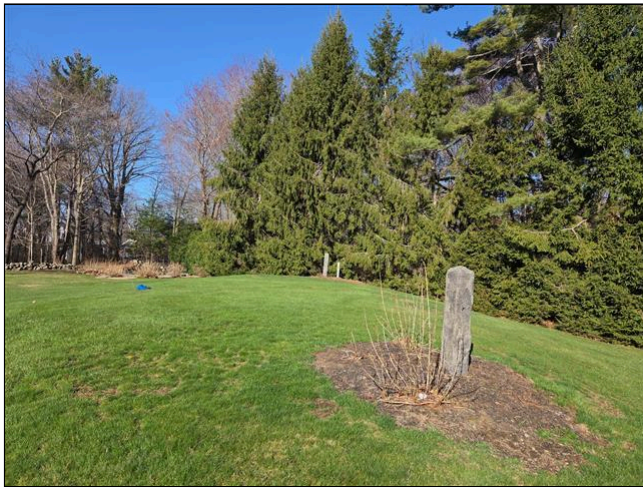
**1.4** The effluent disposable area (EDA) is up hill from the pump chamber along the back side of the driveway and consists of 18 concrete chambers installed on a bed of sand in a parallel distribution manner. One inspection hole was dug in the middle right side of the EDA where conditions were normal. Using a sewer camera, I video scoped the inside of the chamber where there was no standing effluent, significant staining of the sand or any visible settlement.

Also video scoping through the beginning and end vents revealed normal conditions. A functional flow test was conducted where I introduced approximately 100 gallons of water into the pump chamber and activated the pump. The system functioned as intended with some standing effluent observed in the first chamber which is normal after pump activation. Overall the system was found to be in good or middle age condition.

View of EDA

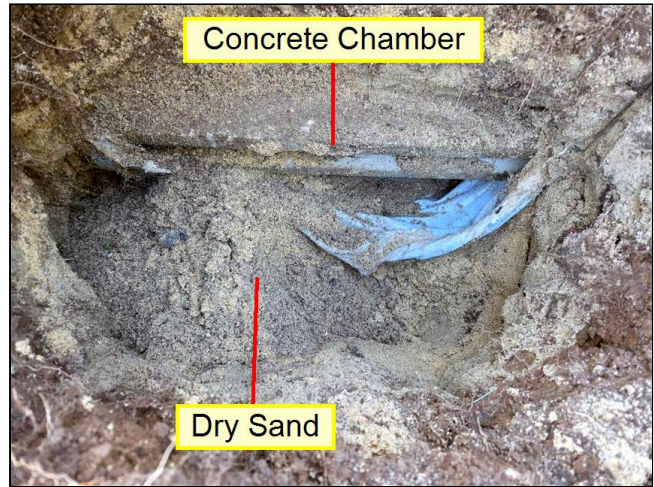
Inspection hole dry

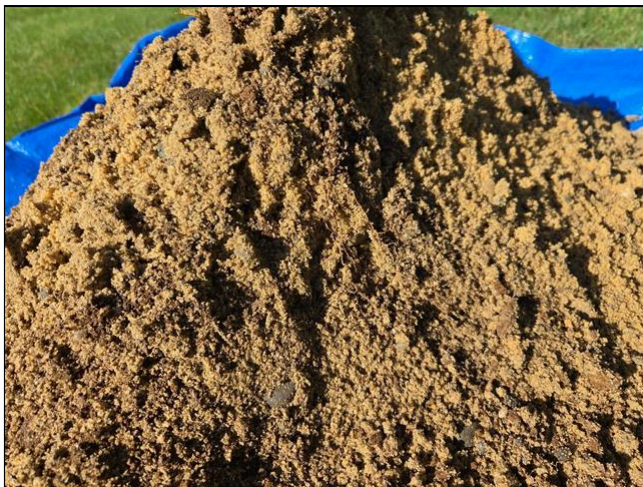
Clean sand removed from EDA

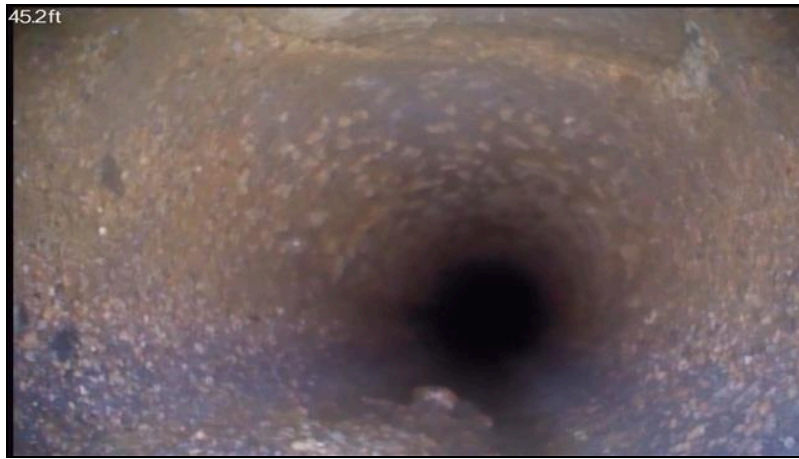
View of distribution line

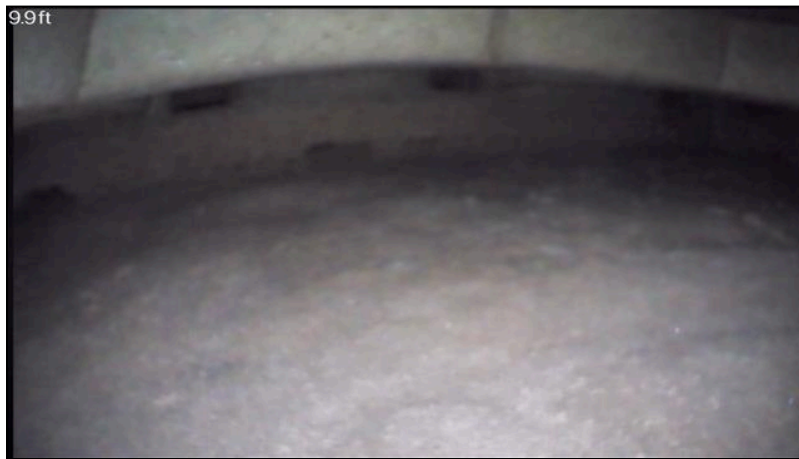
View inside chamber

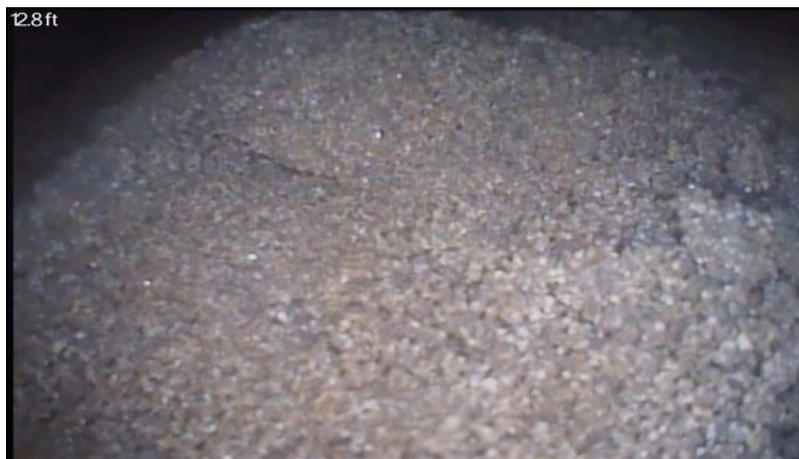
Clean sand inside chamber

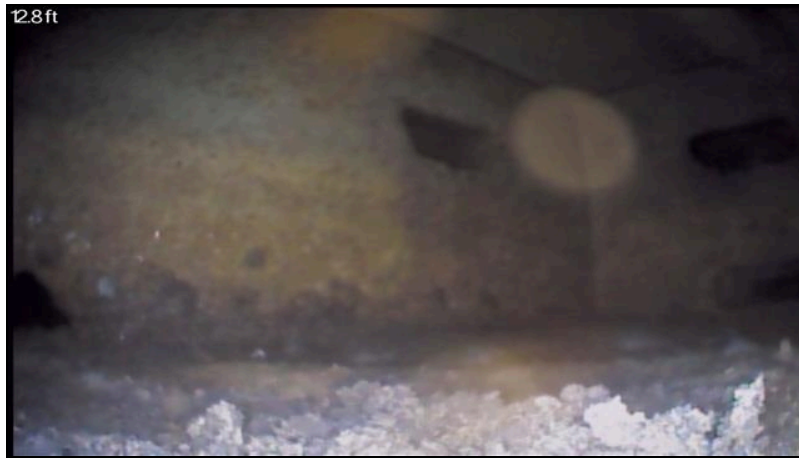
Chamber satisfactory
