Train Collisions and Derailments (in Maryland)

Douglas Hunt*, Wayde Yeager, Katelyn Hamilton, Jonathan Assurian, Nathan Olen

Outline

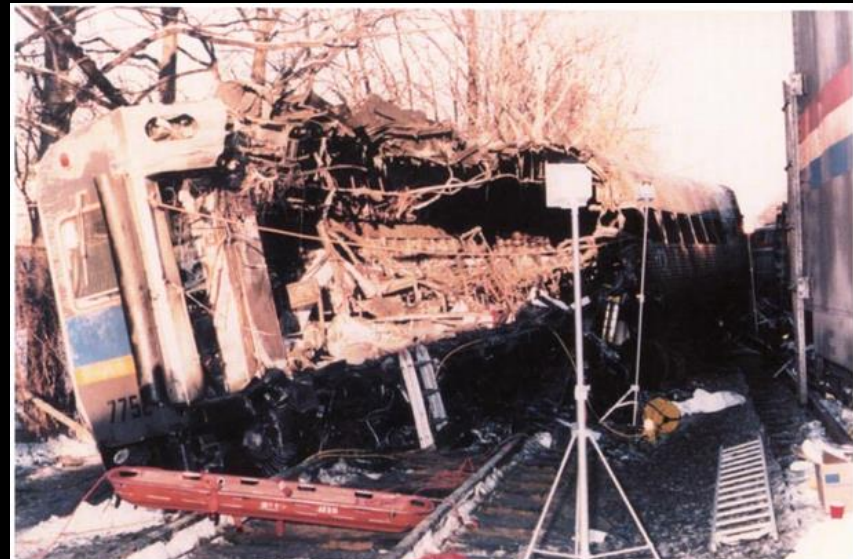
Figure 6--Photograph of postcollision passenger coach cab control car 7752 at accident site.

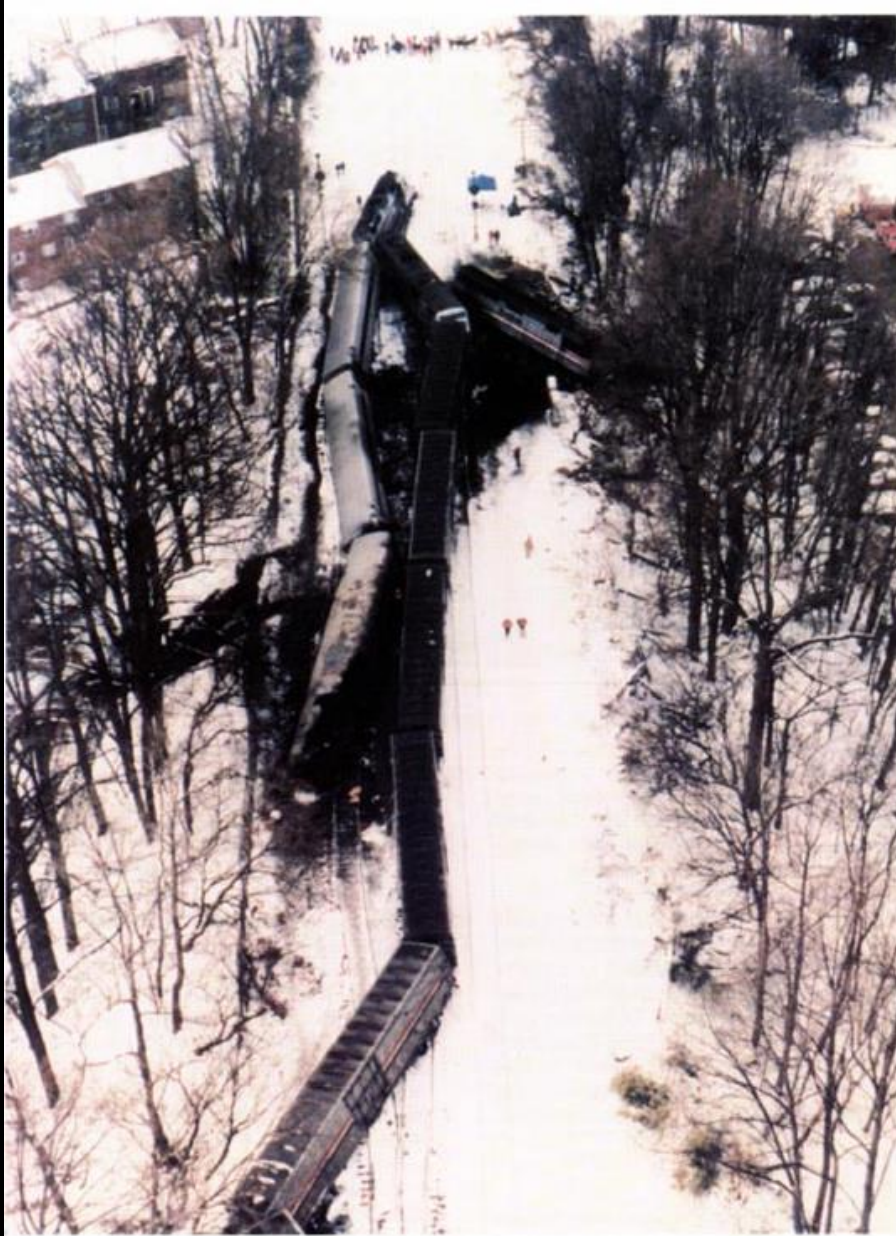
Figure 2--Aerial photograph of postcollision scene.

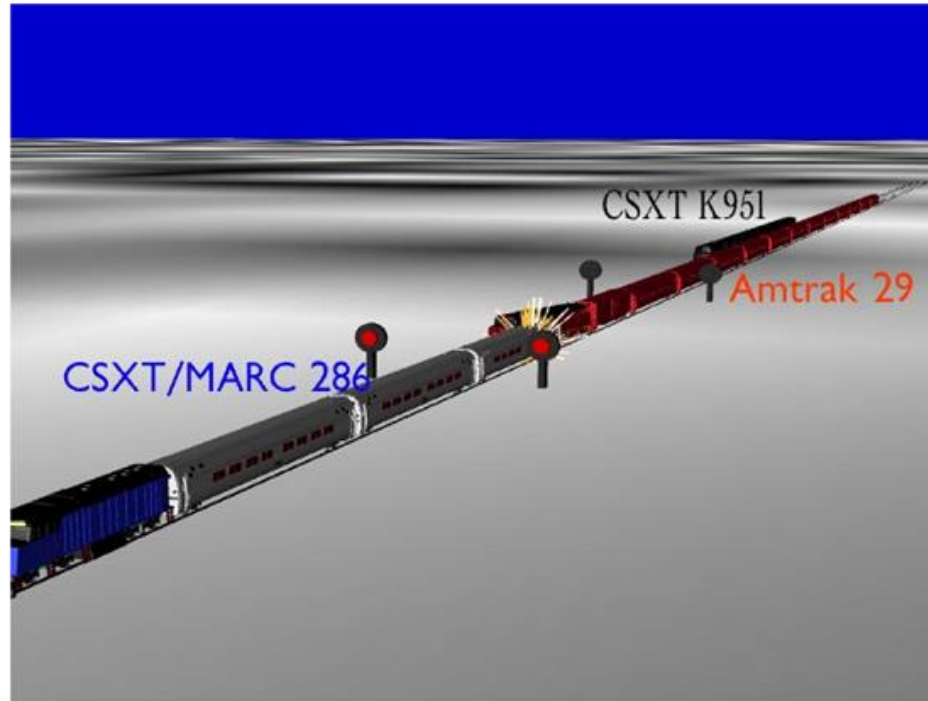
- Human error due to multiple distractions. A safety system to compensate for human error has been suggested.

Figure 1--View of trains at point of impact.

- Amend regulations to require voice communication recordings.
- Require failure modes and human factor analysis for signal system.
- Install cab signals, automatic train stop and train control.
- Require train separation control systems.
- Caution engineers not to use reverser in emergency braking.
- Crash simulation testing for locomotive fuel tanks such as increasing structural strength or raising tanker as well as tank bladders and foam inserts.

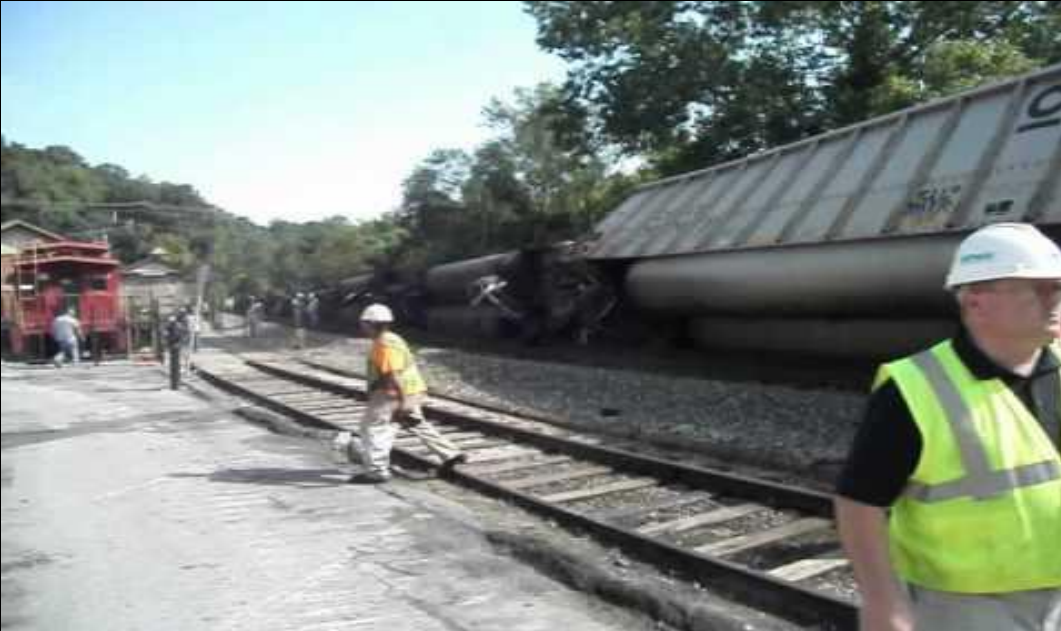
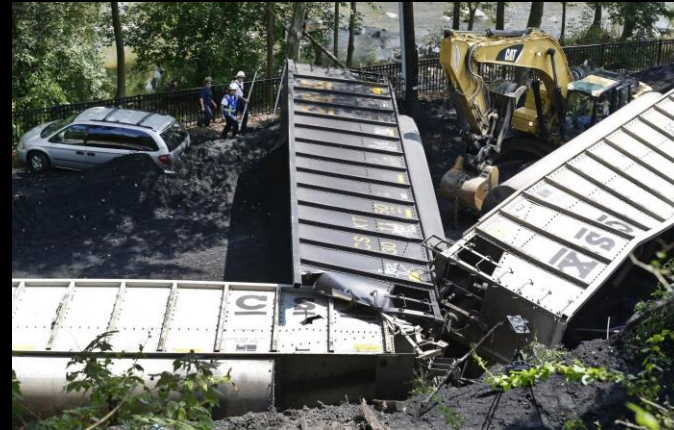
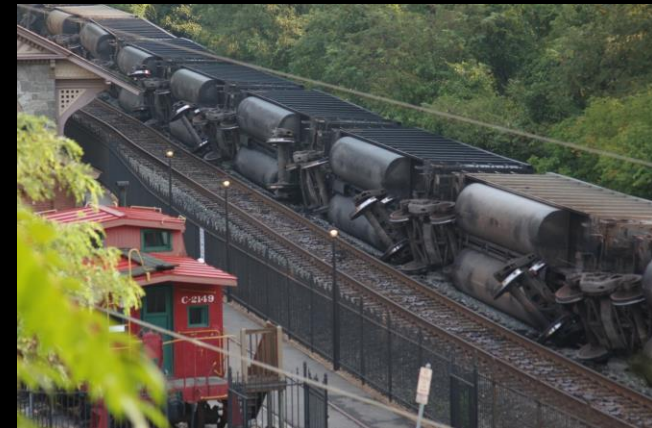
- On August 20th, 2012 just before noon a CSX Transportation train hauling 80 loaded cars full of coal partially derailed.

- The first car behind the locomotive pitched and rolled (that is, all wheels were off the track). The next nine cars overturned to the north of the track. Cars 11 through 17 derailed and fell into the public parking lot that was below the tracks. Cars 18 through 20 overturned. 59 cars did not derail.

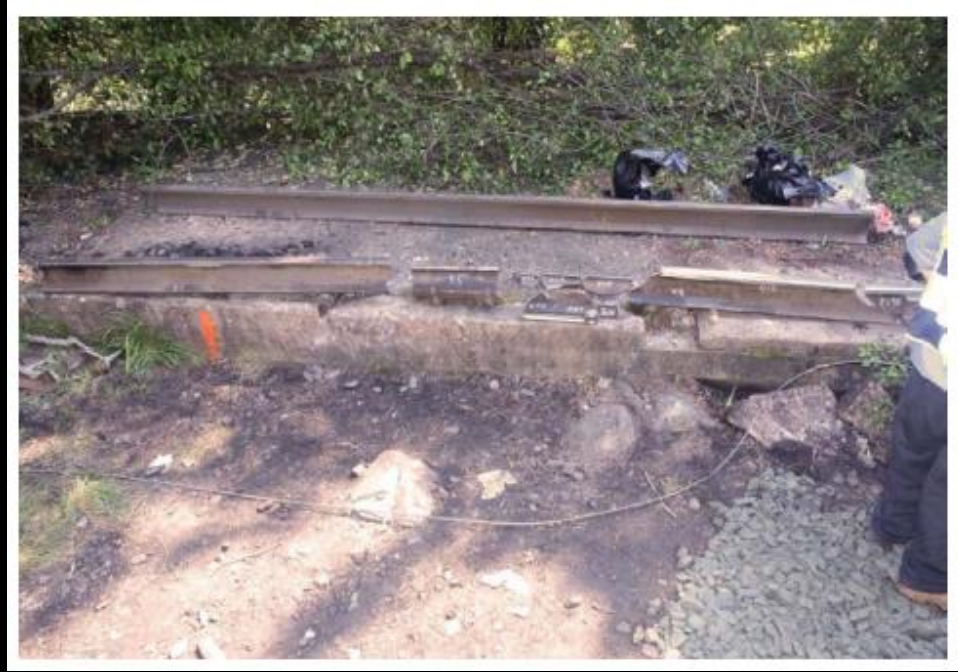
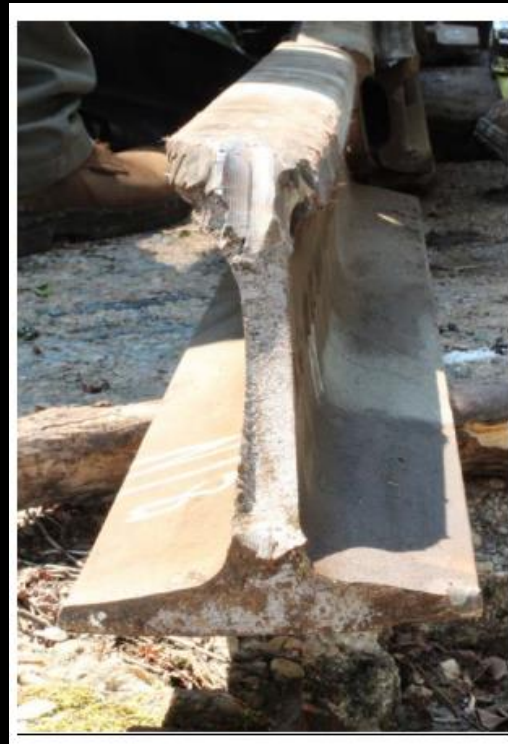
- The laboratory examinations verified that 5 inches of rail were missing. The 17 feet 1 inch of rail exhibited several detail fractures; the largest was about 24 percent of the existing rail head cross section.

- At the point of derailment, the rail fractured due to a detail fracture that initiated from the head checks, patterns indicate that the primary fracture occurred at one of the ends of rail piece.
- Material properties did not appear to be a significant factor in the failure.
- NTSB investigators determined that the defect extended across just 24 percent of the remaining head area, compared to other cases where it extended from 70 to 80 percent of the remaining head area

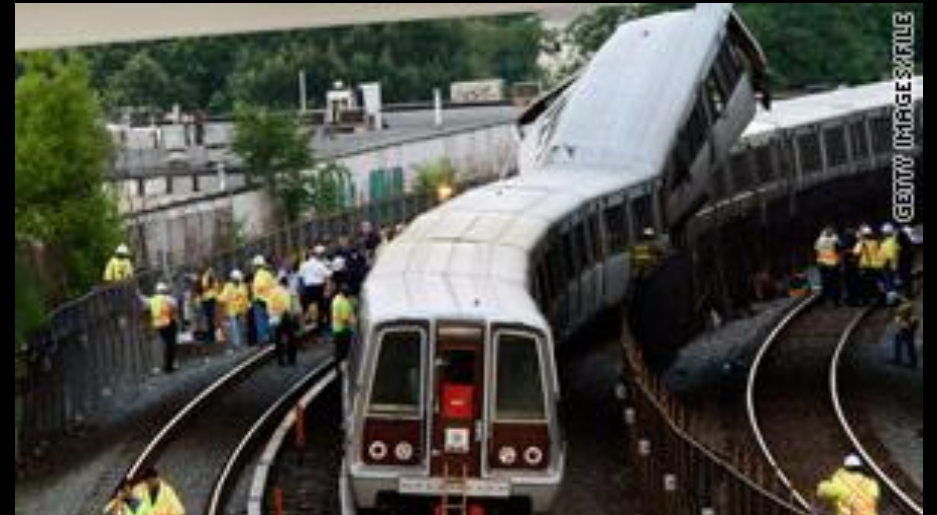
- On June 17th a track circuit was replaced at the site where the collision occurred
- The new track circuit suffered from parasitic oscillations – unable to communicate that the track was occupied by a train
- The still train was in the faulty circuit, so it was “invisible” to the Automatic Train Control system of the moving train
- Emergency break was applied to late

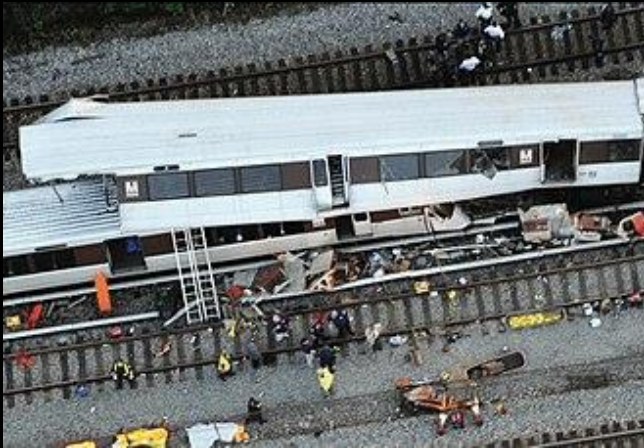
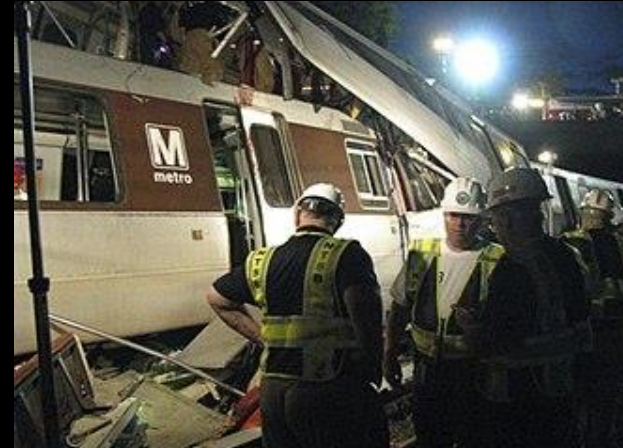
- The circuit malfunctioned, telling the moving train that the track was clear
- The first train had stopped completely inside the malfunctioning circuit
 - Other trains stopping near this spot has rolled forward enough to break the circuit in the next block
 - The first train was being driven in manual, so it was moving at a slower pace and therefore came to a complete stop on the broken circuit
- Incident was originally blamed on conductor for not applying the breaks

- Test circuits more regularly
- Add more circuits to the tracks in order to keep incidents like this from happening
- Look into equipment that identifies failure in parts without having to test each circuit
