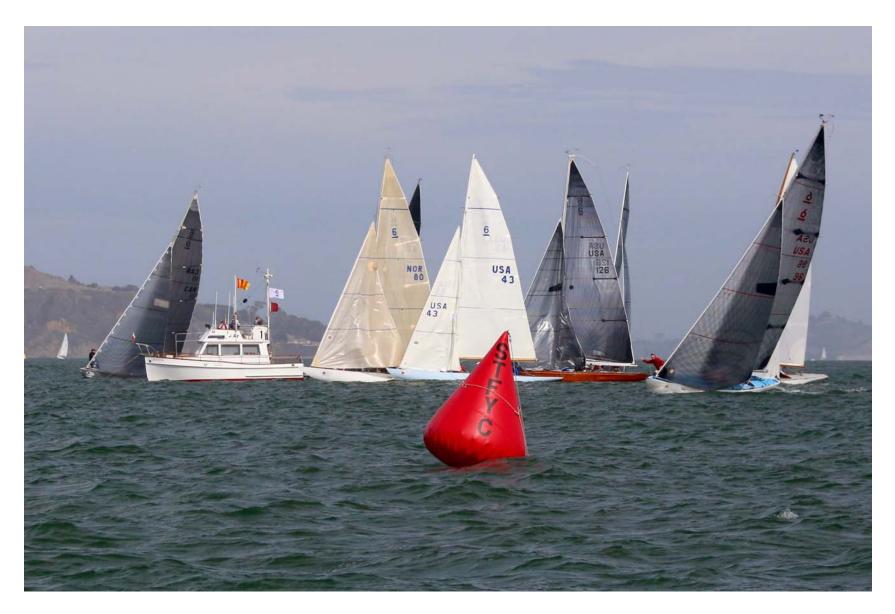
Scoundrel contact had already occurred at forward end of Sprig's jib tracks. See other pages. Sprig advancing.

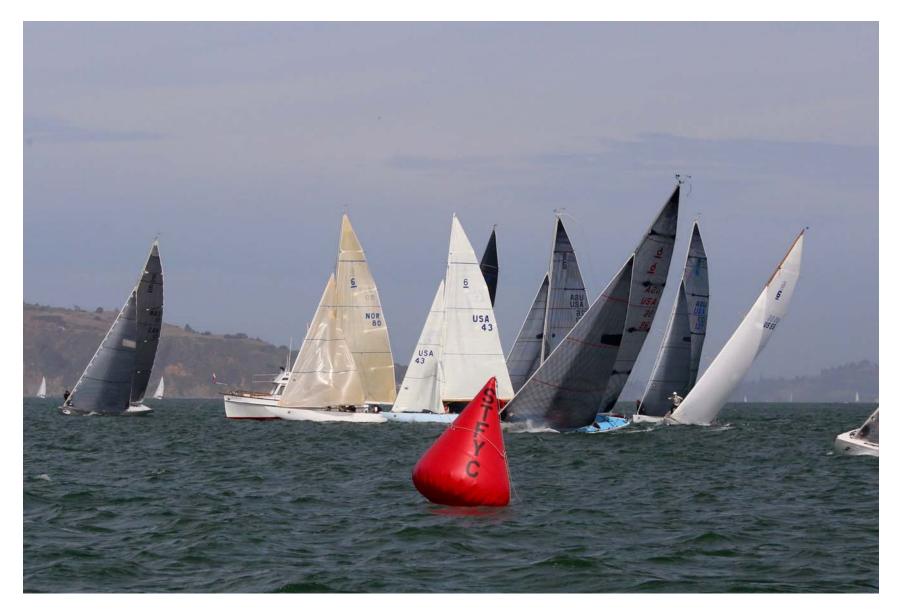
This photo is after Scoundrel contact and just before or at the Arunga time of contact. Arunga change in position from previous photo gives indicate of time between photos.

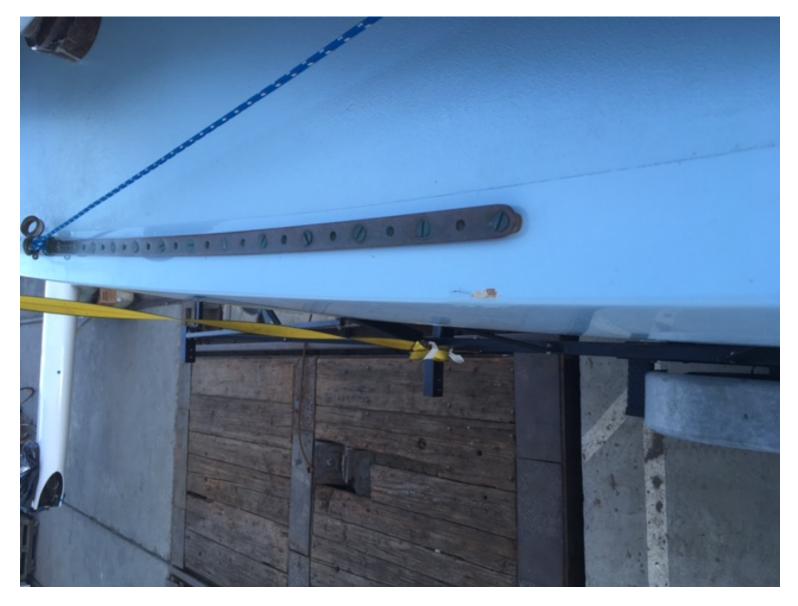
Sprig damage from Scoundrel at forward end of Jib tracks

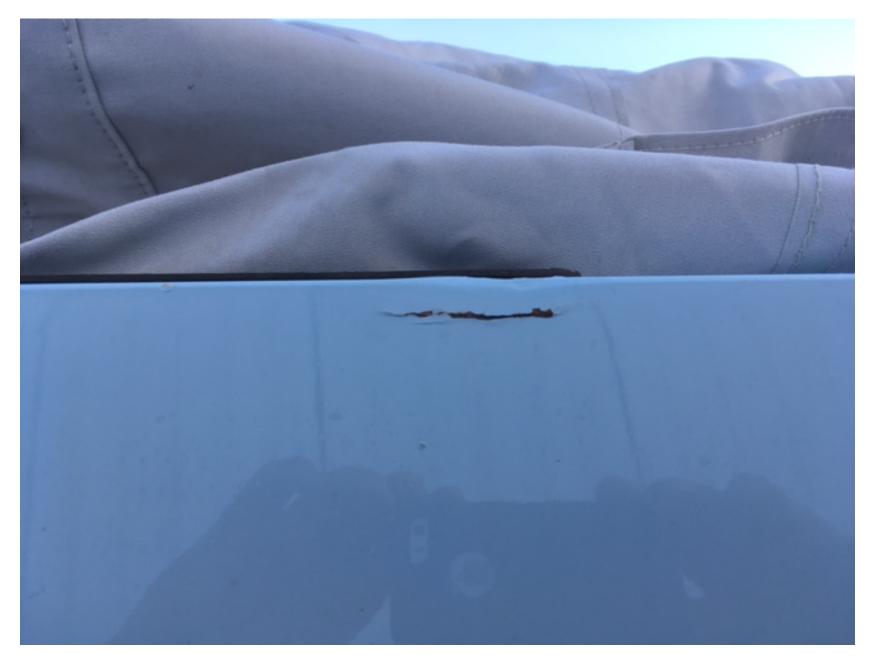
Sprig damage from Scoundrel at forward end of Jib tracks Page 4 of 5

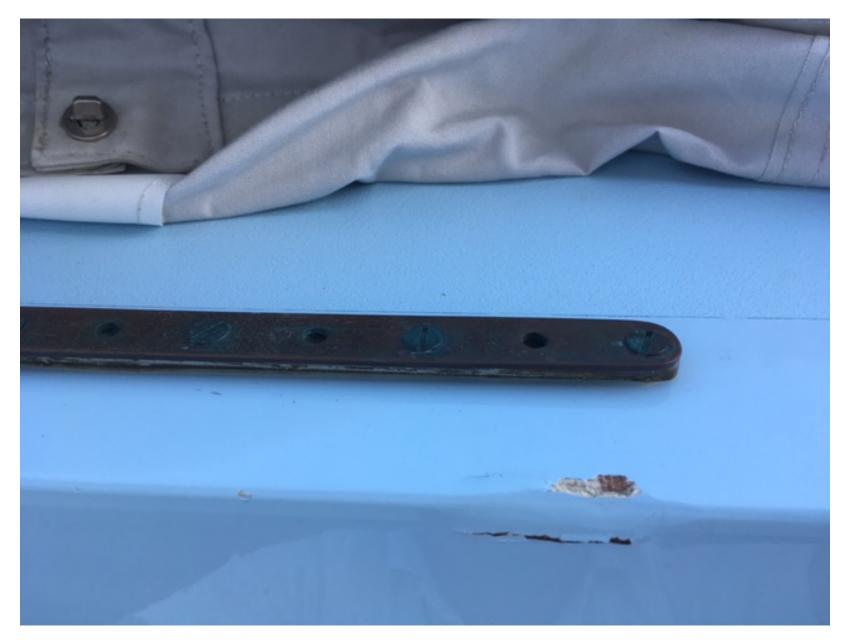
Sprig damage from Scoundrel at forward end of Jib tracks
