Hurlbutt Elementary School

HURLBUTT ELEMENTARY SCHOOL - FACILITY CONDITIONS ANALYSIS

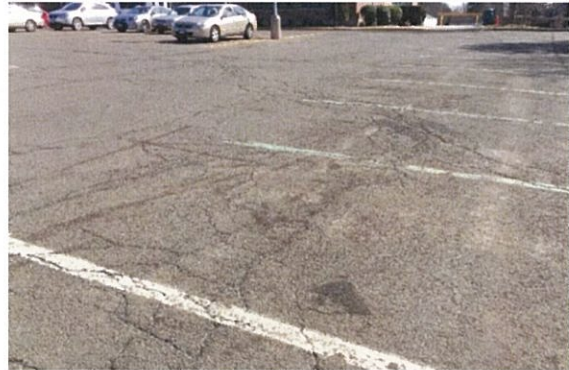
Both concrete and bituminous pathways allow for pedestrian connections from all of the houses around the site. The entire front parking lot has significant cracks throughout the asphalt and should be completely repaved. The teacher parking lot near North House is currently not paved nor does it have any connecting sidewalks to the existing sidewalks and does not meet handicap accessibility. The pathways are in good condition. The surrounding fields appear to be compacted and should be addressed as spring arrives.

Figure 3: Typical parking lot cracks at front

TAG NO.	ASSESSMENT	SYSTEM/ CODE REFERENC E	RANKING				CORRECTIVE ACTION	ITEMIZED ESTIMATED COST	REMARKS
			4	3	2	1			
SITE CONDITIONS									
S1	Front bituminous parking area is approaching the end of its life. Cracks cover the area and the bituminous curbs are starting to fail.	Civil		3			Reclaim and repave.	\$ 192,000	
S2	Front concrete sidewalk has cracking	Civil		3			Replace portion of sidewalk	\$ 12,000	
S3	Timber guard rail is beginning to heave and fall over	Civil			2		Repair portion	\$ 15,000	
S4	Handrails at stair do not have the proper extensions	ADA		3			Weld on the extensions	\$ 2,000	
S5	Concrete sidewalk at South house has area of significant cracking				2		Reclaim and replace the effected area	\$ 8,000	
S6	Hillside erosion near South house hardscape/basketball area			3			Continue timber retaining wall	\$ 8,000	
S7	Proximity of North House playscape to School Rd is problematic - chain-link fence is dated & too low				2		Add a more appropriate physical barrier to the North House playground at school road	\$ 15,000

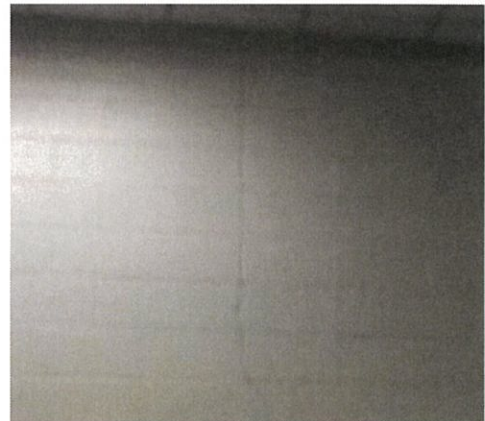
Figure 8: Crack at east wall of gym

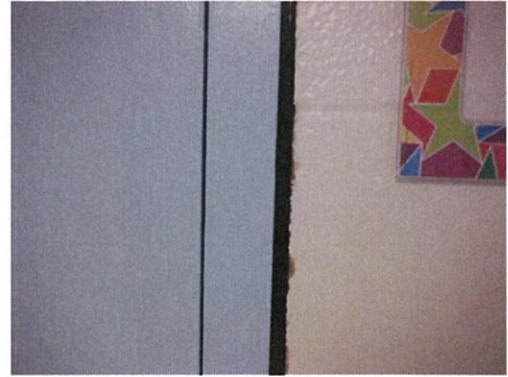
The facility consists of a variety of doors, frames and hardware due to the different ages of all the portions of the school. Most doors are wood with a variety of glazing opening within the leaf. Some are painted while others are not. Some of the painted doors could use a fresh coat of paint. Most hardware has been upgraded, specifically door levers in order to meet code. However, there are still some doors still have knobs that require grasping and twisting. These should be altered as the others have. Most frames are hollow metal frames. Overall they are in good condition with a general need of repainting frames, specifically in East and South Houses. In North House some frames have begun to pull away from the CMU and should be caulked.

Figure 9: Door frame at North House

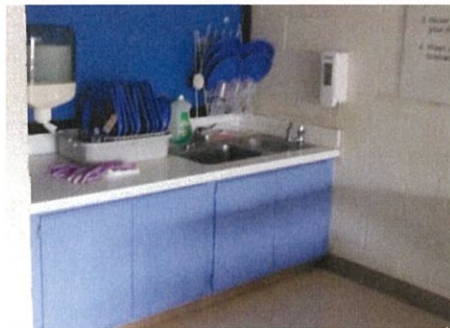
Figure 10: Casework in North House

Most casework and built-in shelving throughout the school is dated. Most notably the dated casework is in the East House as they appear to be original. South House has been updated however the plumbing interferes with the knee space clearance. The Center House has newer plastic laminate casework and those appear to be in good condition. The casework in North House is not quite as dated but some are in tough shape and they do not have a knee space at the sinks and drinking fountains. Most casework throughout does not meet the required height or have the required knee spaces. Most of the sinks within the casework are also not accessible.

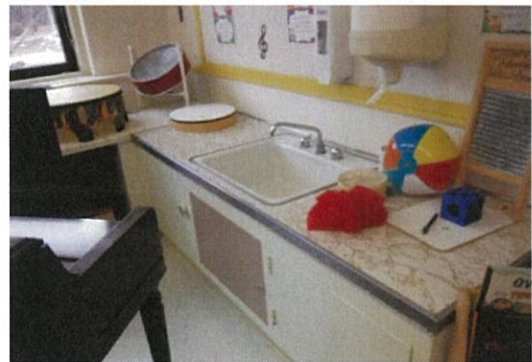
Figure 11: Casework at East House

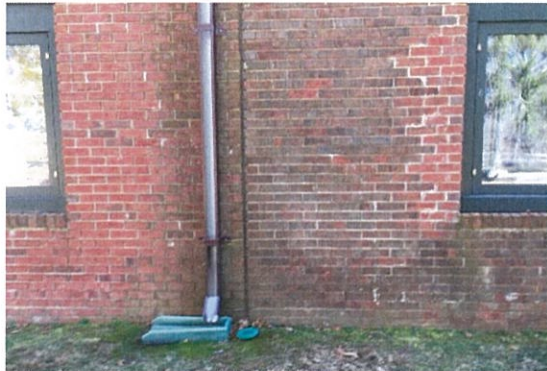
Figure 12: North House masonry conditions

Overall, the mortar is in fair condition with limited areas in need of repointing. Certain areas are in need of more attention. For instance, the base of some of the facades and areas around gutters have mildew and some spalling is present. Most notably this occurs at North House. These areas should be cleaned, repointed and sealed to prevent any further damage. Other areas such as the chimneys may need additional repointing. Some of the exposed foundation walls parging is flaking and may need to be repaired. The through wall base flashing on the east side of North House is deteriorating. This type of repair is rather costly, but this could be allowing water to enter the cavity. It may be the culprit of the water infiltration in the basement elevator machine room below. North House seems to have masonry in most need. Center, East and South have limited areas in need of maintenance. Overall the masonry appears to be in good condition.

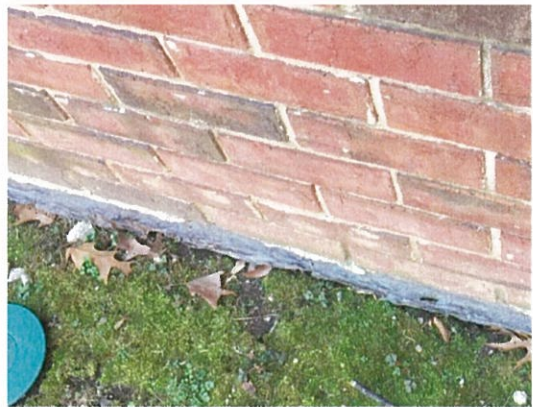
Figure 13: Through wall flashing condition at North House

A6	North House lower level south facing windows are peeling		3	Scrape, prime and paint	\$ 6,000	
A7	Base through wall flashing at North House is deteriorating		2	Remove lower three courses of brick and flashing. Reinstall copper flashing and brick.	\$ 32,300	This could be part of the cause of leaks in basement
A8	Foundation parge coating is peeling		3	Wash and provide a parge coat to foundation wall	\$ 10,000	
A9	Roofs will be nearing the end of its useful life (based on warranty)		4	The roofs are due for replacement in approximately 2020+/-	\$ 1,565,000	Estimate includes asphalt and EPDM to match existing
EXTERIOR SUBTOTAL					\$	1,783,900

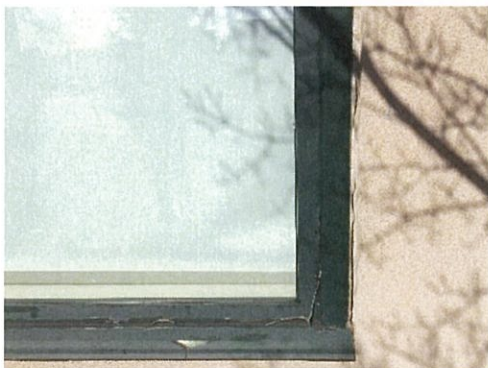
Figure 14: Window at lower level of North House

When evaluating the energy efficiency of a building, it is known that nearly 25–40% of all heat energy is lost through windows. The windows were replaced when the addition was constructed with double-glazed aluminum frame windows. They appear to be in good condition. Caulk is beginning to fail and in need of replacement. Many door frames, mullions and thresholds are beginning to show signs of rust. The ballast roof is in great shape. The EPDM roof also appears in good shape. The wood fascia throughout are in fair condition with some areas in need of more attention. They should be scraped, primed and painted to continue their lifespan.

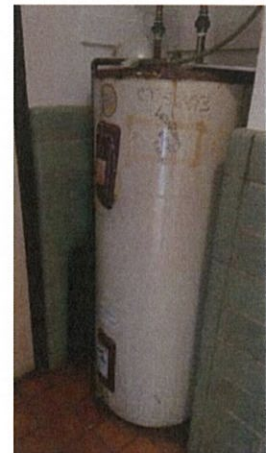
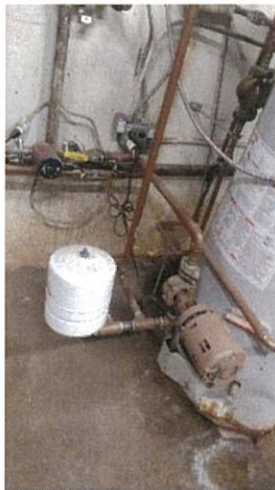
The boiler room in the basement of East House contains 2 domestic hot water heaters. One of the water heaters is a gas-fired water heater having an input rating of 199,900 BTUH and a storage volume of 76 gallons. The system is approximately 14 years old. The system should have an average life expectancy of approximately 15-20 years and remaining life expectancy it about 1-6 years. The boiler room of East House also contained a Bosch tankless water heater that was not plugged in and is assumed to be out of service. This water heater is connected to a 119-gallon storage tank. On the main level of East House, in the kitchen area, is an abandoned water heater that says "LEAKING - OFF LINE" on the outside of it. The gas water heater should be replaced within the next 5 years. The tankless water heater should be checked for serviceability and put back into working order or should be removed. The abandoned water heater in the kitchen area should be removed.

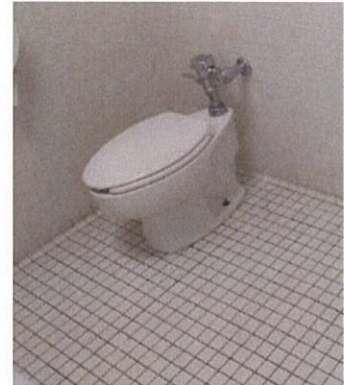
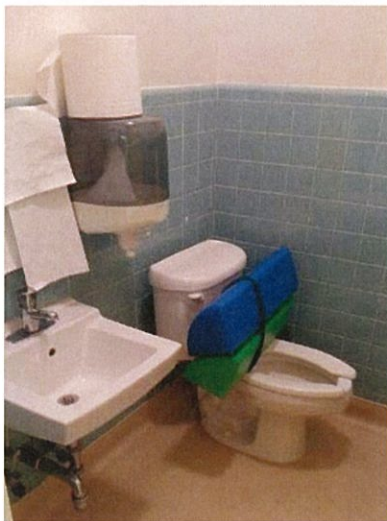
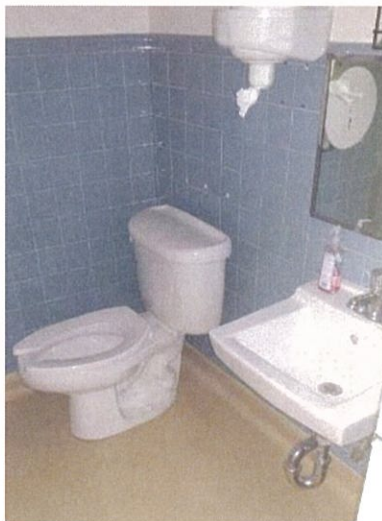
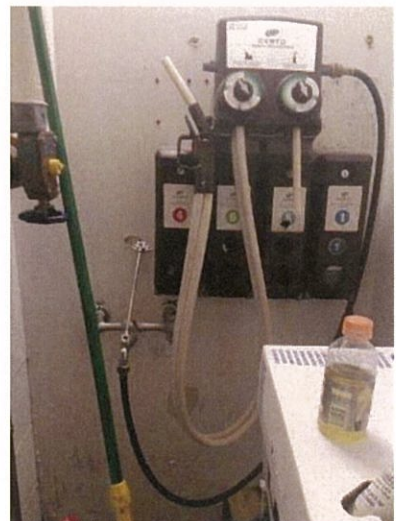
While the overall condition of the fixtures is good, some of the issues noted during the visit are noted below. One of the water closets appears to have had the vacuum breaker portion of the flush valve cut (See photo to right). The manufacturer should be consulted to figure out the location of the "critical line" (typically at least 6" long) for the particular flush valve. If the flush valve has been cut shorter than this, it can create a backflow condition that would allow for contamination of the water supply. Any lavatory or sink that is designed as and ADA accessible fixture needs to have insulation on the piping in the knee space (See photo below). The piping may also need to be reconfigured on additional fixtures. to provide the proper clearances (See photo below). A janitor's sink was observed with hoses connected to the faucet from a chemical feed system without a vacuum breaker to prevent back siphoning in the event of a drop in building water pressure. The condition could result in contamination the domestic water system creating a safety hazard. Recommend installing a vacuum breaker as soon as possible (See photo below).

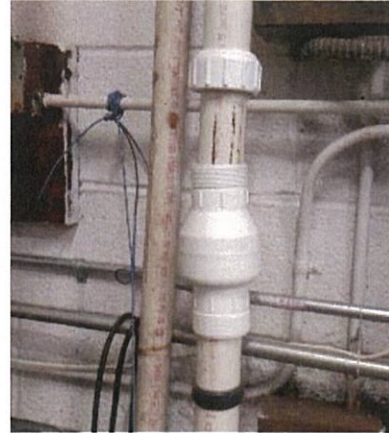
The sanitary for the school is handled by means of a septic tank. None of the fixtures in the kitchens appeared to be connected to an automatic grease recovery unit or grease interceptor. The local health department should be contacted to see if this is a requirement for their district. There is a sump pump located in the basement of the East House. The check valve for the discharge of the pump is not installed correctly. This should be repaired in order to prevent and leaks. There was also another sump pump located in the basement of the North House, but it was inaccessible due to boxes stored in the area. No other sanitary or storm piping issues were observed during the visit. If there are any areas with known issues, it is recommended that the pipes in that area get scoped with a camera to see if the root of the issue can be determined.

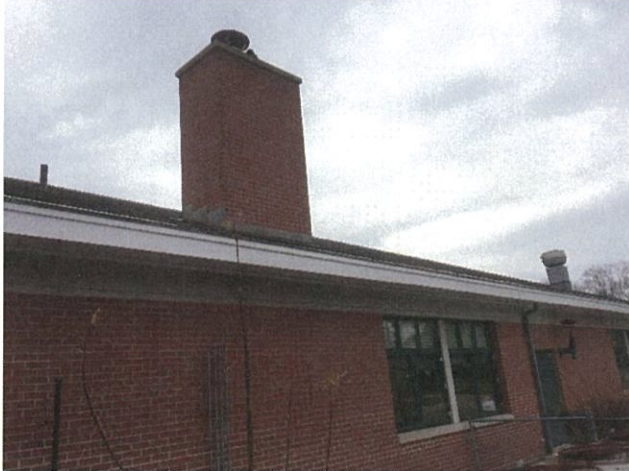
Chimney height for two of the four Boiler Rooms appears to be inadequate. Chimney height for the Central Area and North Wing Boiler Rooms appears to be code compliant but may be inadequate to prevent introduction of flue gasses into the building. The Central Area chimney is below the height of the outside air intakes, making it likely that flue gasses will be drawn into the air intakes under certain wind conditions. The North Wing chimney does not appear to be high enough to prevent introduction of flue gasses under all conditions, especially if new rooftop equipment or air intakes are provided as part of future HVAC upgrades. Consideration should be given to

increasing the height of the two chimneys. All chimneys should be cleaned and inspected by a company specializing in chimney installation and maintenance.
